COLORADO CULTURAL RESOURCE SURVEY

Architectural Inventory Form

1. Resource Number: 5CF406.100
2. Temporary Resource Number: 101
3. County: Chaffee
4. City: Salida
5. Historic Building Name: Parker Terrace
6. Current Building Name:
7. Building Address: 121-23 E St.
8. Owner Name and Address: Simonson, Peter M., 931 Elm Drive, Salida, CO 81201

48. Report Title: Downtown Salida Historic Buildings Survey, 2001-02

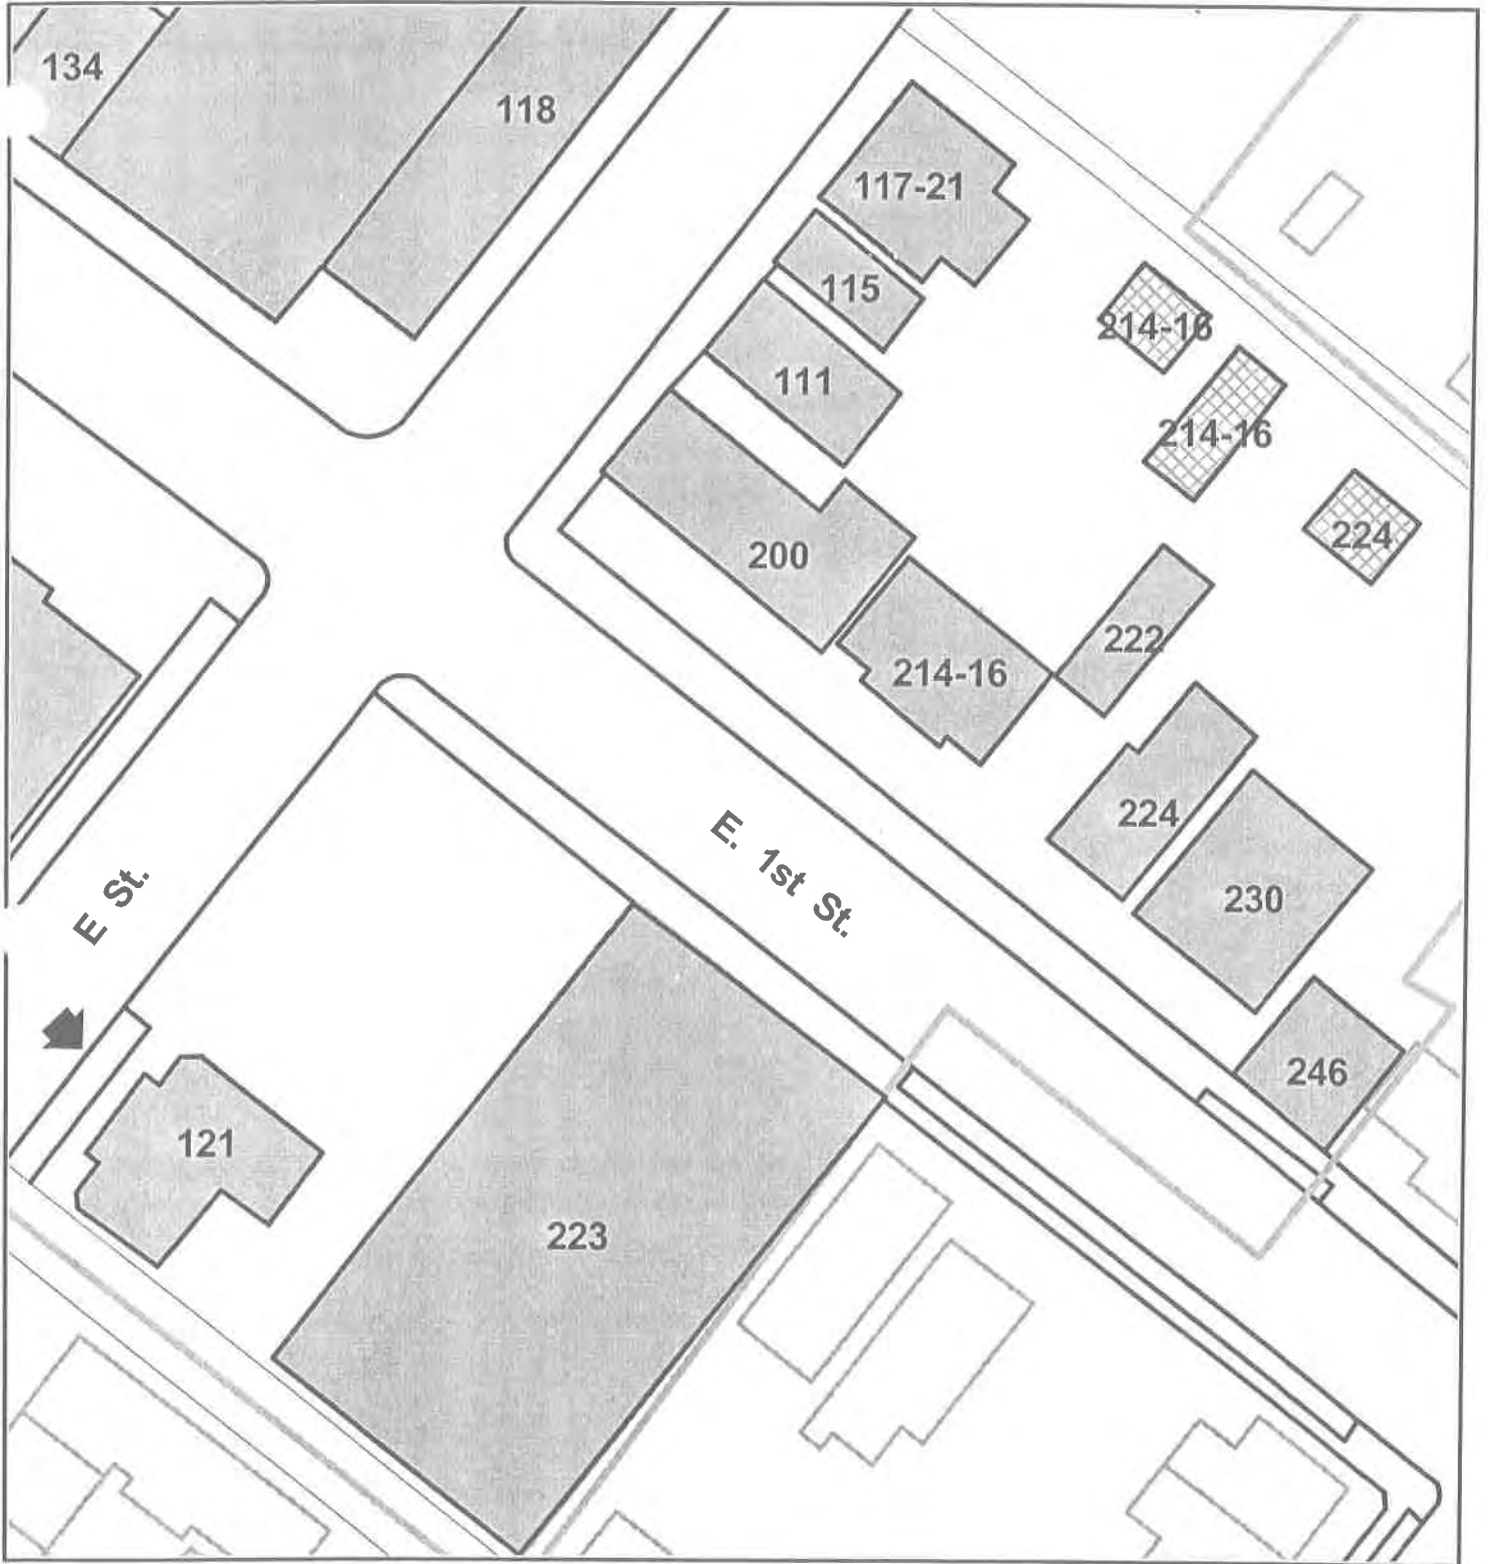
121 E Street, 5CF406.100

Two-story stuccoed duplex residence with raised foundation covered with concrete. Façade has central bay that projects forward and beveled corners on north and south. Stucco covers cornice and other features of building. Upper story of projecting bay has two tripartite metal frame windows with plate glass lights flanked by casement windows. Round arched molding is visible above windows. First story also has two arches visible above entrances which have multi-light nonoriginal doors and small vertical windows with glass blocks. Bays flanking center bay have tall segmental arched double-hung sash windows with rock-faced stone sills on the second story and large

segmental arched windows with plate glass and stone sills on the first story. The beveled corners have segmental arched double-hung sash windows on each story. The south wall is blank and has a one-story projection at the rear. The north wall has segmental arched windows on the second story and a stuccoed chimney projecting from the top of the first story. On the first story of the north wall are segmental arched windows filled with glass blocks. There is a one-story projection on the south, rear.

Alterations to this building, including application of stucco to the walls and window alterations, have diminished its historic physical integrity.
