ARCHITECTURAL/HISTORICAL COMPONENT FORM

- 1) Resource No. 5CF239 2) Temp No. 28 3) Name Shoe Service
 4) Address 100 Blk. E. Second 5) District Name N/A
 I. INTEGRITY: 6) Condition: Good Fair Deteriorated
 7) Original Use commercial property 8) Present Use commercial property
 9) Original Site Moved Date(s) of Move: _____
 10) Unaltered Altered Explain: Stucco over brick on side facades.

3)Resource Name Shoe Service 4)Project Name FCRC Survey

23)Report Title Historical Surveys of Colorado Communities: Upper Arkansas Valley, Salida

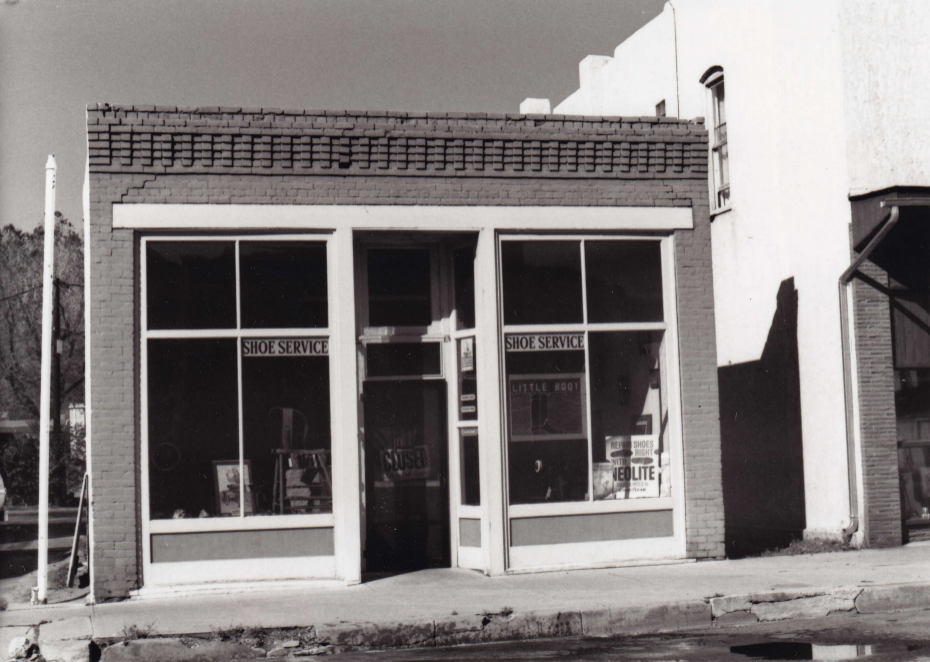
Frame Number 10
 Roll Number CF 2
 Facade Orientation N

18)Disturbance:none light X moderate heavy total ; Explain stucco over brick
on side facades

Within Salida, this one story brick building provides a fine intact example of late nineteenth century commercial architecture. A very simple structure, it is distinguished by a brickwork pattern at the cornice line, and a storefront area dominated by a central recessed entrance flanked by large display windows which, previous to the extensive use of indoor lighting, allowed sufficient amounts of natural light into the building. The storefront is framed in wood.

20)Management Recommendations continued maintenance of structure
