ARCHITECTURAL/HISTORICAL COMPONENT FORM

1) Resource No 5CF270 2) Temp No. 59 3) Name Band Box Cleaners  
4) Address 119 North F 5) District Name Salida Commercial District

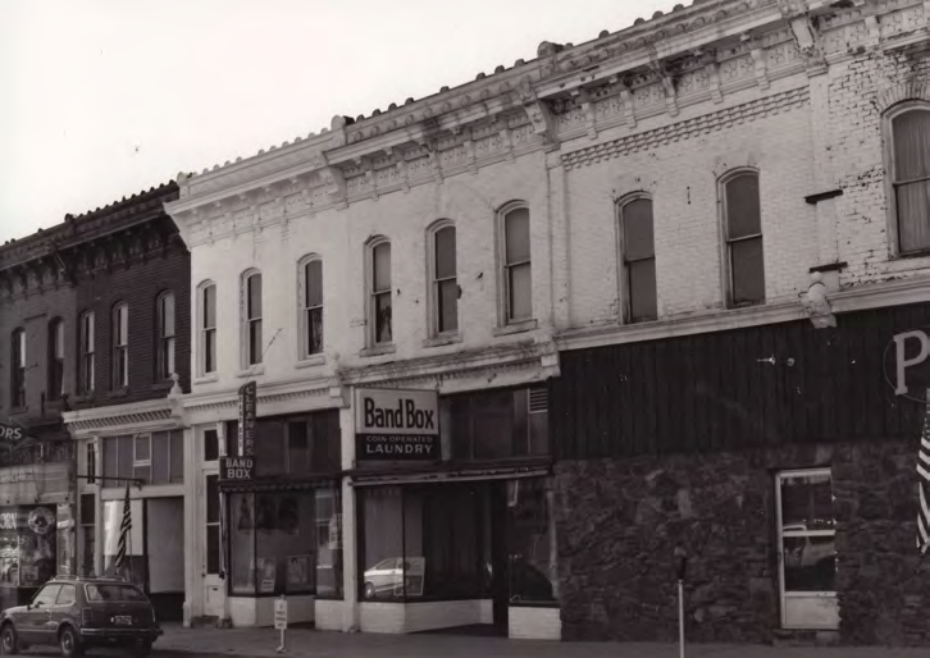
Frame Number 9  
 Roll Number CF4  
 Facade Orientation W

10) Unaltered  Altered  Explain: Brick siding over kickplates (panels  
beneath display area)

A two story brick commercial building featuring six segmental arch bays, the bracketed metal cornice which connects the building to its neighbors, and a continuous lintel separating the storefront area from the upper story. On the ground level are two recessed entrances flanked by display windows and highlighted above by a transom window. A side entrance to the second story is also evident.
