ARCHITECTURAL/HISTORICAL COMPONENT FORM

- 1) Resource No. 5CF245 2) Temp No. 34 3) Name part of Stallsworth Motor Co. Datsun Dealership  
 4) Address 139 W. Third 5) District Name n/a  
 I. **INTEGRITY:** 6) Condition: Good  Fair  Deteriorated   
 7) Original Use commercial property 8) Present Use commercial property  
 9) Original Site  Moved  Date(s) of Move: \_\_\_\_\_  
 10) Unaltered  Altered  Explain: Display windows partially covered.

3)Resource Name part of Stallsworth 4)Project Name FCRC Survey

23)Report Title Salida

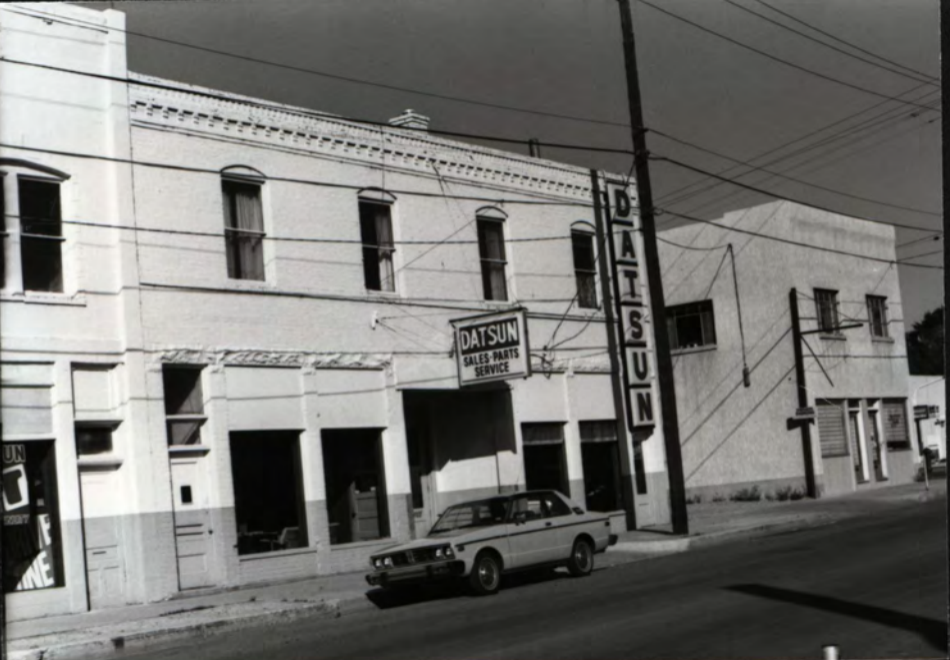
Frame Number 3  
 Roll Number CF 3  
 Facade Orientation N

**IV. SIGNIFICANCE:** Assess whether or not the resource has any historical or architectural merit by checking appropriate categories and justifying below. Include any relevant historical data.

A two story brick structure distinguished by brickwork patterns at the roofline, four segmental arch openings on the second floor, and an intact storefront area. The large display windows which are partially covered are highlighted by cut stone lintels.

18)Disturbance:none  light  moderate  heavy  total  ;Explain Display windows

partially covered

20)Management Recommendations Refer to Secretary of the Interior's

Standards for Rehabilitation
