ARCHITECTURAL/HISTORICAL COMPONENT FORM

- 1) Resource No. 5CF295 2) Temp No. 84 3) Name Elks Lodge  
 4) Address 148 E. Second St. 5) District Name n/a  
 I. INTEGRITY: 6) Condition: Good  Fair  Deteriorated   
 7) Original Use Elks Lodge 8) Present Use Elks Lodge  
 9) Original Site  Moved  Date(s) of Move: \_\_\_\_\_  
 10) Unaltered  Altered  Explain: One story brick addition on east side.

23)Report Title Historical Surveys of Colorado Communities: Upper Arkansas Valley, Salida

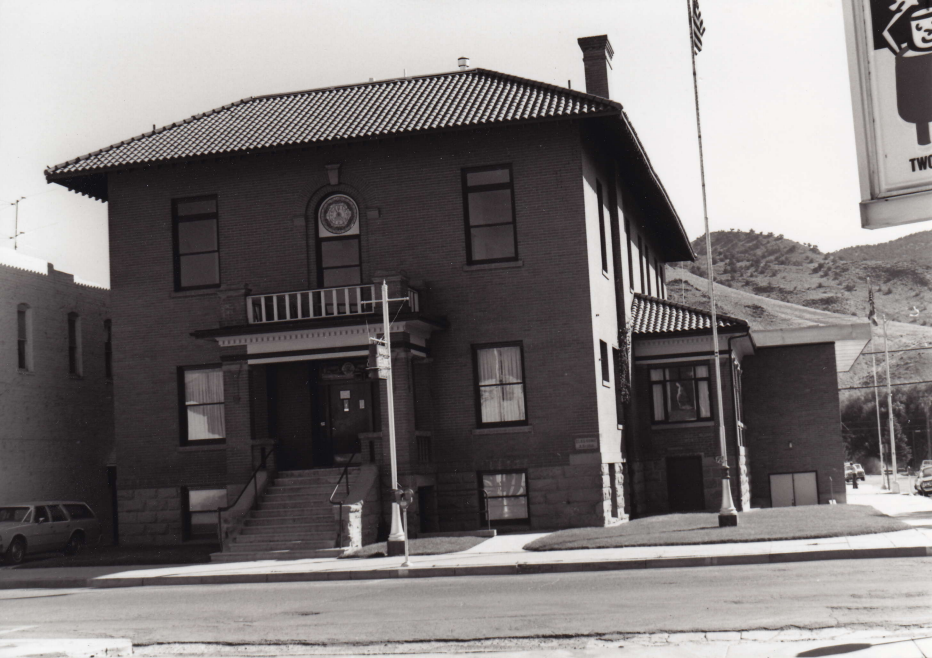
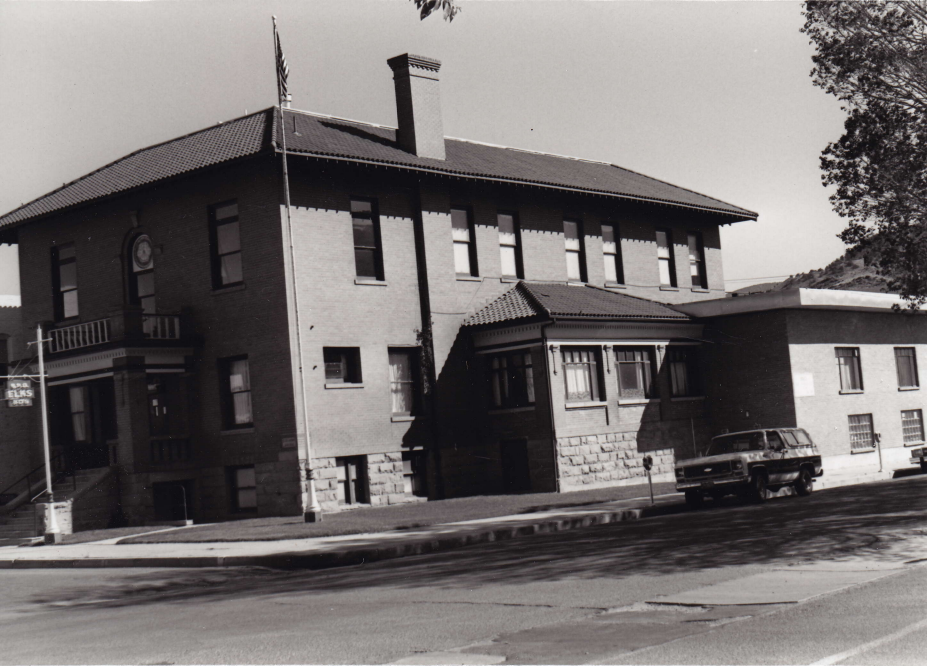
Frame Number 18,19  
 Roll Number CF 5  
 Facade Orientation S

The Salida Elks Lodge, constructed in 1910 at the cost of \$20,000, is a two story brick building, rectangular in shape and with a truncated hip roof which is covered with barrel tile. (The roof of the one story eastside addition, which is part of the original building, is also covered with barrel tile.) The building's facade is characterized by a central entrance highlighted by a balustraded porch. Above the porch is a round headed bay, partially filled with stained glass. Double hung bays flank both the window and the first floor entrance. A new brick one story addition appears on the east side of building.

18)Disturbance:none    light X moderate    heavy    total    ;Explain new brick one story  
addition (a somewhat compatible one) on east side
