# COALDALE SCHOOL

## HISTORIC STRUCTURE ASSESSMENT

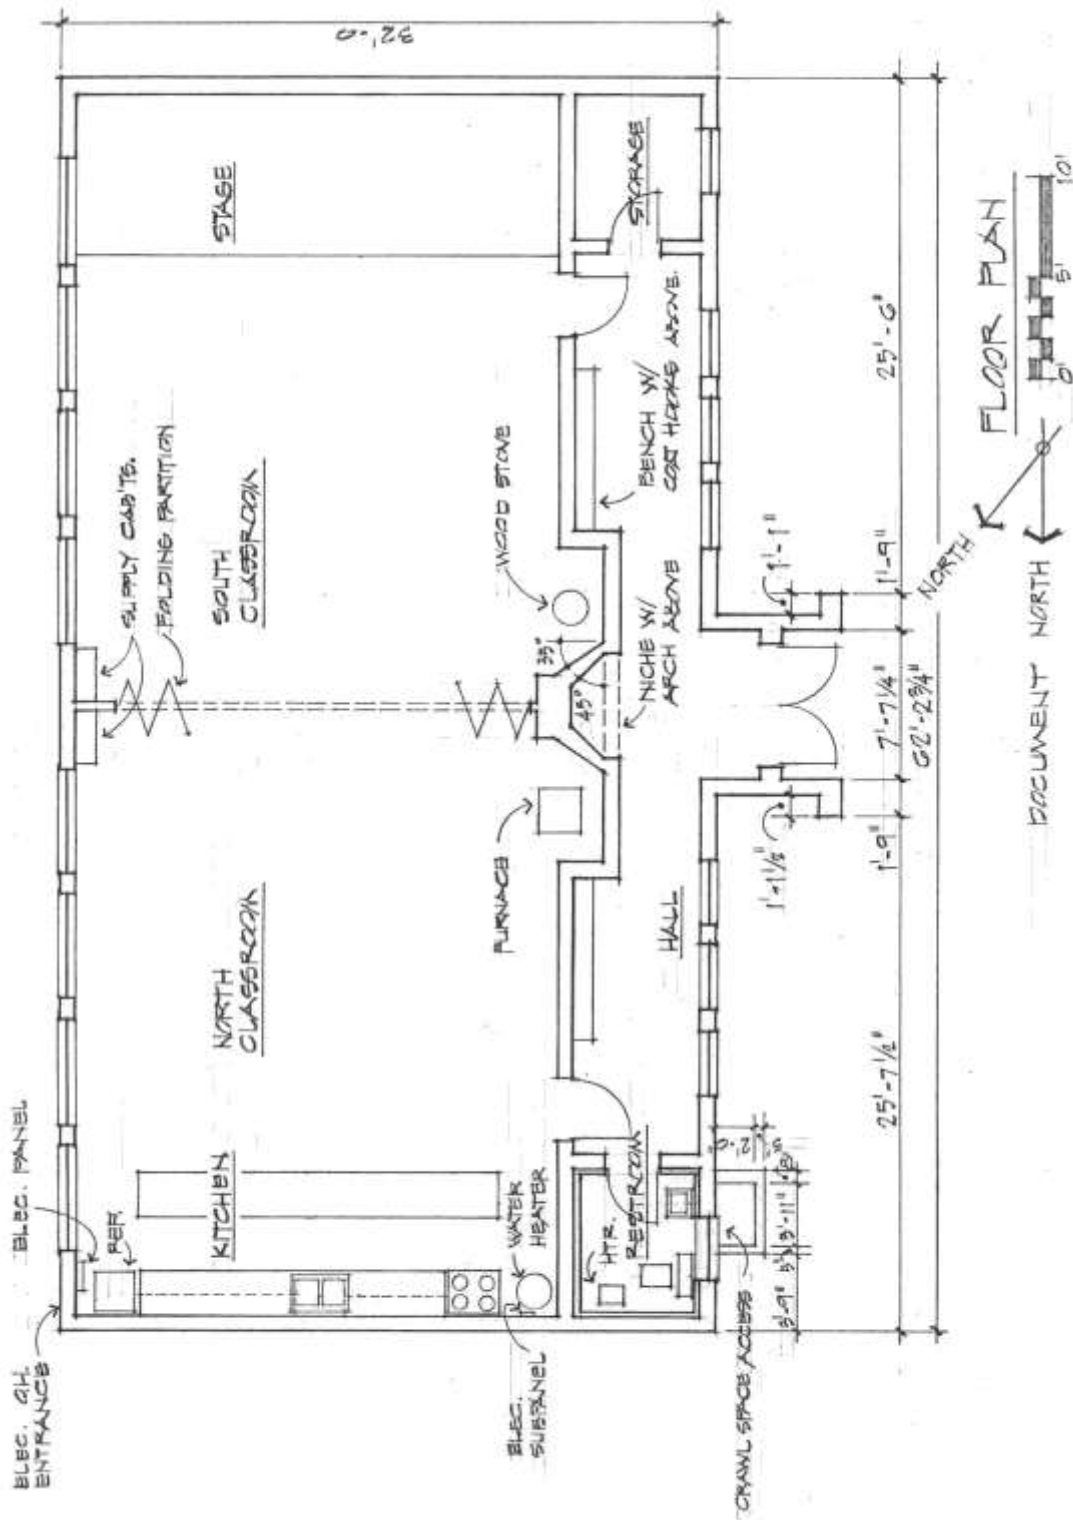
# STRUCTURE CONDITION ASSESSMENT

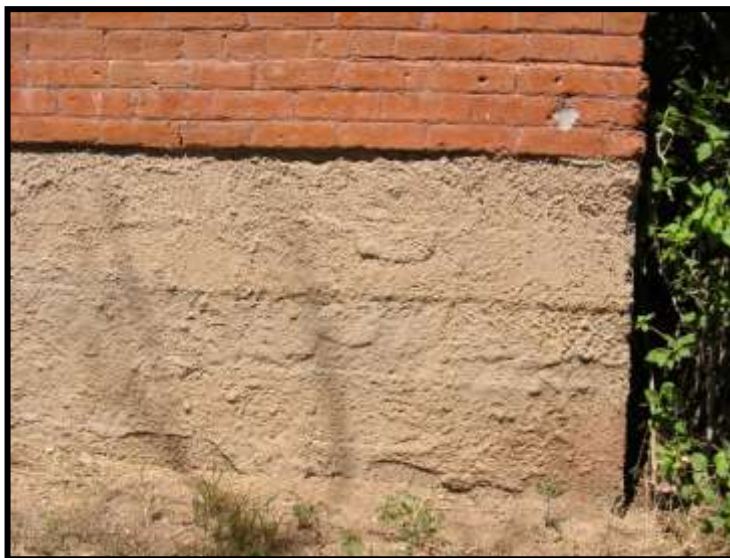
*Figure 12. Foundation wall. South wall, southeast corner, showing parget coat over horizontal formboard marks.*

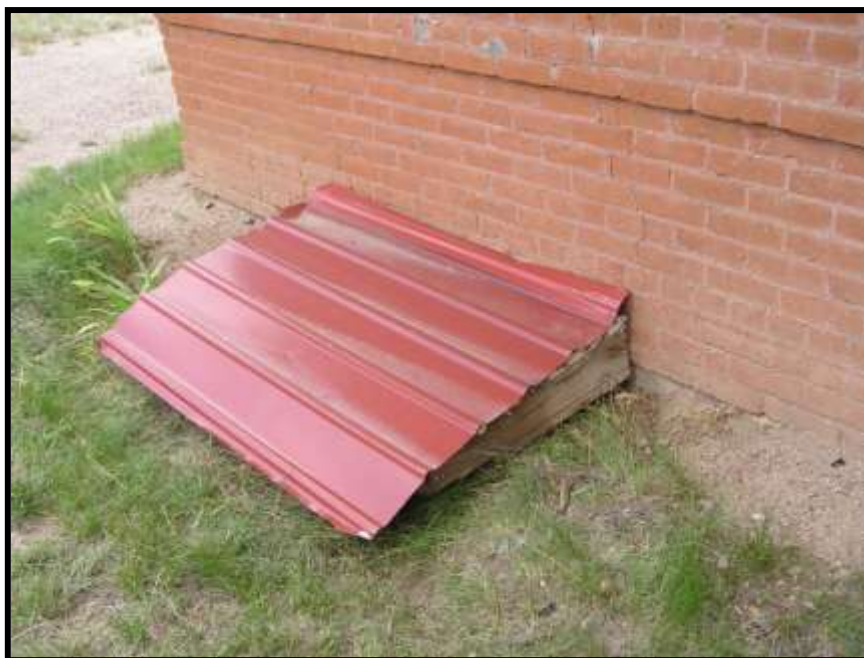
*Figure 13. Crawl space entry cover. West wall, looking northeast*

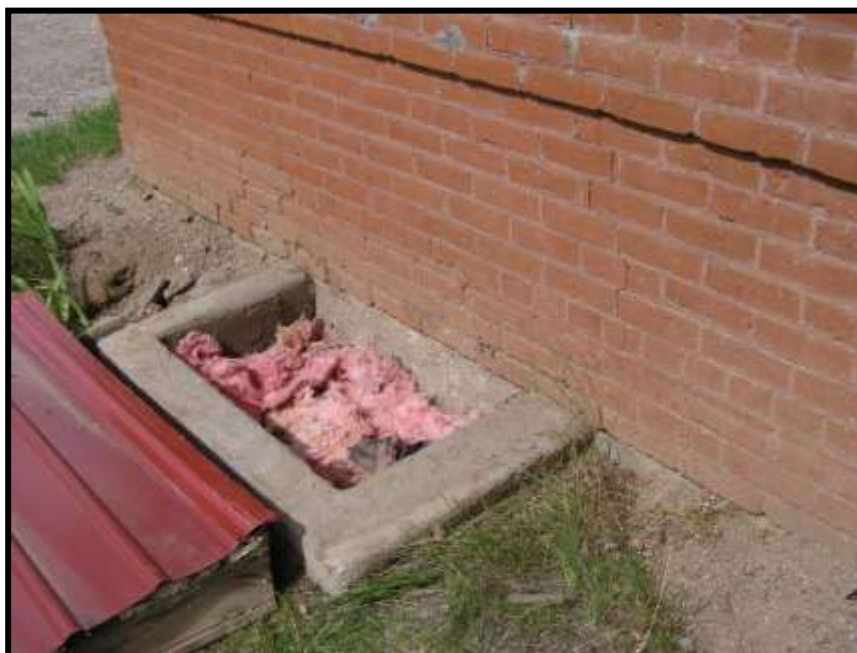
*Figure 14. Crawl space entry, north end of west wall. Below the pieces of fiberglass batts is more insulation of various types.*

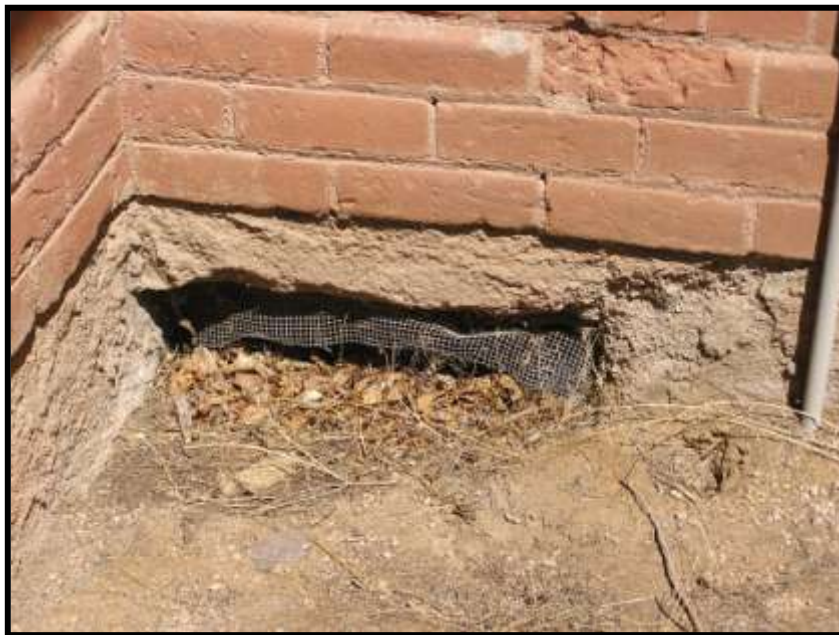
*Figure 1. Crawl space vent, west wall at intersection of entry Wall. Note more spalled and poorly patched brick.*

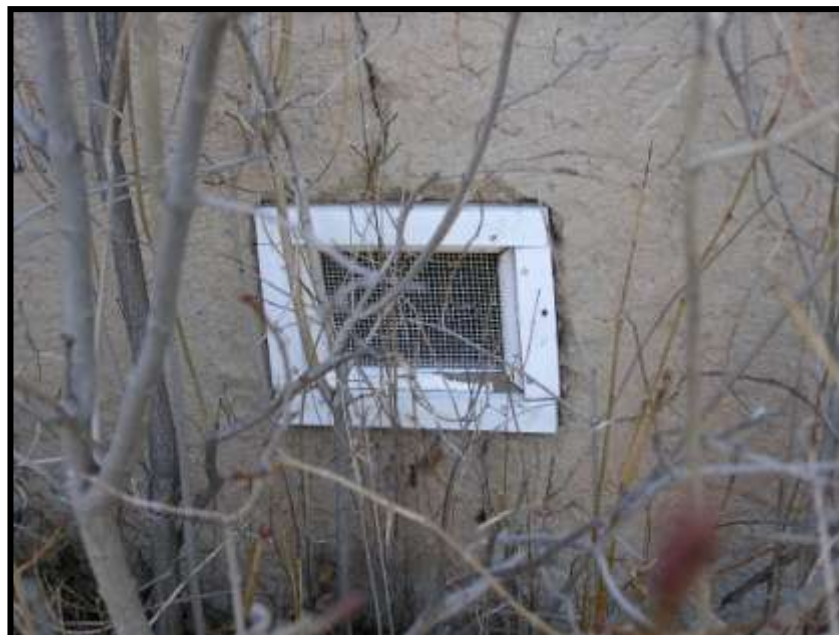
*Figure 2. Crawl space vent, east foundation wall.*

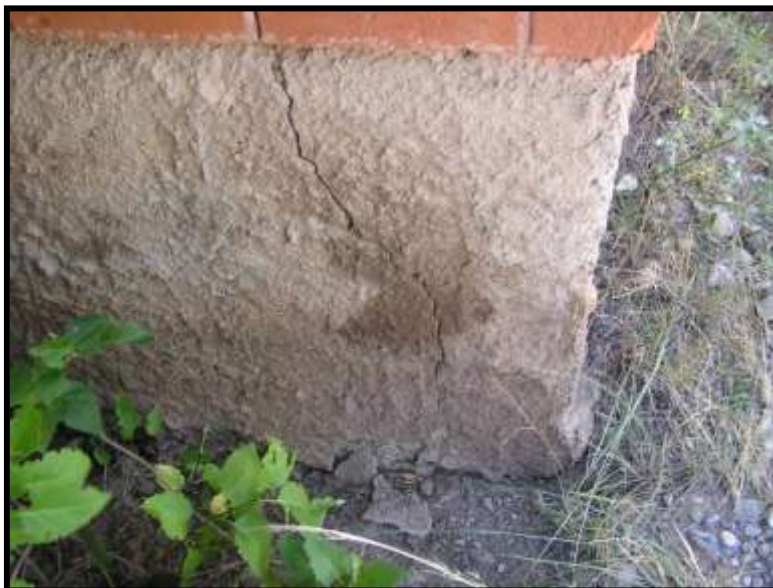
*Figure 17. Foundation crack, east wall at northeast corner. Crack continues up to end of window sill (See Figure 52 for same crack on interior). Stain on pargeting is probably due to moisture entering the crack.*

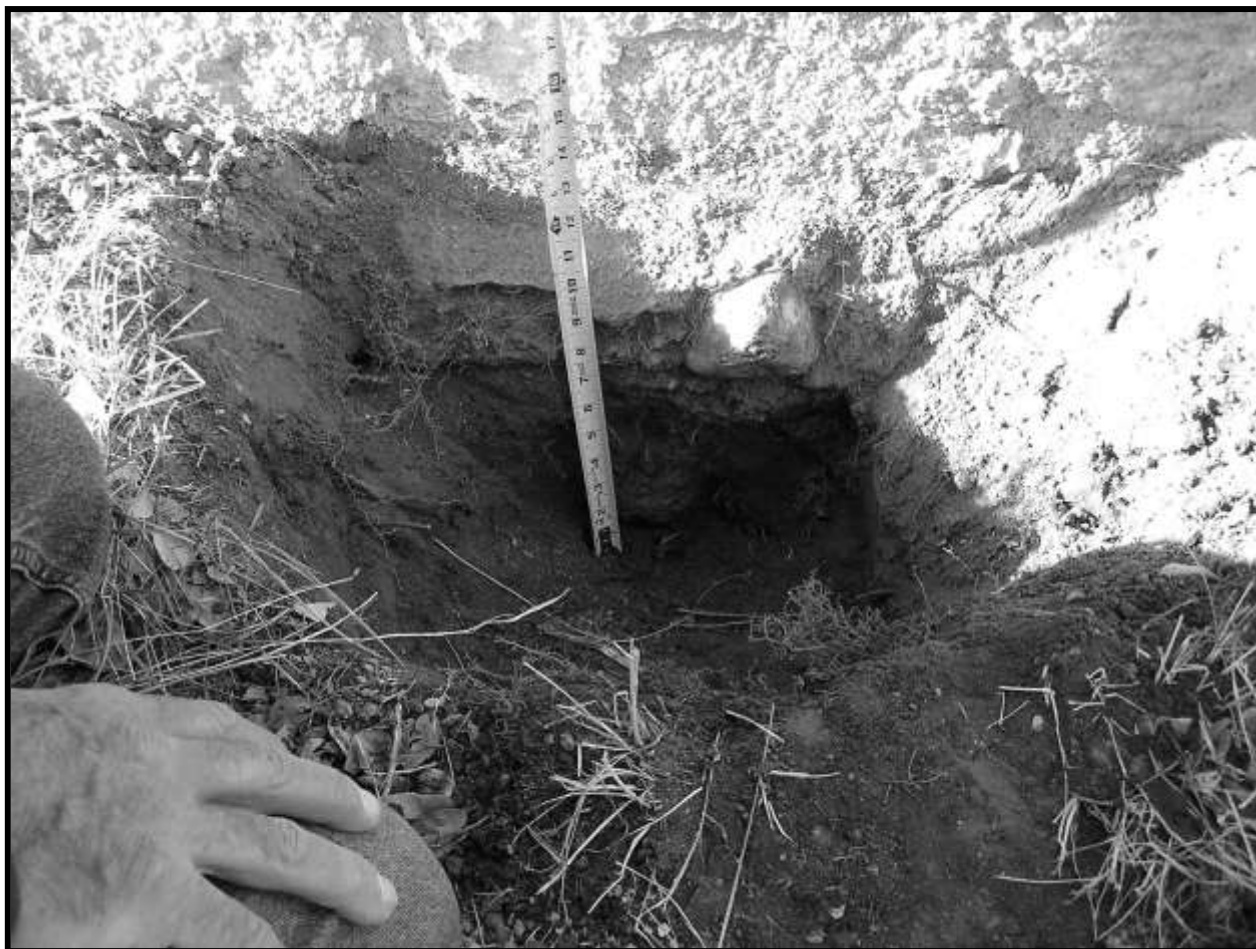
*Figure 18. Stone rubble exposed below pebbledash stucco parge coat. East end of south wall, looking north.*

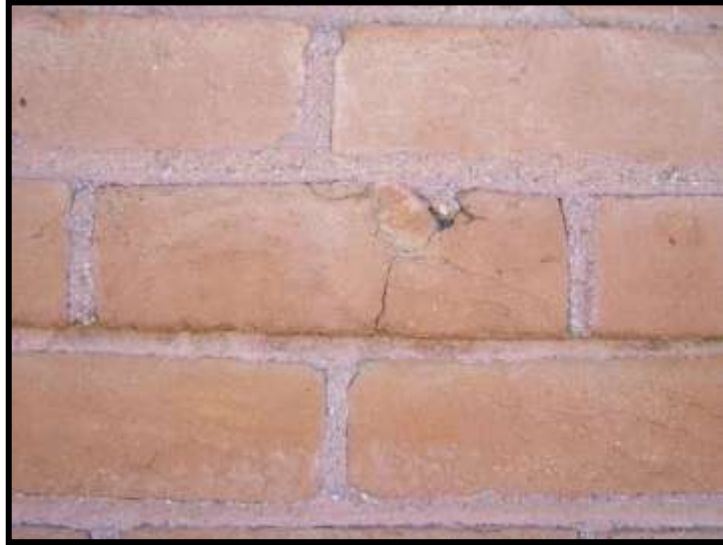
*Figure 26. Brick with imperfections at north wall. Note vertical crack through the imperfection which is the weakest point.*

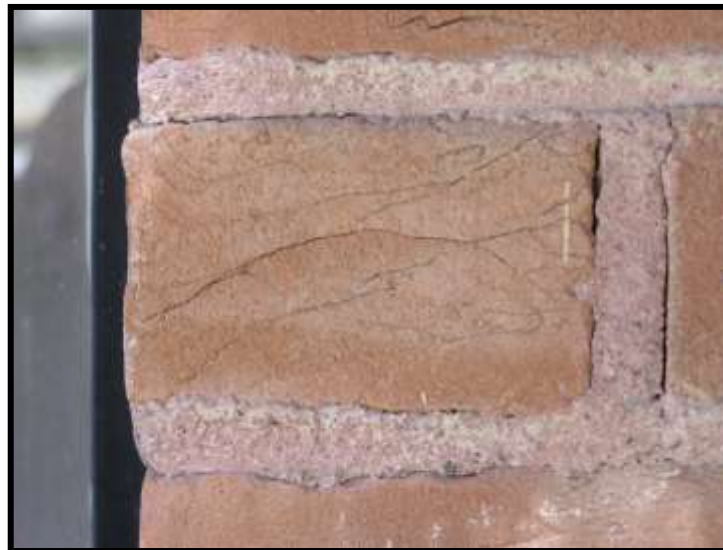
*Figure 27. Dry pressed brick, end view. Cracks in brick are from hand placement of clay in the form. Brick probably laid with bottom up. Note red tinted mortar and stuck joints, vertical and horizontal.*

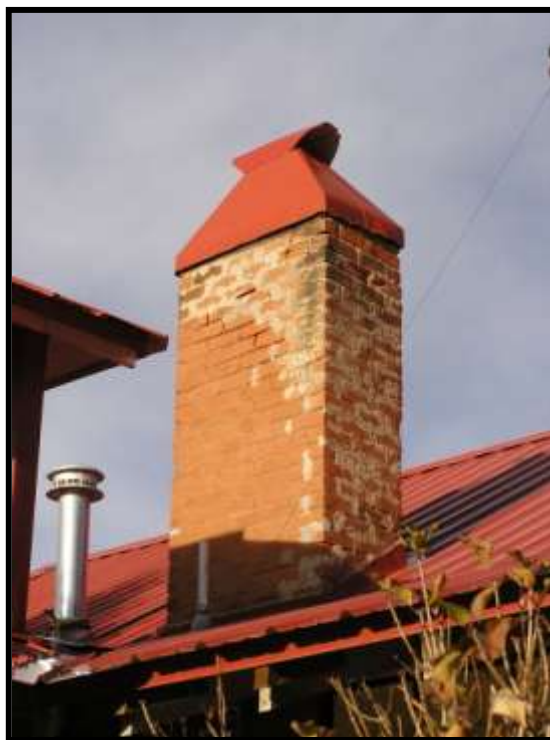
*Figure 28. Chimney with red painted steel cover, looking northeast.*

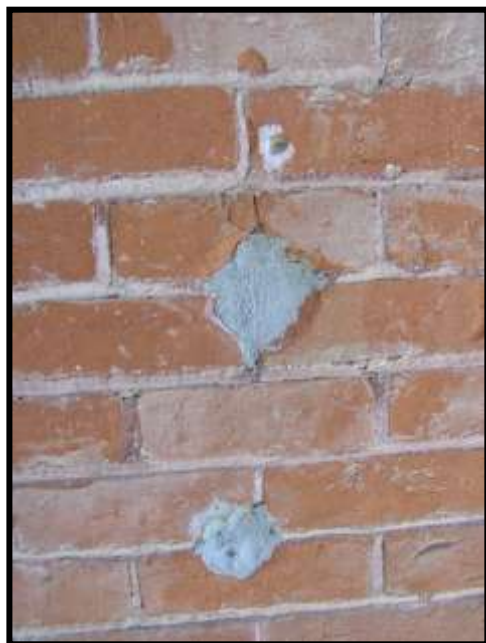
Figure 29. Brick damage inflicted by adults, **twice**—first by making holes, second by inappropriate patching.

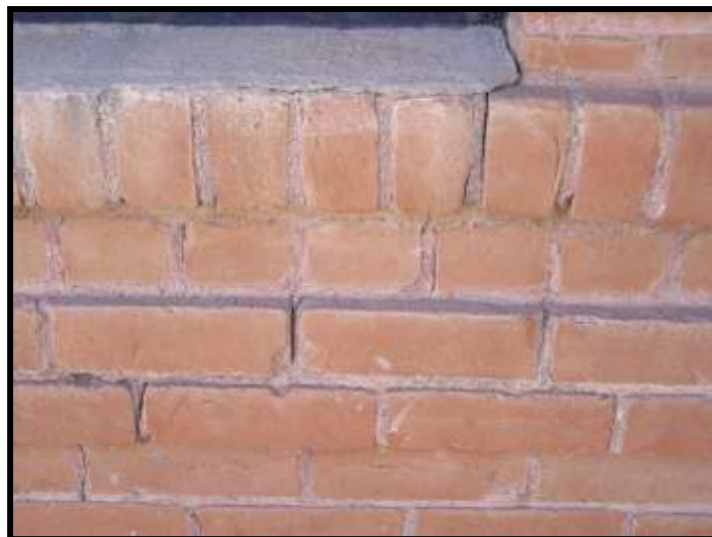
Figure 30. Crack at sill and below, south end of sill, northernmost window in Hall.

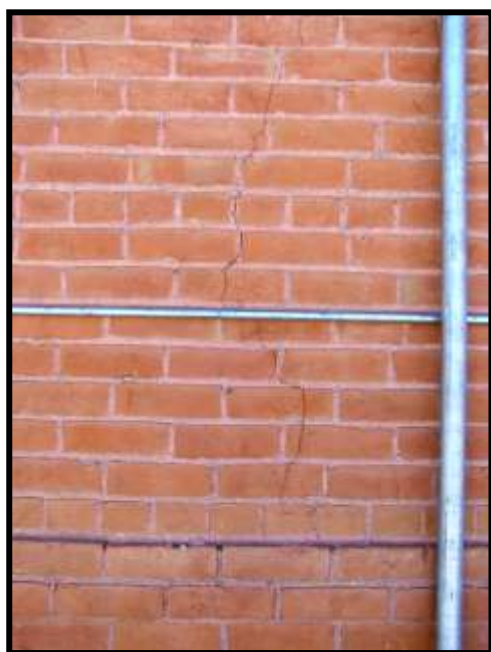
Figure 31. Vertical hairline crack to left of kitchen waste vent, north wall. While crack is thin, it is very long, continuing several feet downward and upward from eye level.

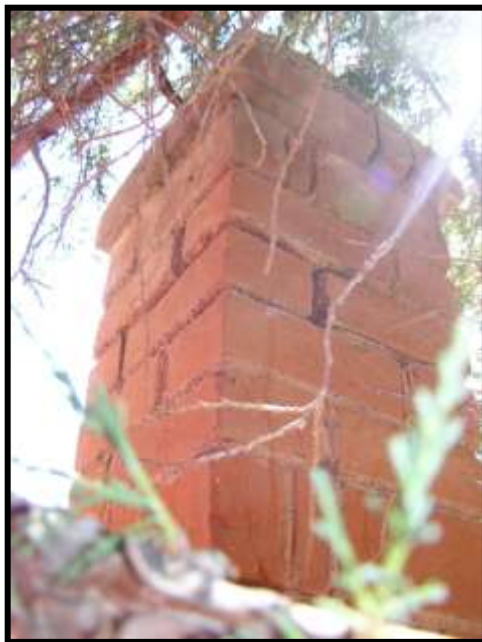
*Figure 32. Northernmost entry pilaster, looking southwest from behind. Note open mortar joints.*

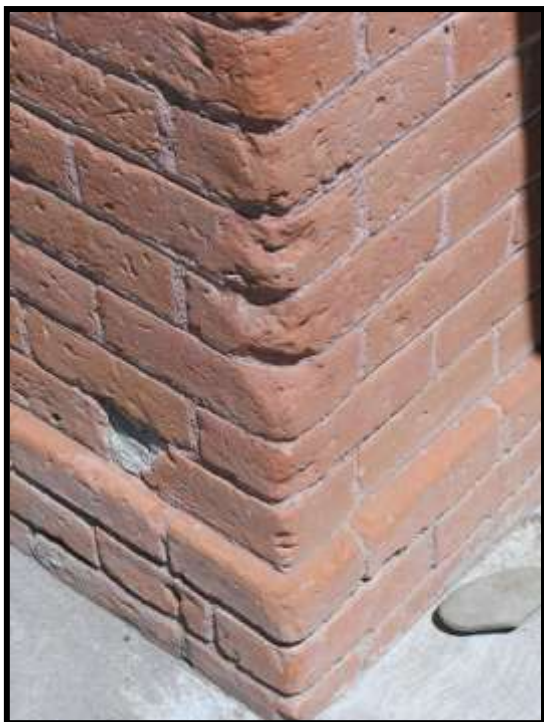
*Figure 33. Brick corner low on pilaster at entry. Most of the rounding and damage can be attributed to children and should remain, unless or until it becomes a structural problem. Compare with Figure 35.*

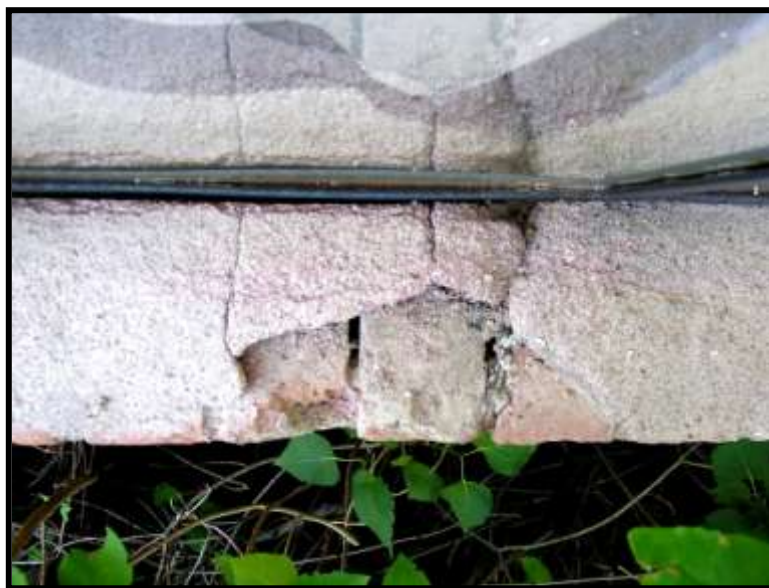
*Figure 34. Mortar wash, east wall northernmost window. Deterioration is typical of similar in several locations.*

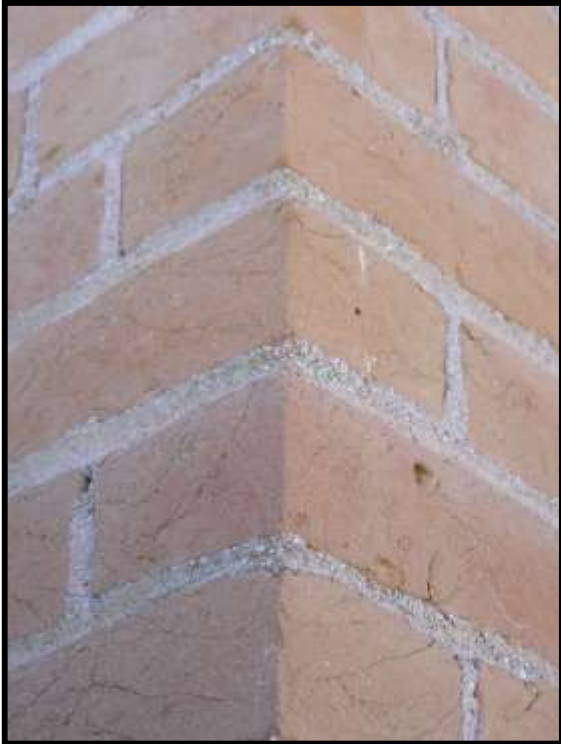
Figure 35. Brick corner high on pilaster at entry. Compare with Figure 33.

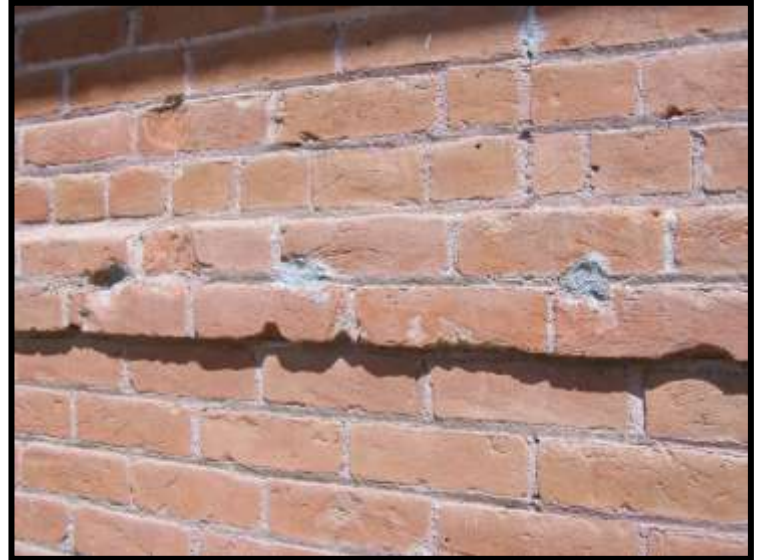
Figure 36. Spalled and patched brick.

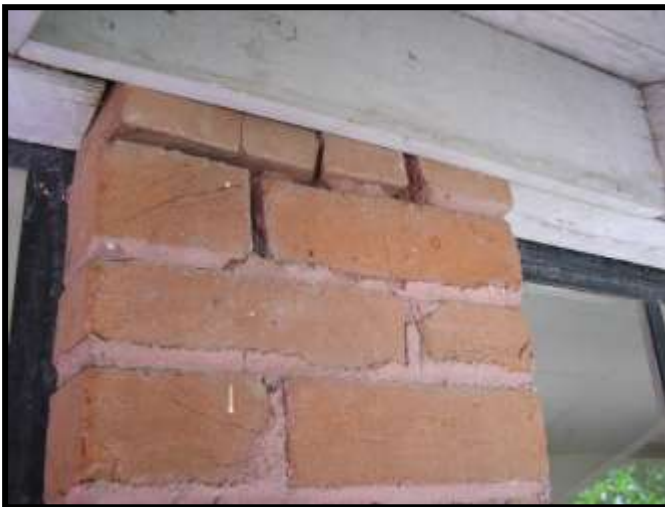
Figure 37 (Left) Brick pilaster between windows, south portion of west wall. Note red tinted mortar with struck joints, spalled brick corner, and open joints at upper courses.

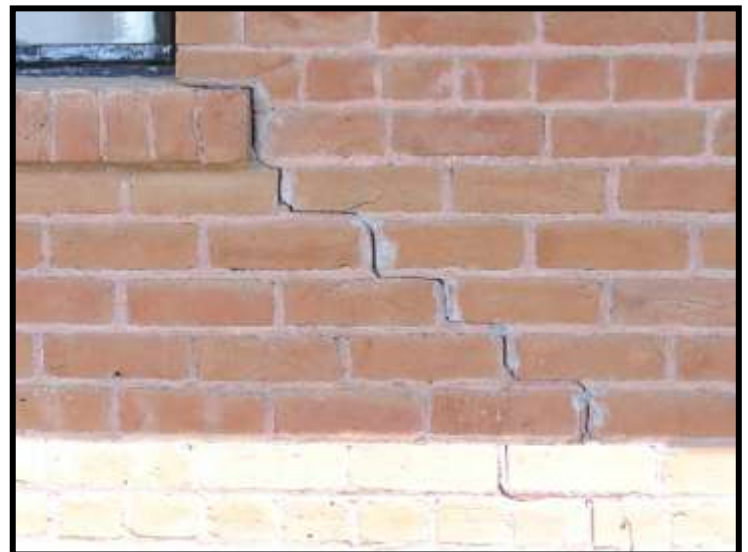
Figure 38. (Right) Stairstep cracking, from foundation to sill of restroom window, west wall.

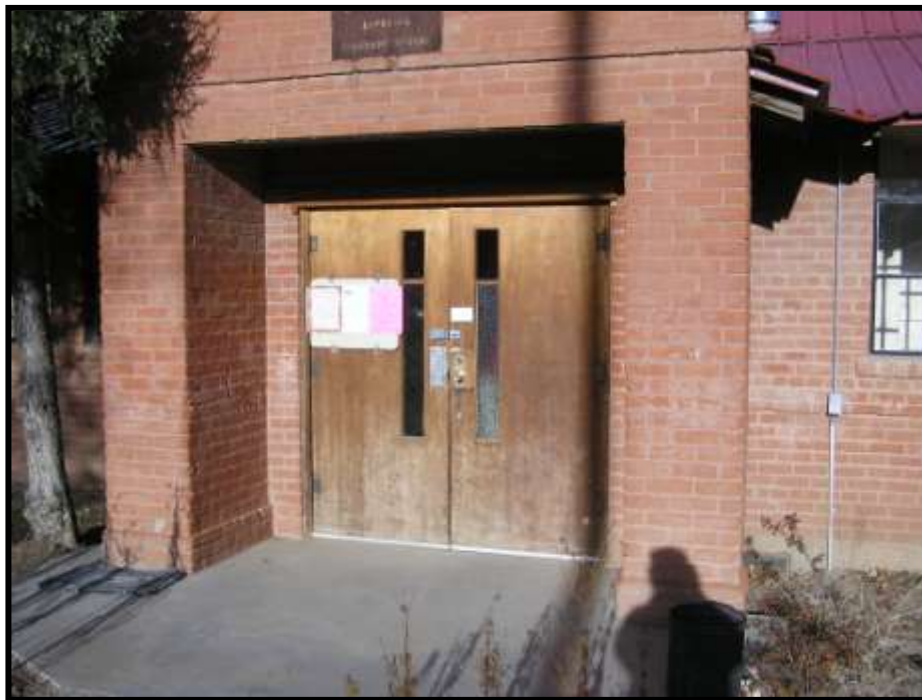
*Figure 39. Entrance doors. Looking east.*

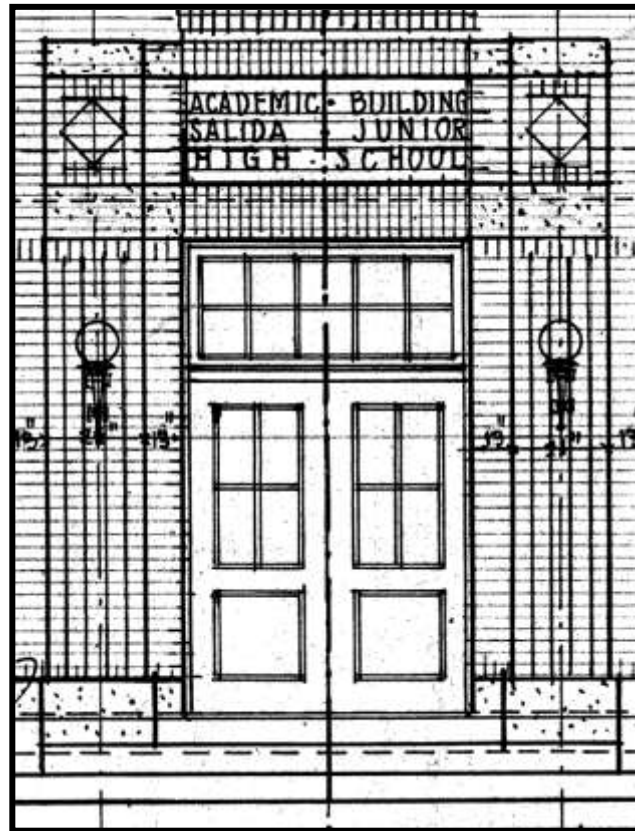
Figure 43. Drawing of original entry doors, Kesner Junior High School, Salida.

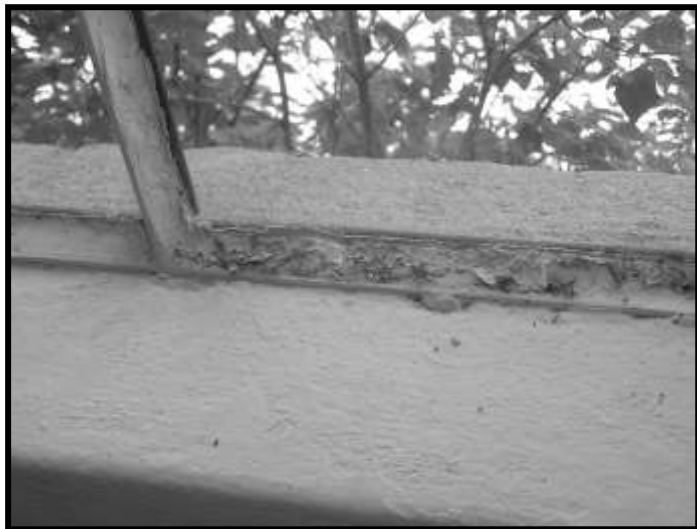
*Figure 44. Window putty, east wall. Poor condition.*

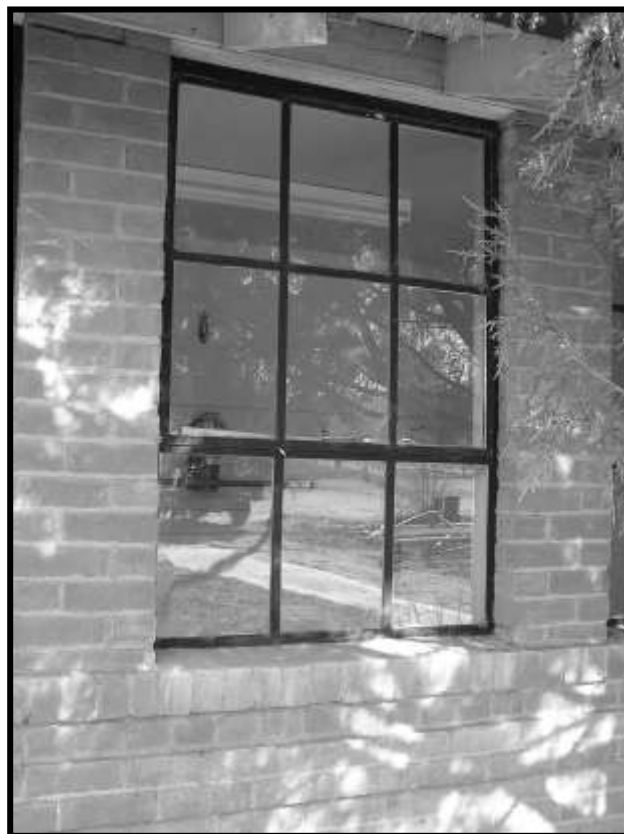
*Figure 45. Hall window, west façade, looking southeast. The upper two rows of lights are operable as a*

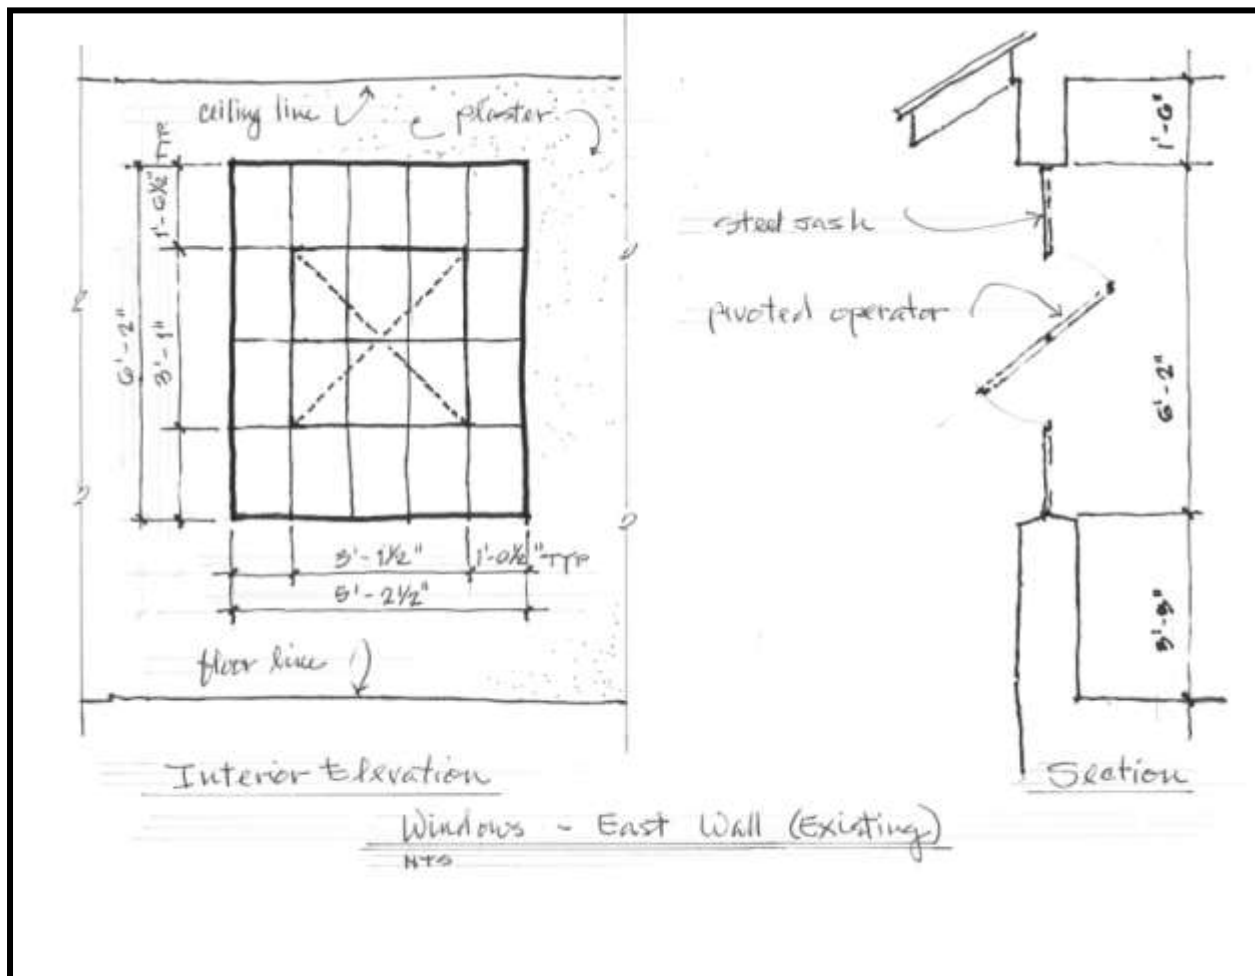
Figure 48. Windows, east wall (existing).

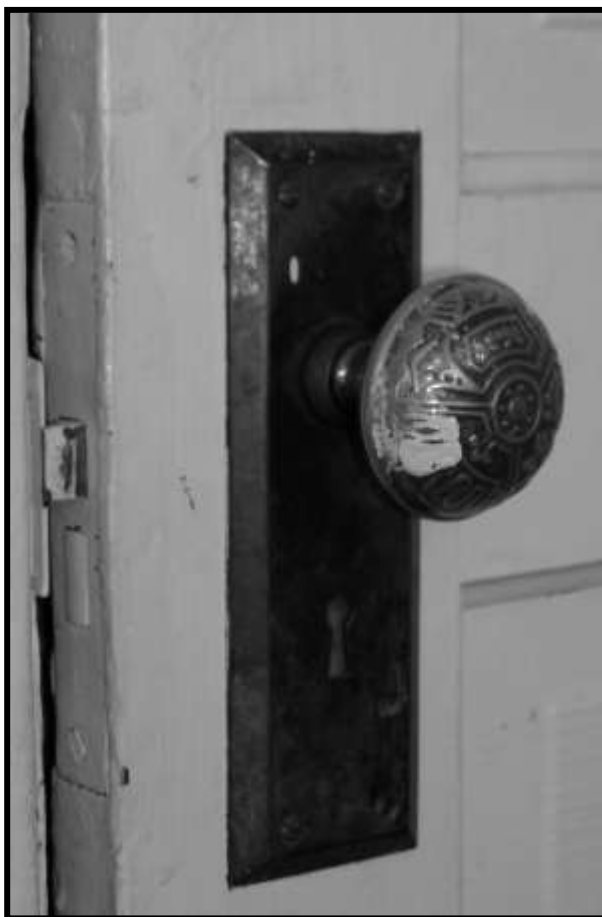
*Figure 49. Decorative doorknob from hall to south classroom.*

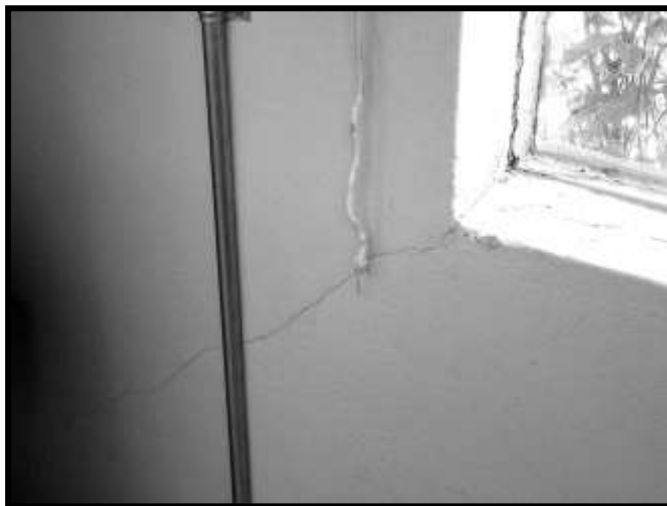
*Figure 50. Diagonal crack from sill down to left in North Classroom. North end of sill, north window, east wall. (See Figure 17 for same crack on exterior.)*

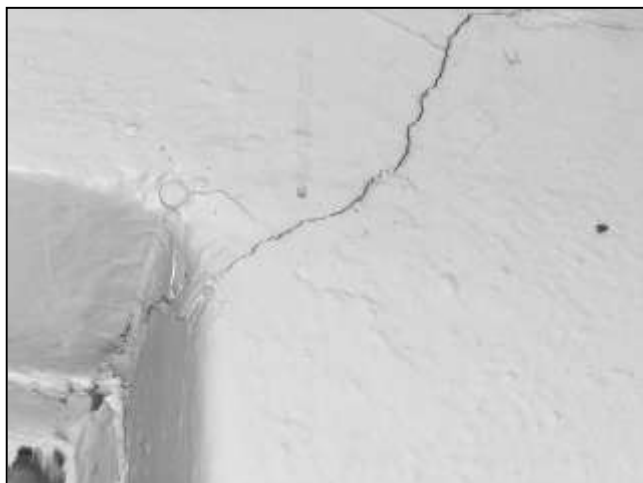
*Figure 51. Diagonal crack at window head in Hall.  
North window, west wall.*

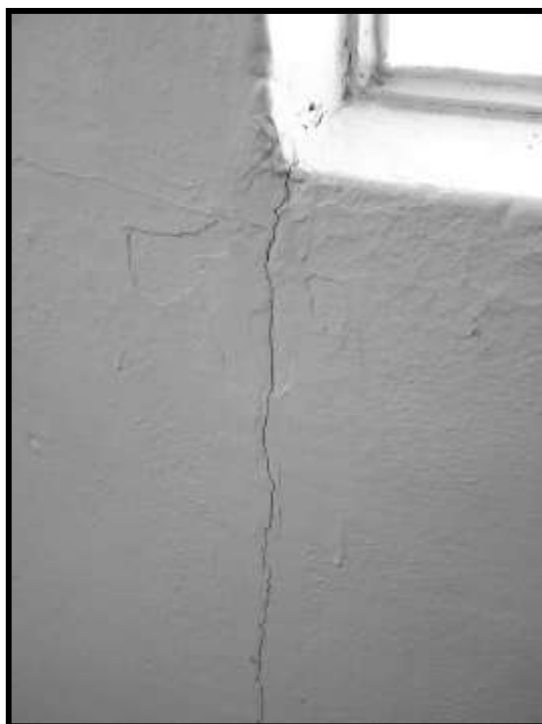
*Figure 52. Vertical crack in window sill, west  
wall in Hall.*

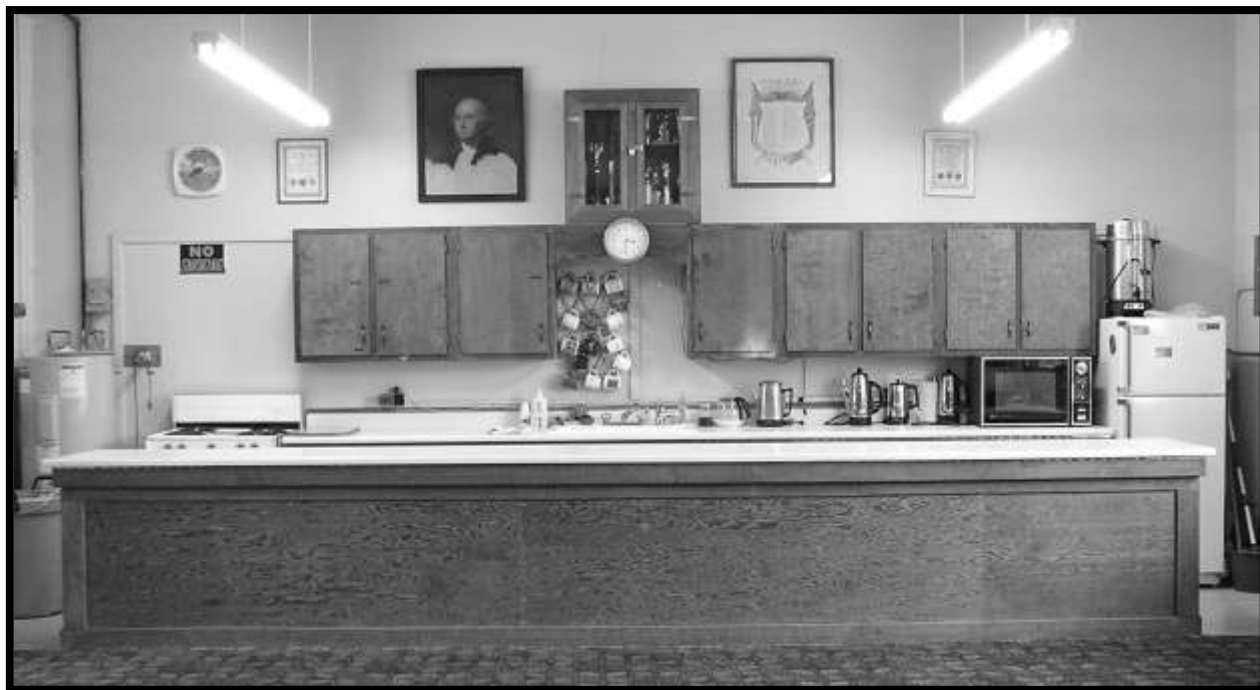
*Figure 53. Kitchen. Facing north end of classroom.*

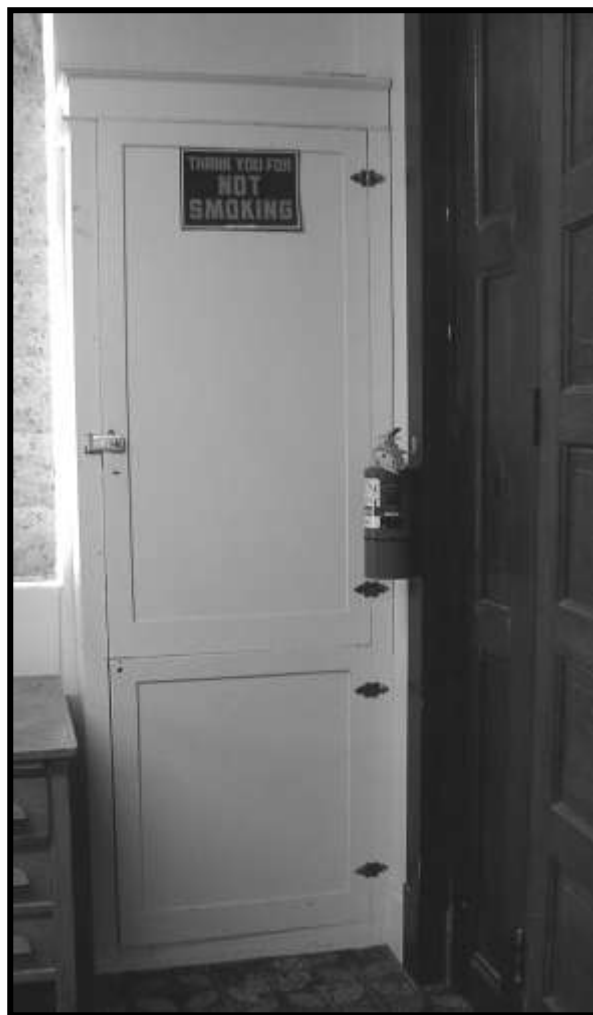
Figure 54. Teachers' cabinet, east wall of north classroom, looking east.

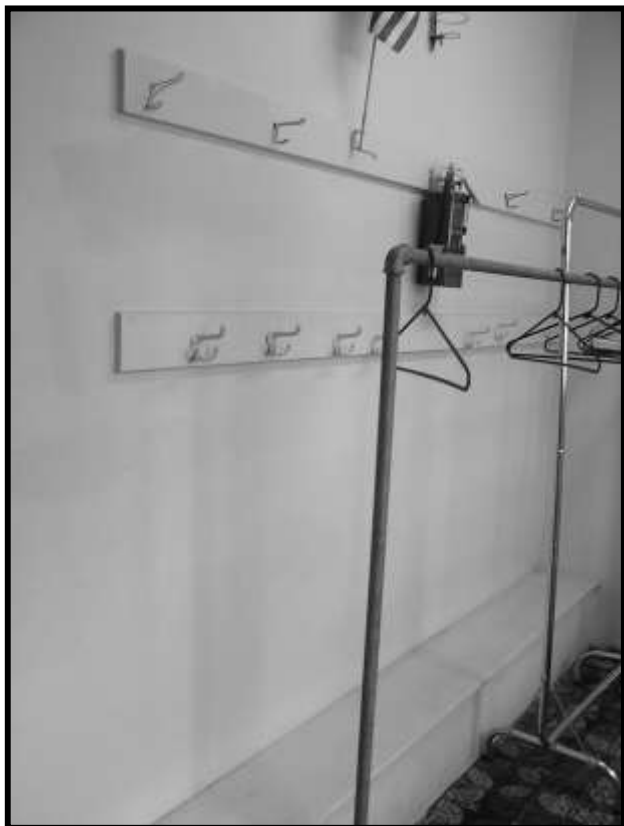
Figure 56. Hall, north end. Coat hooks with bench below and portable coat racks.

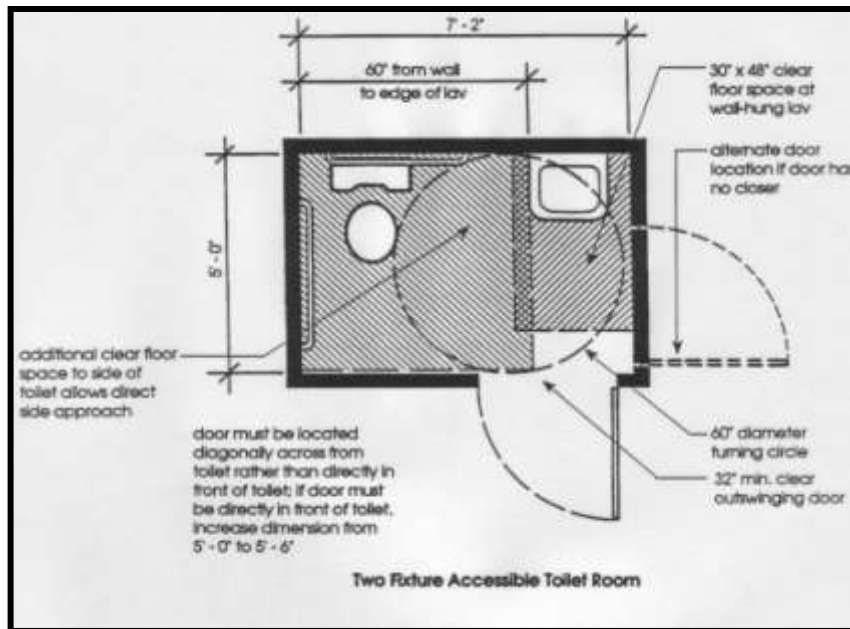
Figure 72. Example 1, accessible toilet room.

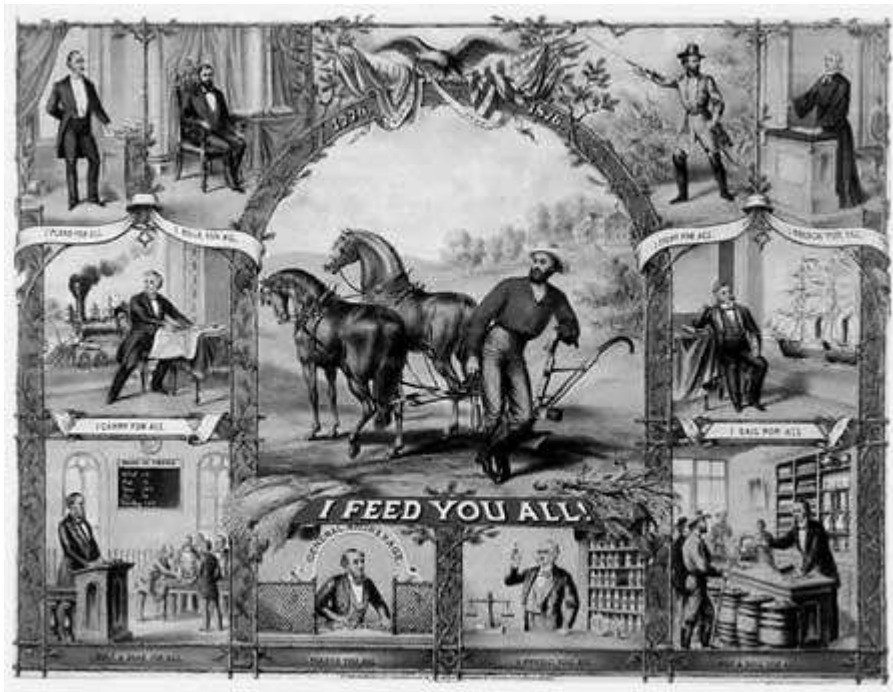
The Grange was founded in 1867 as a fraternal trade society for small farmers and their families in the United States. The National Grange of the Order of the Patrons of Husbandry was founded by a Freemason named Oliver Hudson Kelley in Fredonia, New York. It was a secret society arranged along the lines of Freemasonry, and dedicated to promoting rural life. However, its initial membership included great numbers of urbanites.

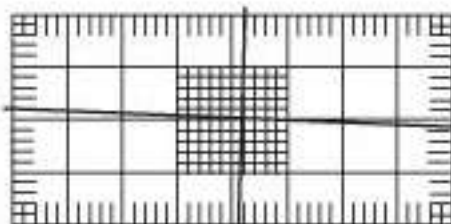
# APPENDIX E - PRESERVATION BRIEF 13
