HISTORIC STRUCTURE ASSESSMENT

**EDGAR KESNER
MEMORIAL BUILDING**

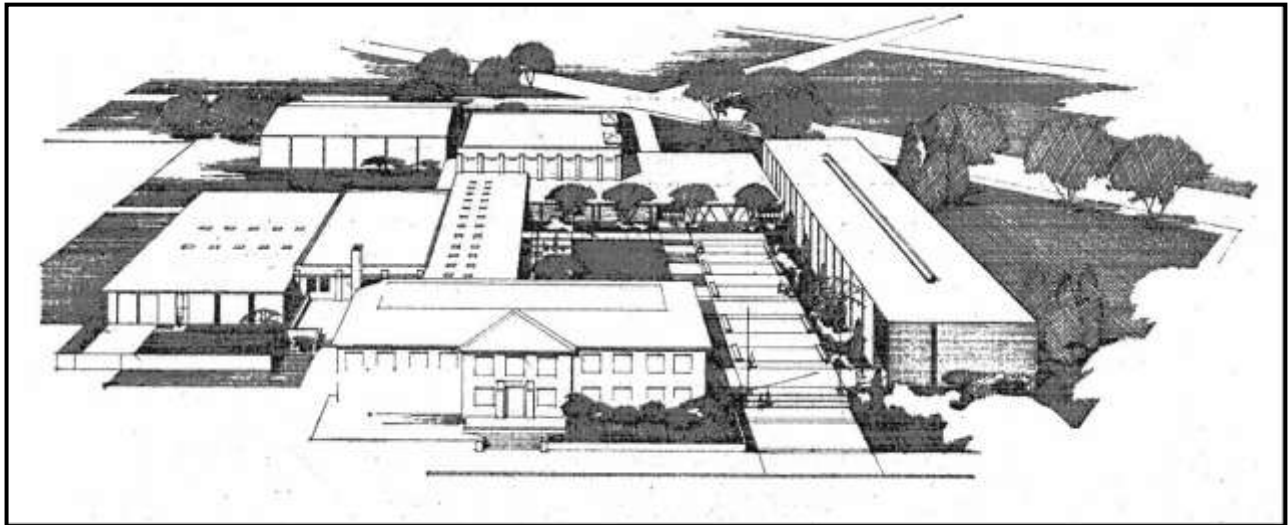
Figure 5. After the old high school burned in 1962, architects Ditzen, Rowland, Mueller & Associates of Boulder prepared this perspective drawing (view west) showing the new high school campus. The Kesner Building is in the center foreground. Melien Hall, erected in 1978, now occupies the northeast corner of the site. SOURCE: Mountain Mail, 25 October 1963.¹

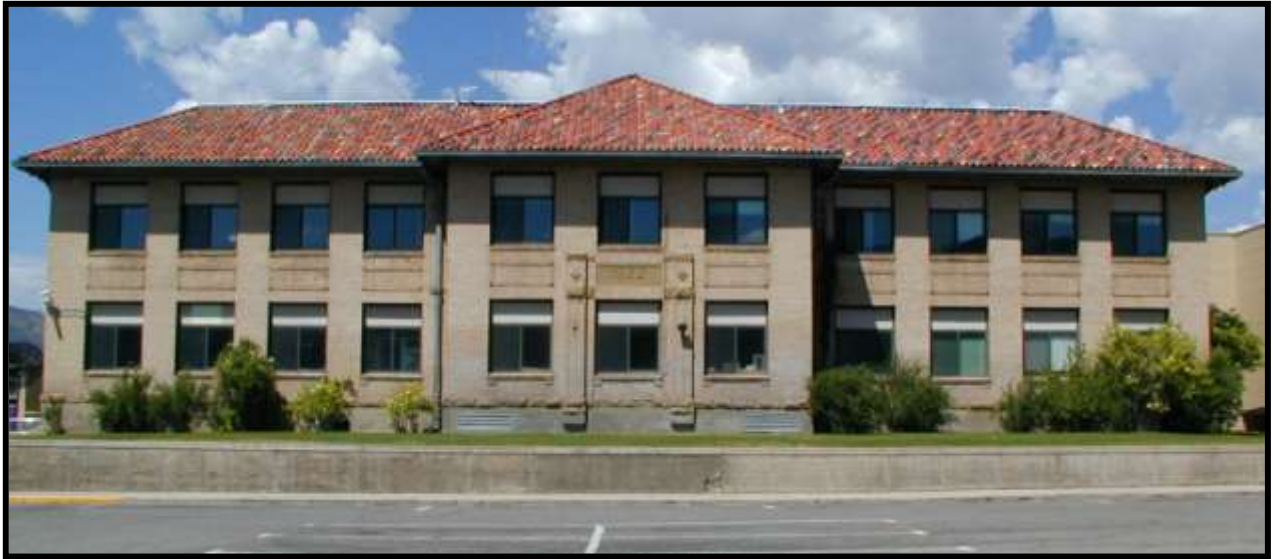
Figure 6. Kesner Memorial Building in 2003. Looking west.

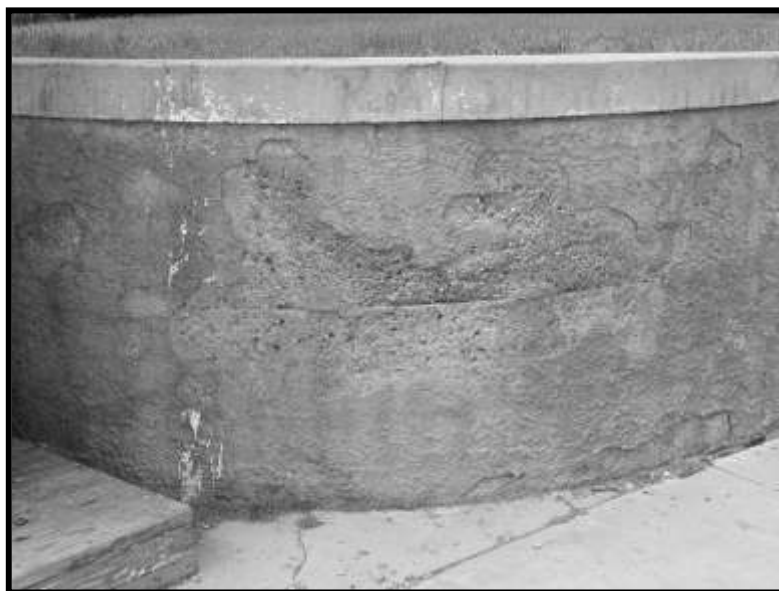
Figure 9. Concrete retaining wall curved corner with concrete cap and pebbledash stucco finish below. Note horizontal line in concrete showing two concrete pours.

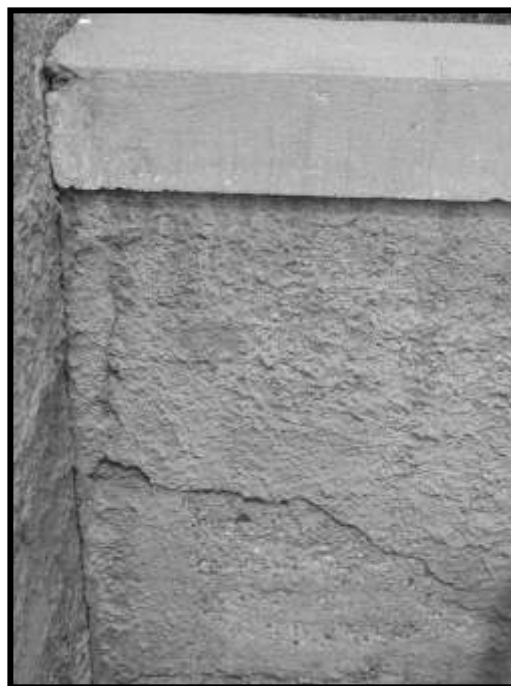
Figure 10. Retaining wall close-up.

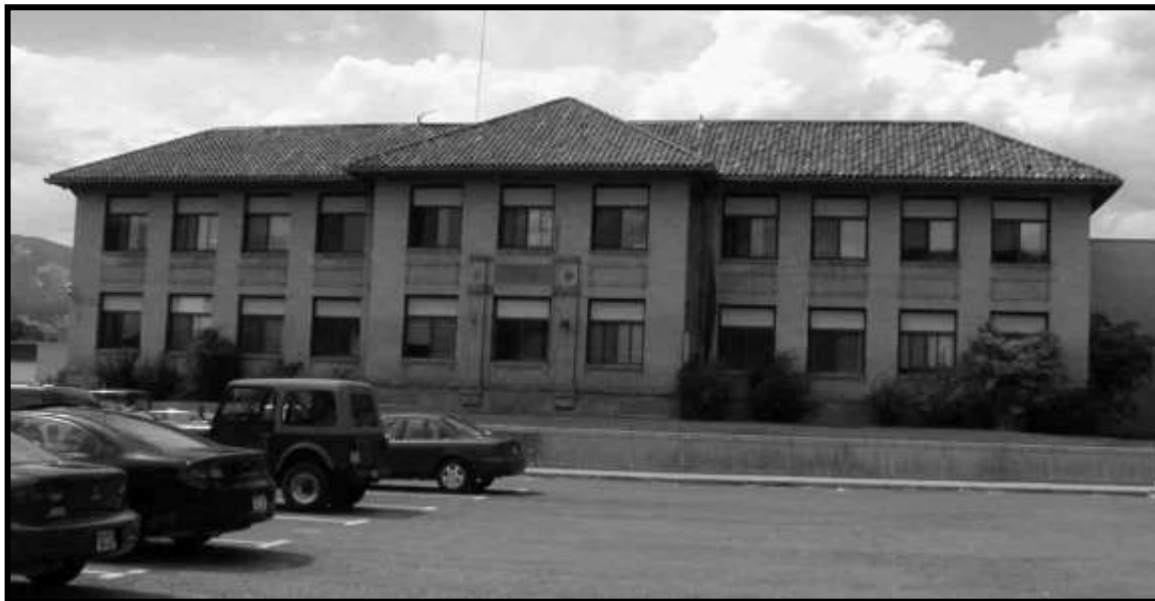
Figure 12. East Façade, Kesner Memorial Building, 2002. The original main entrance and steps were in the center of the protruding bay.

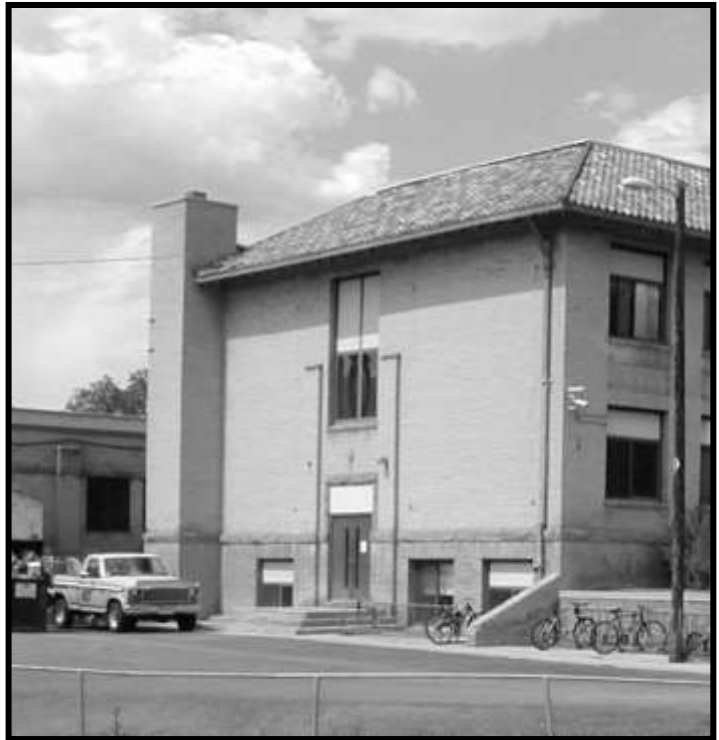
Figure 17. South façade, with Manual Training Building visible to left of chimney.

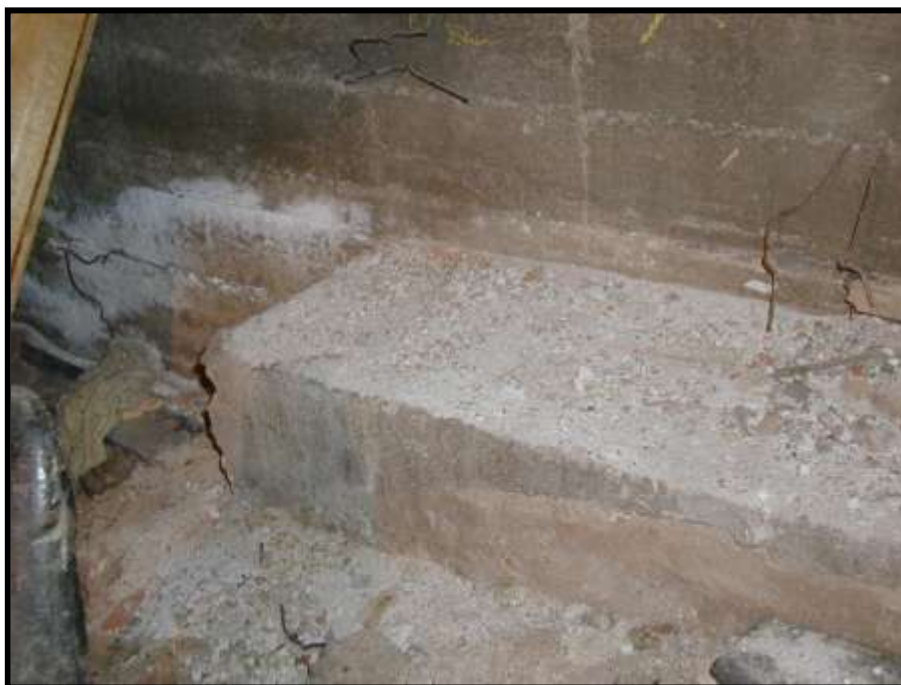
Figure 18. Foundation and stepped footing, west wall, basement. Note efflorescence.

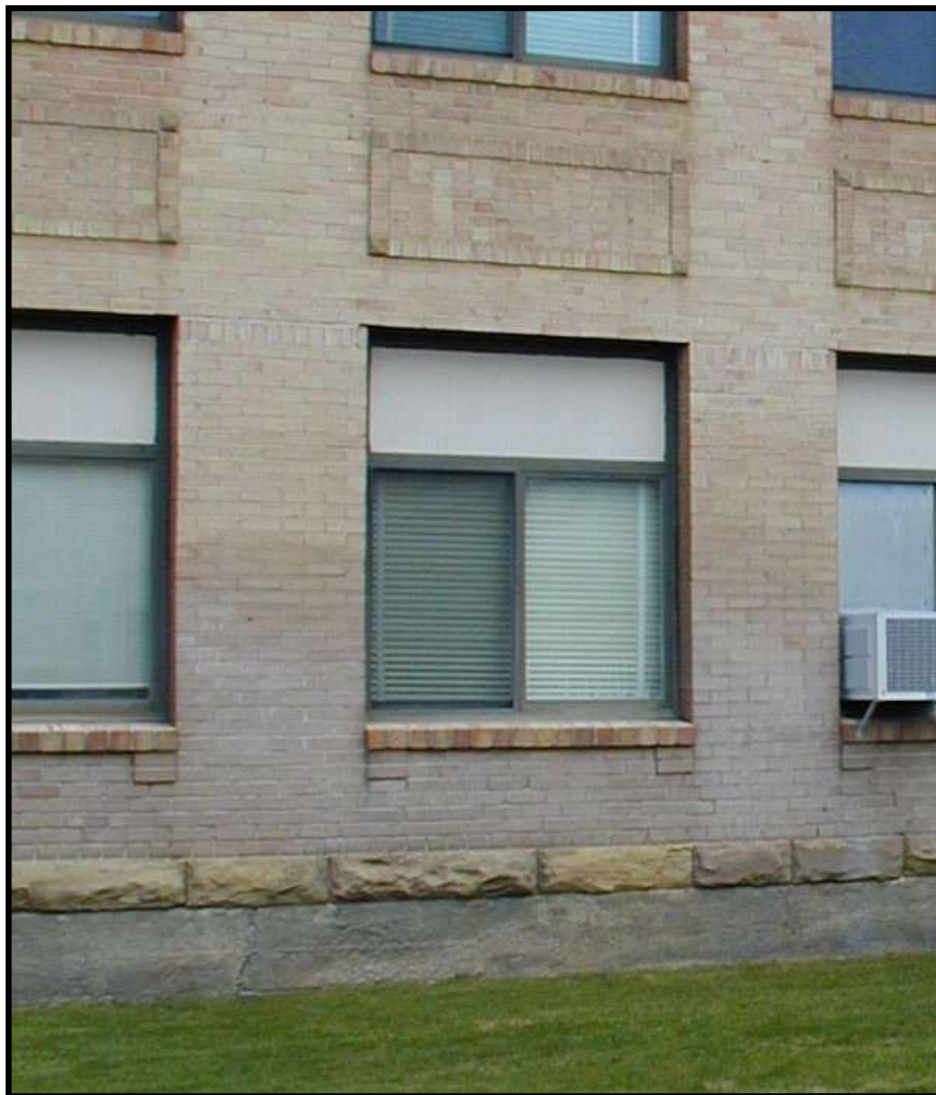
Figure 19. Note stained area from watering grass. West wall, looking southeast.

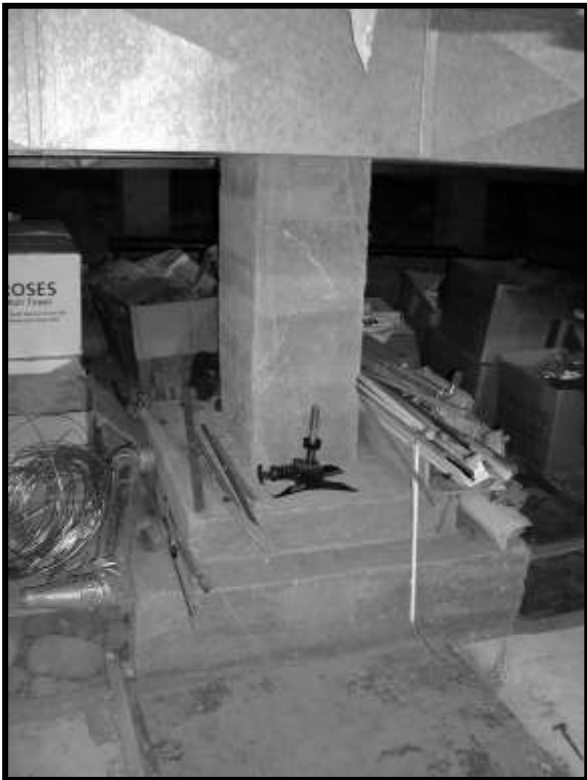
Figure 21. Interior concrete column (pier) with footings. Note lack of efflorescence. Ventilation trunk duct overhead.

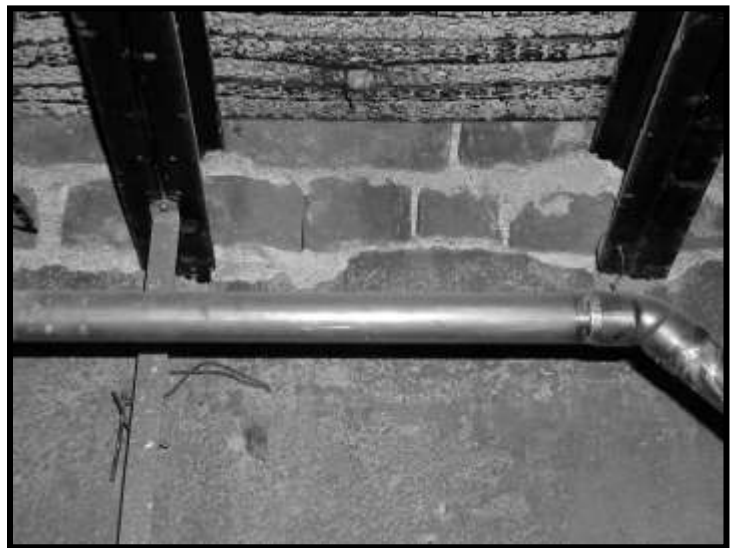
Figure 22. Double steel channel joists bearing on exterior foundation wall. Note brick infill between joists. Brick is the water table backing

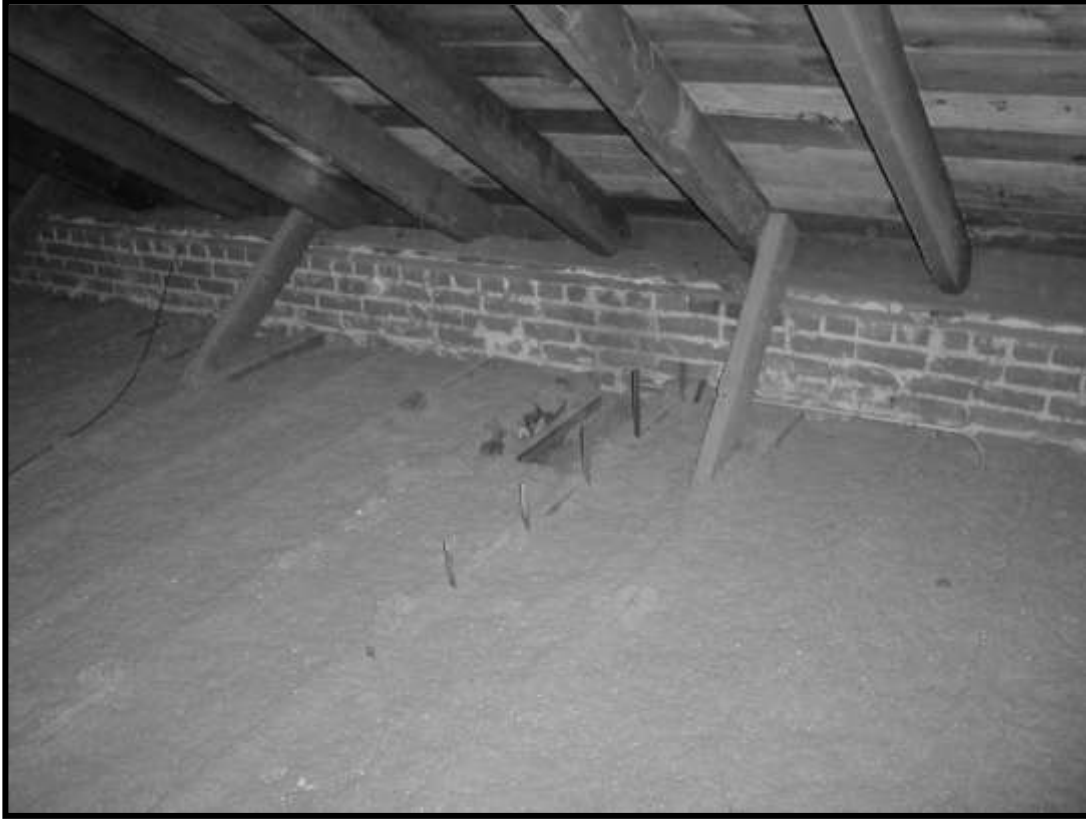
Figure 25. Blown-in insulation in attic with steel wall framing channels protruding through ceiling.

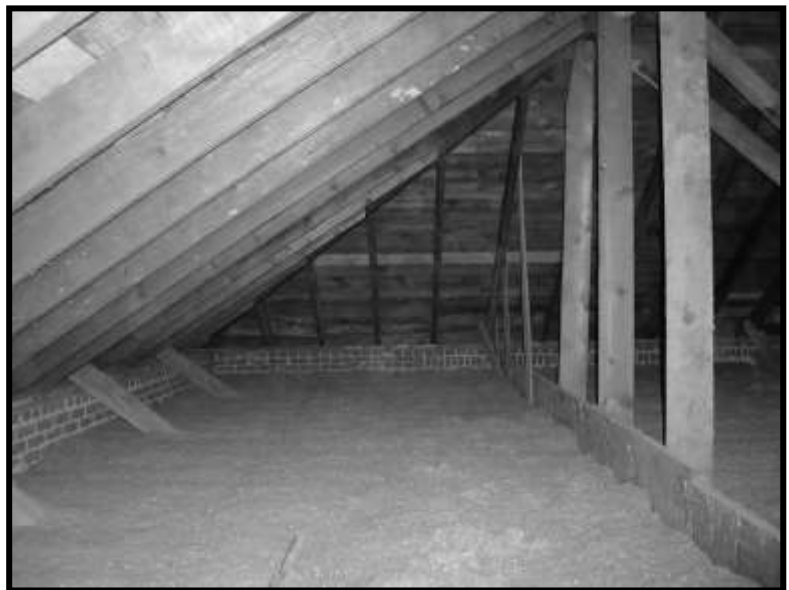
The second floor ceiling rafters are 1 1/2" x 4 1/2" at 16" on center running east west supported at the outside wall and on the corridor walls. A longitudinal 2" x 10" board above the

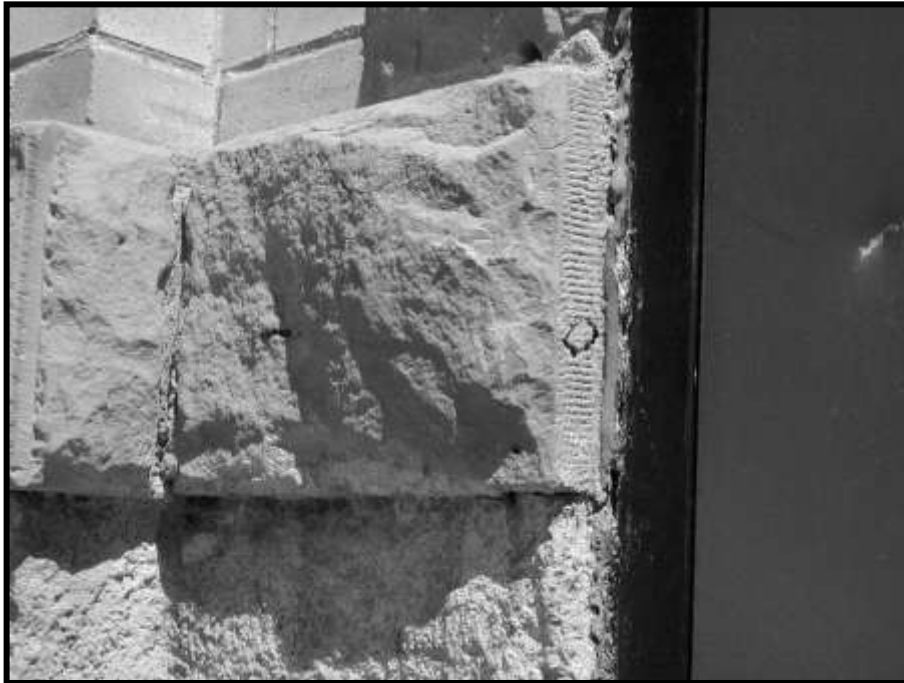
Figure 27. Sandstone water table (inside corner) showing pebbledash stucco below, brick above, door jamb at right.

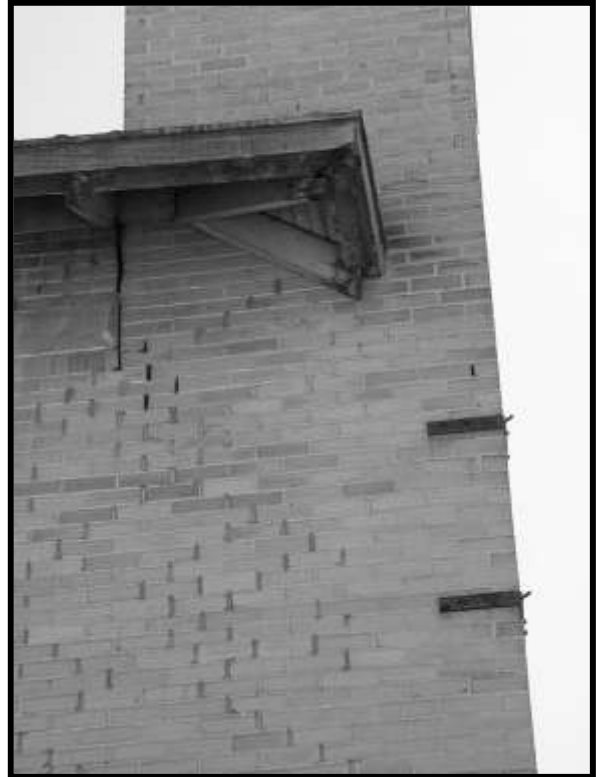
Figure 31. Brick chimney showing metal corner straps and poorly repointed stairstep cracking. Looking east.

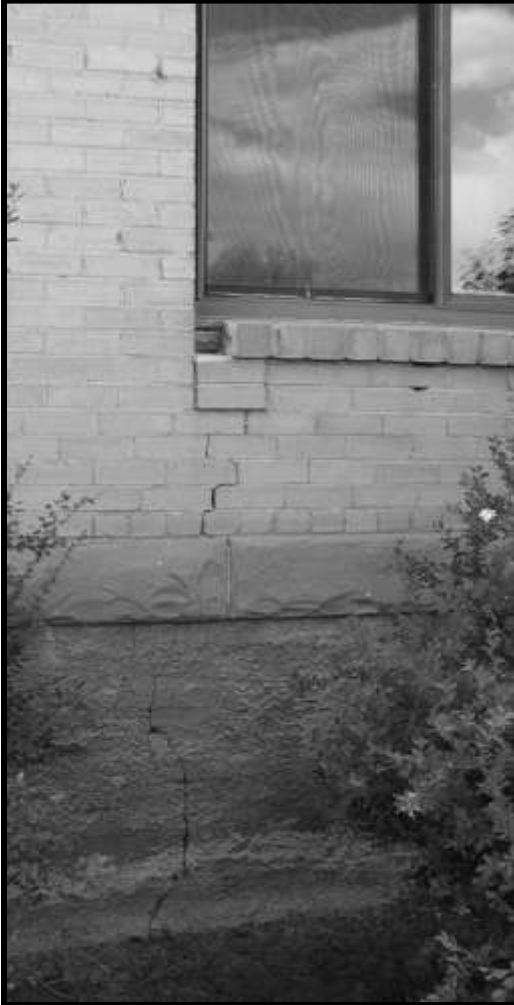
Figure 33. East wall, second window from south. Diagonal cracking under window. Note pebbledash stucco coat on foundation wall beneath sandstone water table to grade

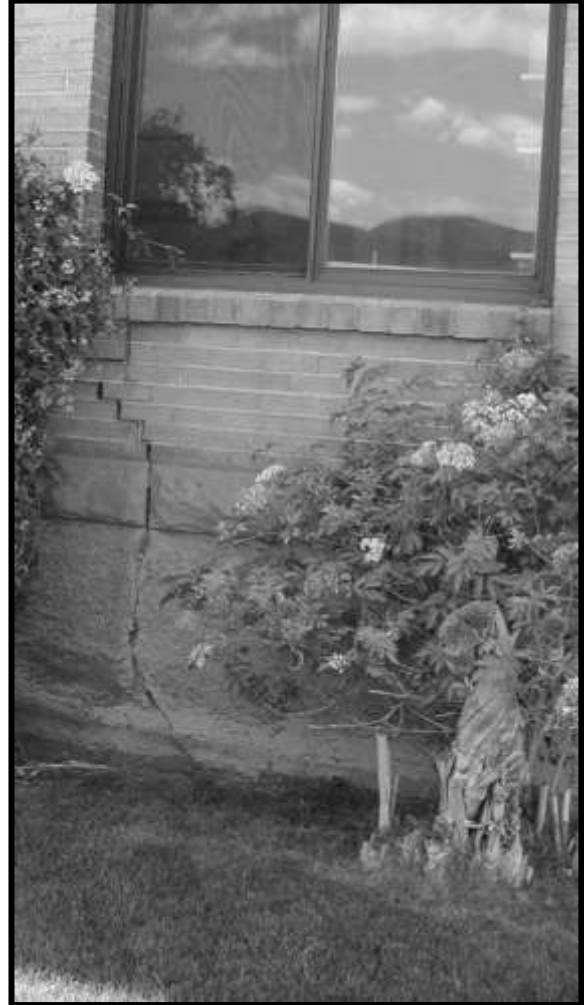
Figure 32. East wall, third window from south. Diagonal cracking under window.

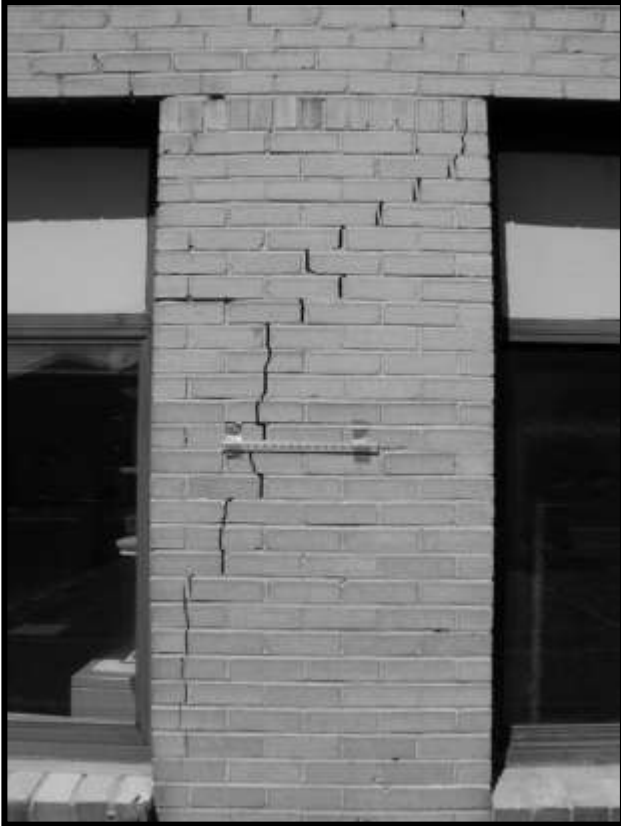
Figure 35. East wall, between third and fourth windows from south. Large continuous crack. Note broken bricks.

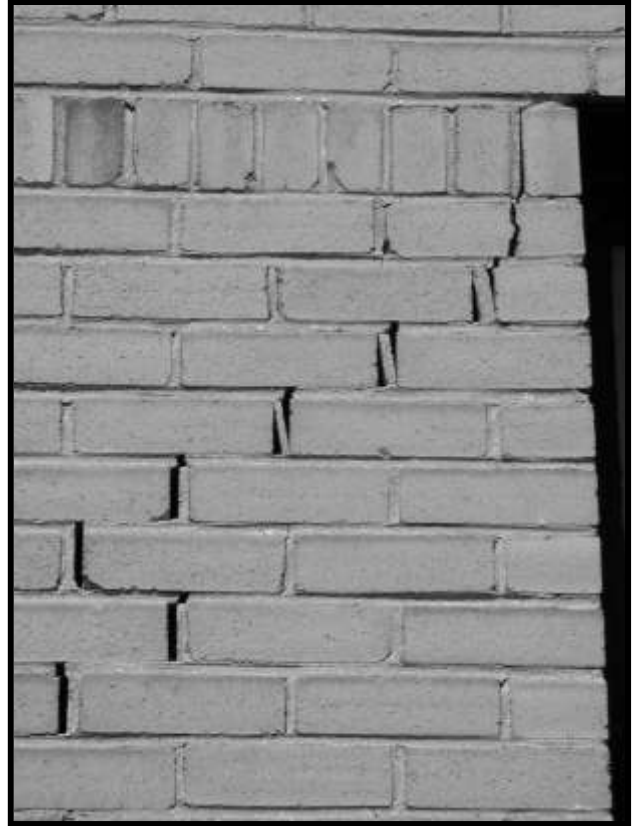
Figure 34. Detail of upper portion of crack shown in Figure 34.

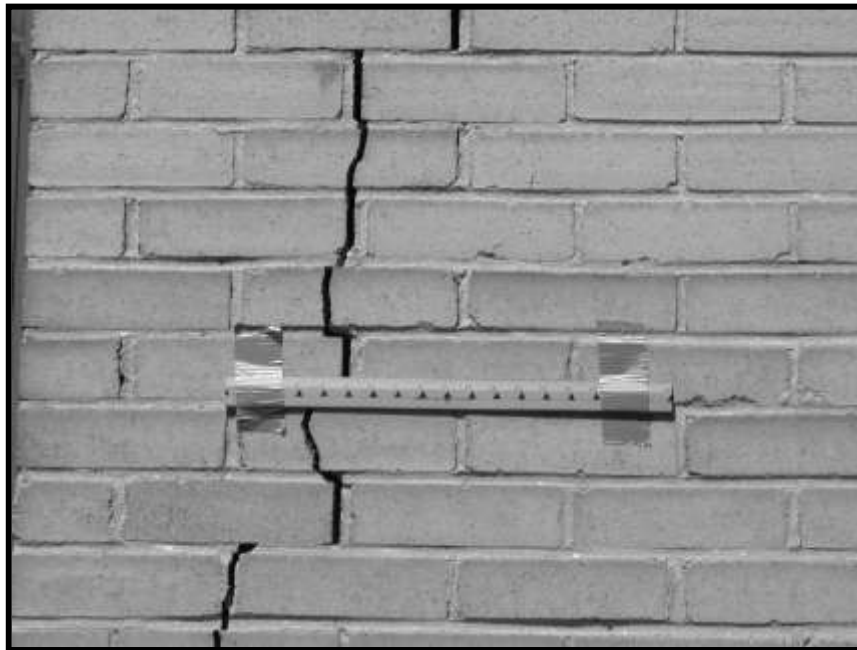
Repeated wetting stains brick on the west wall to a height of six to nine feet above grade from lawn watering activity. There also are stains below a room air conditioner mounted in a window on this side of the building.

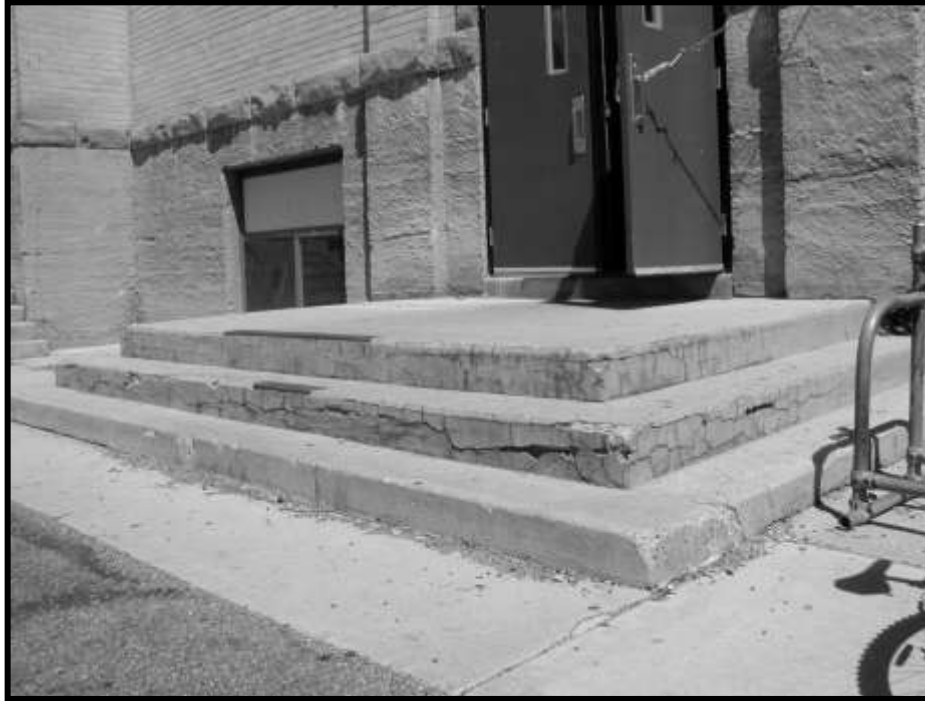
Figure 37. Concrete stoop at south entry doors. Note cracking and crazing, especially at top risers.

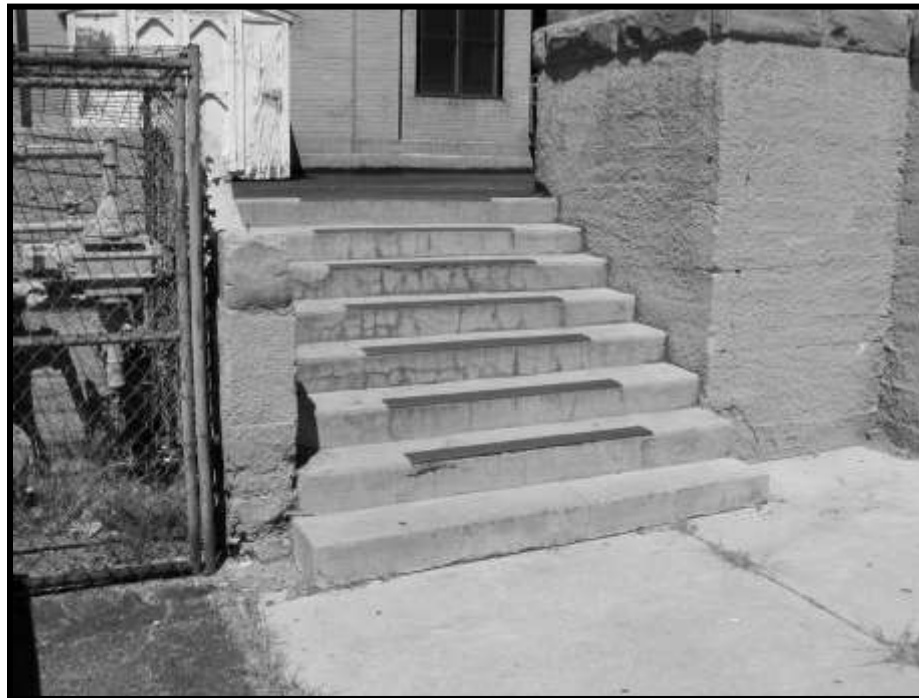
Figure 39. Concrete guardrail with stone Coping supported on soldier brick course. Note coping stone on roof deck.

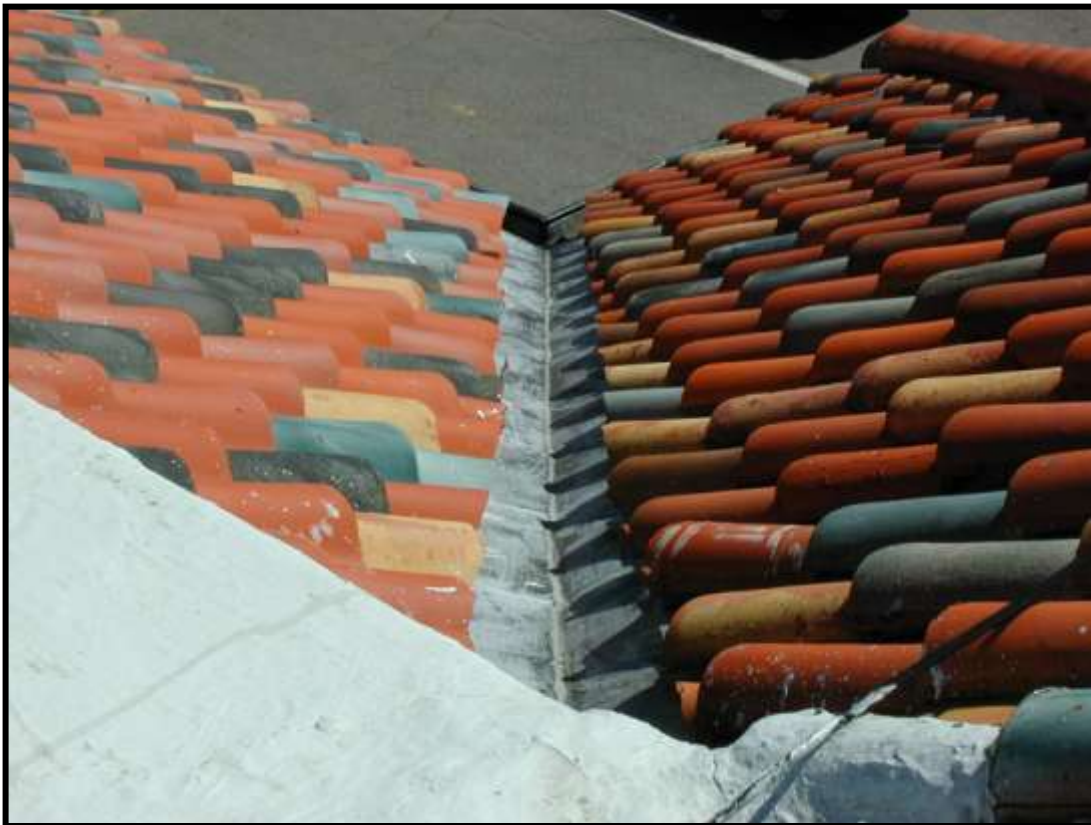
The top "flat" roof (*Figure 22*) is built-up, the original drawings calling for "composition roofing on deck" and has been reroofed one or more time. The current roof was coated last year with white roof coating. This roof drains onto the pitched tile roof below. The hip of the projected wing on

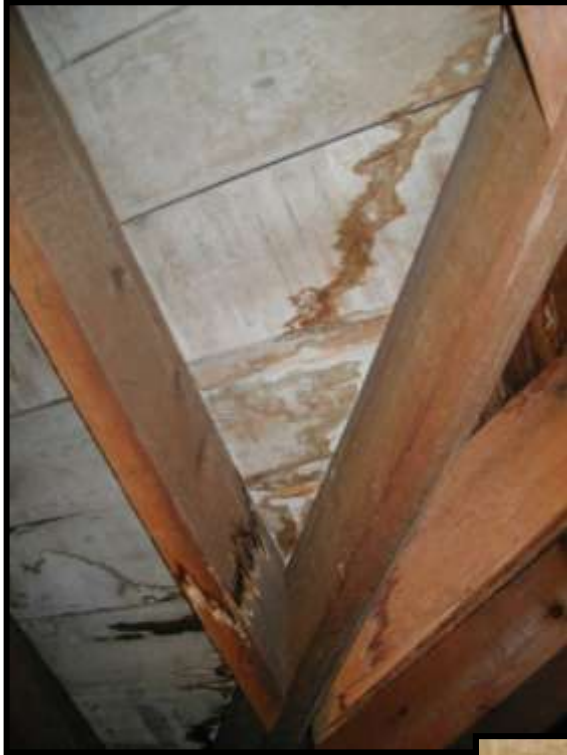
The building paper under the tiles is brittle, cracked and torn from age, water and wind damage.

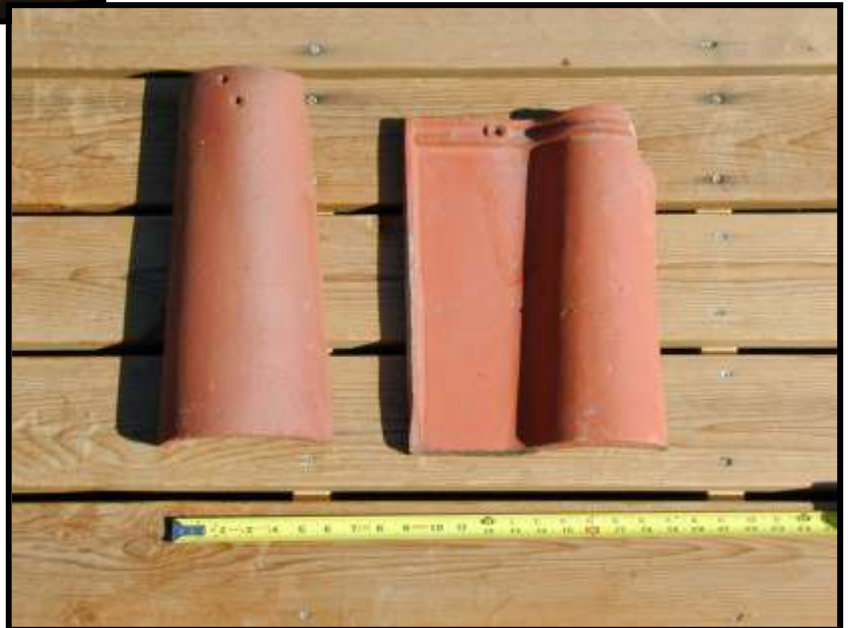
Figure 44. Examples of roof tiles.

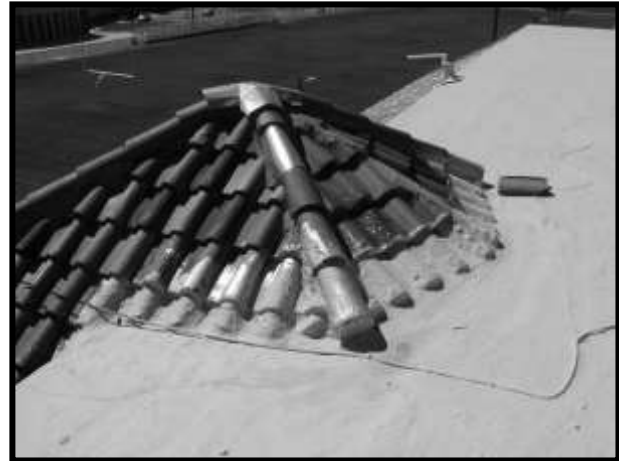
Figure 45. Makeshift metal flashing at top of point of the east pavilion projection roof.

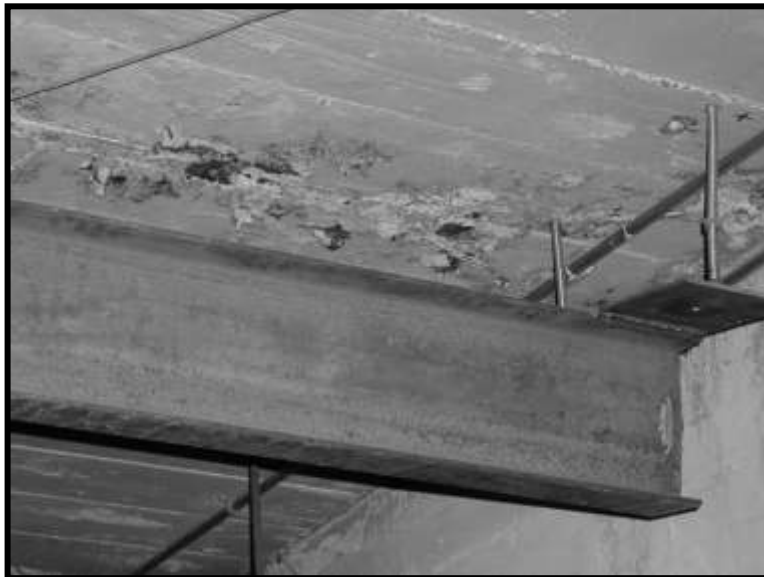
Figure 47. Boiler room concrete slab ceiling. Note flaking paint on ceiling above steel beam.

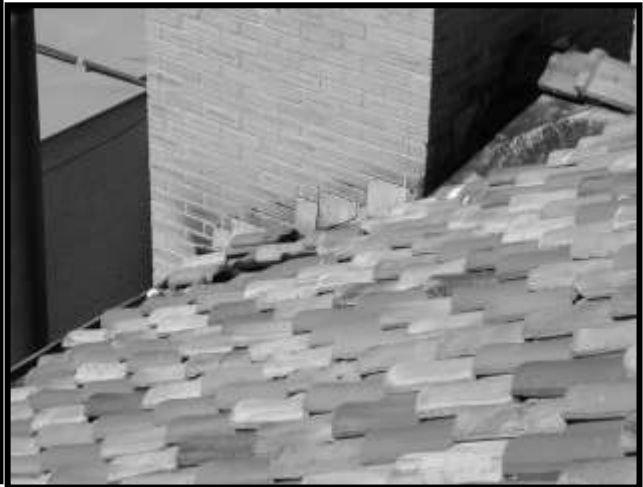
Figure 49. Stepped flashing and saddle flashing at chimney-roof interface.

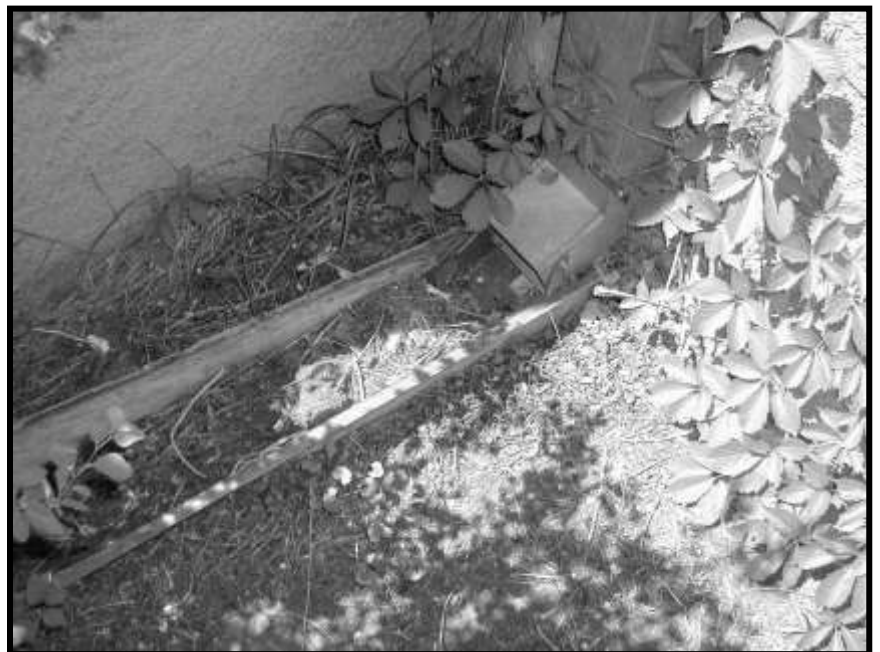
Figure 51. Downspout at south end of east wall. Discharge is into sheet metal trough that is sloped backward against building.

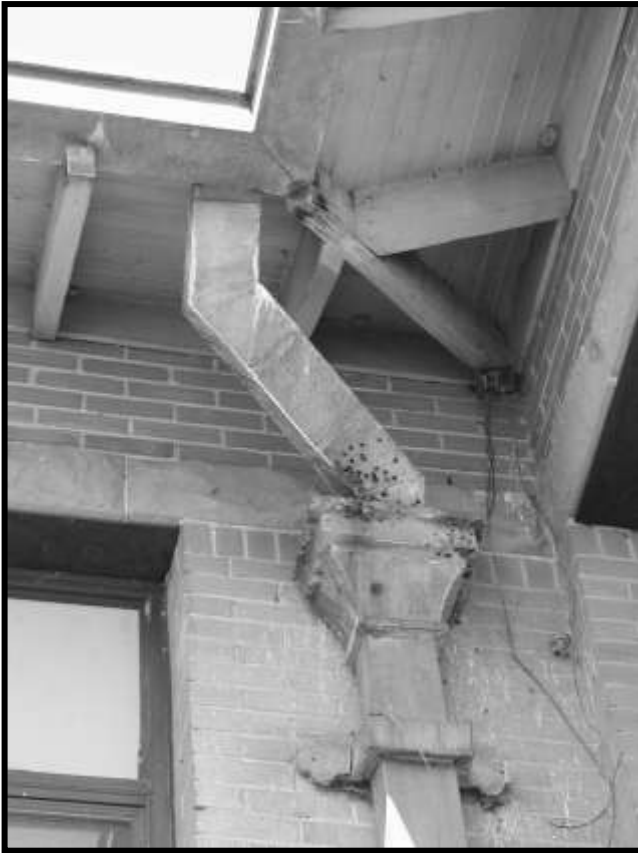
Figure 52. Downspout, south end of pavilion projection, east wall. Note bullet holes in leader and conductor head, and water stained rafter tail ends.

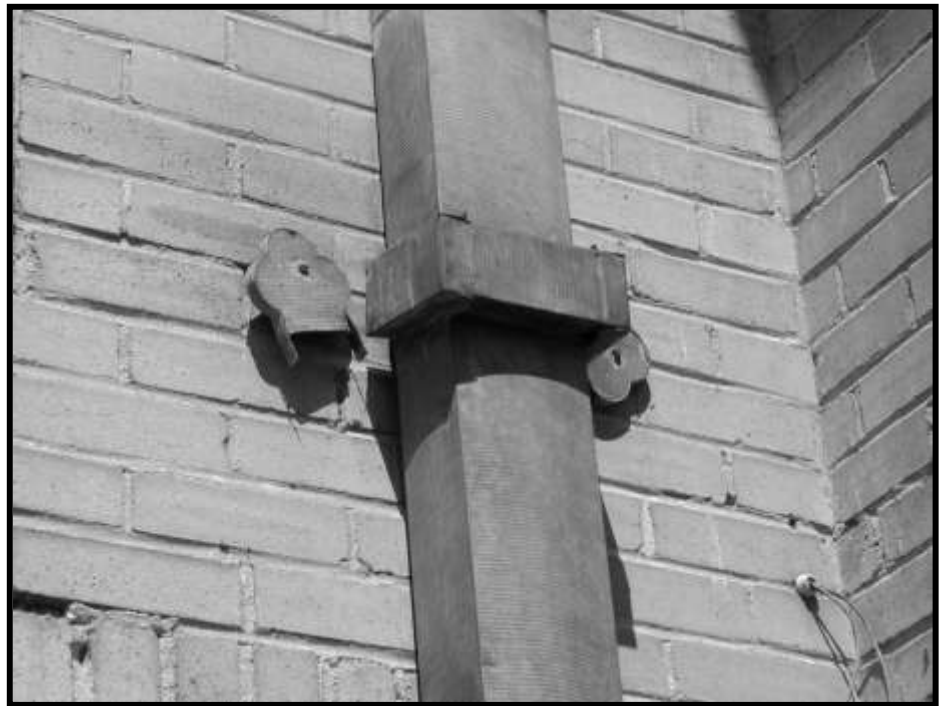
Figure 53. Broken downspout wall anchor bracket.

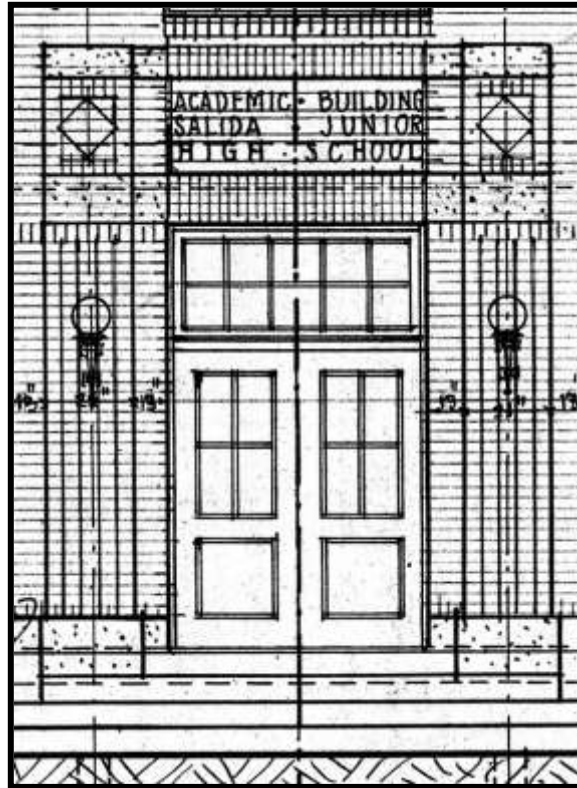
Figure 54. Main (east) entrance to Kesner Building, 1922 drawings.

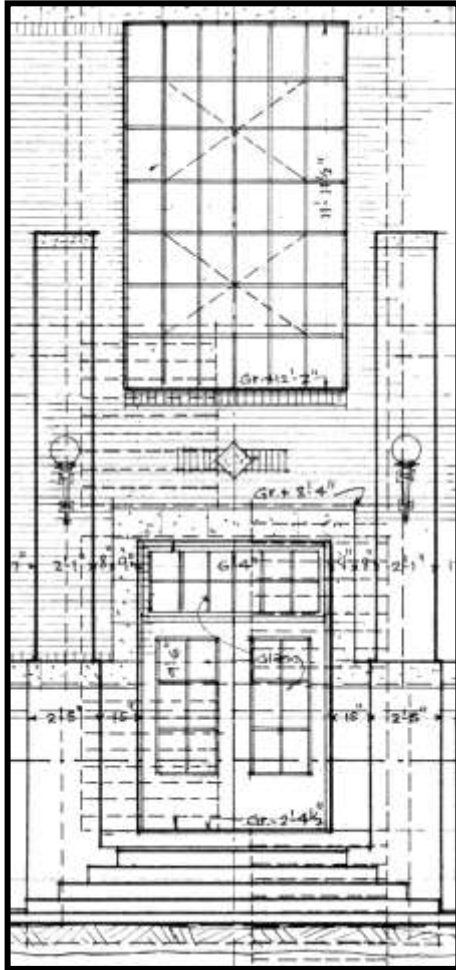
Figure 56. South entrance, 1922 drawings (left).

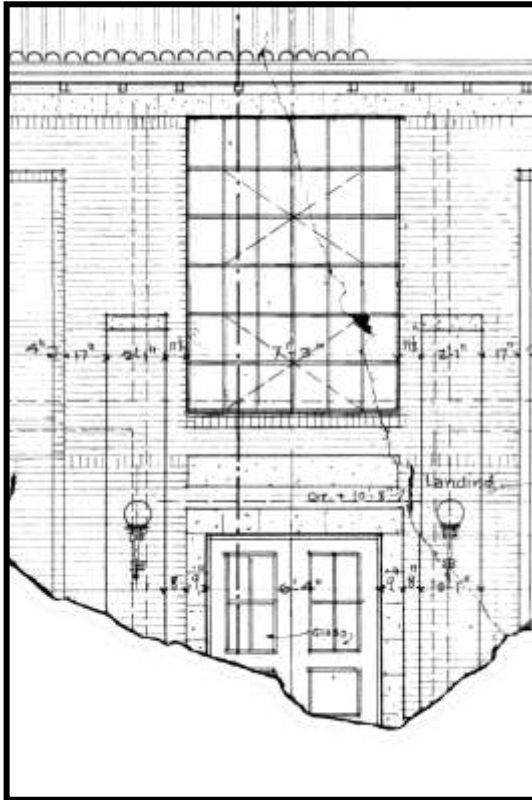
Existing Entry Doors

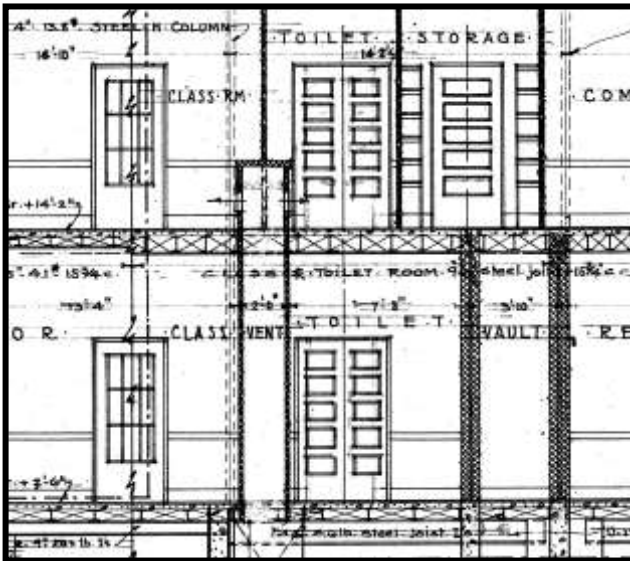
Figure 60. Part of a cross-section of the building from the 1922 drawings, showing

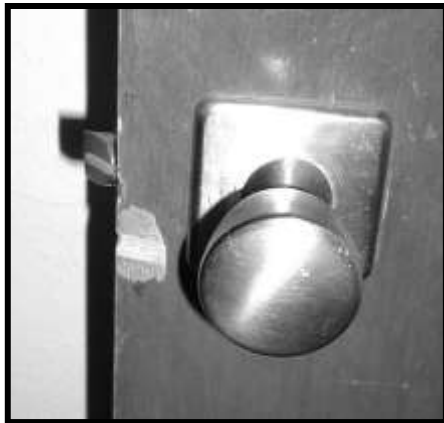
Figure 65. Today's typical room interior door knob.

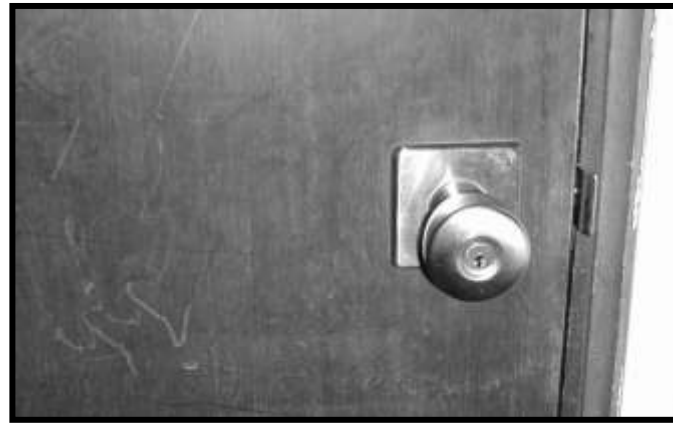
Figure 64. Exterior (hall side) door knob. Note scratched condition of door.

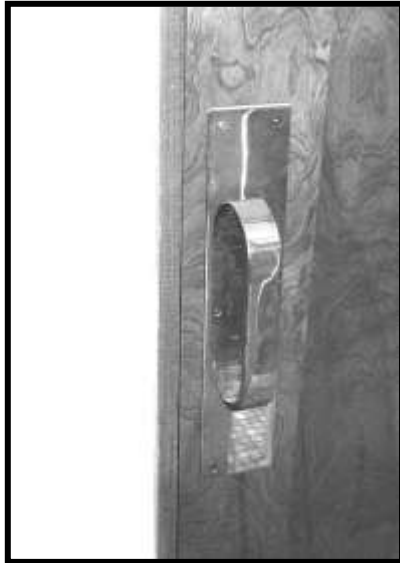
Figure 66. Restroom exit handle .

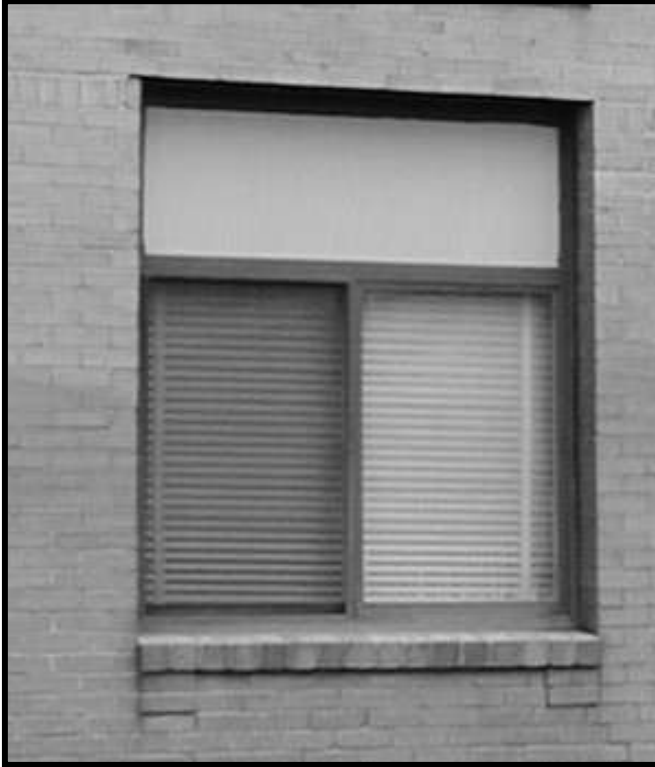
Figure 69. Example, window exterior. Note original size of window opening, filled in to accept new sliders.

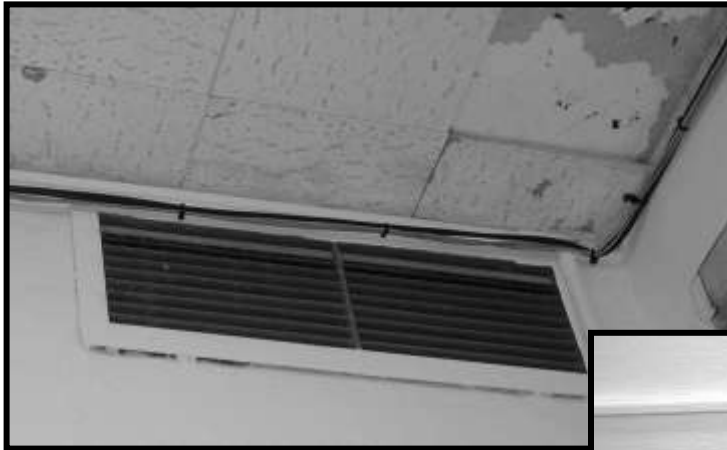
Figure 75. Ceiling at northeast corner of Room 117. Note missing tile, and stains on those at the edge of the ceiling. Also note exposed wires and wire mold running around the top of the wall.

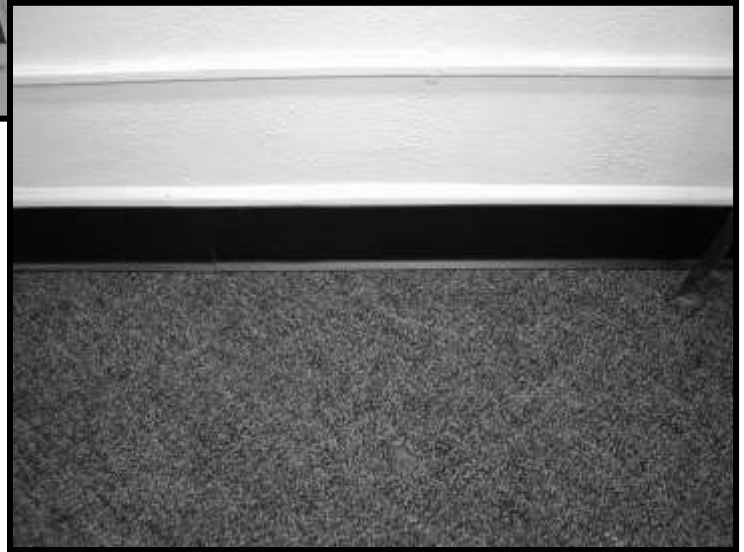
Figure 76. Detail, Room 117. Carpet at bottom half of picture, with black base over original wood base. Quarter-round at top of base is original painted wood. Toward top is ubiquitous wire mold

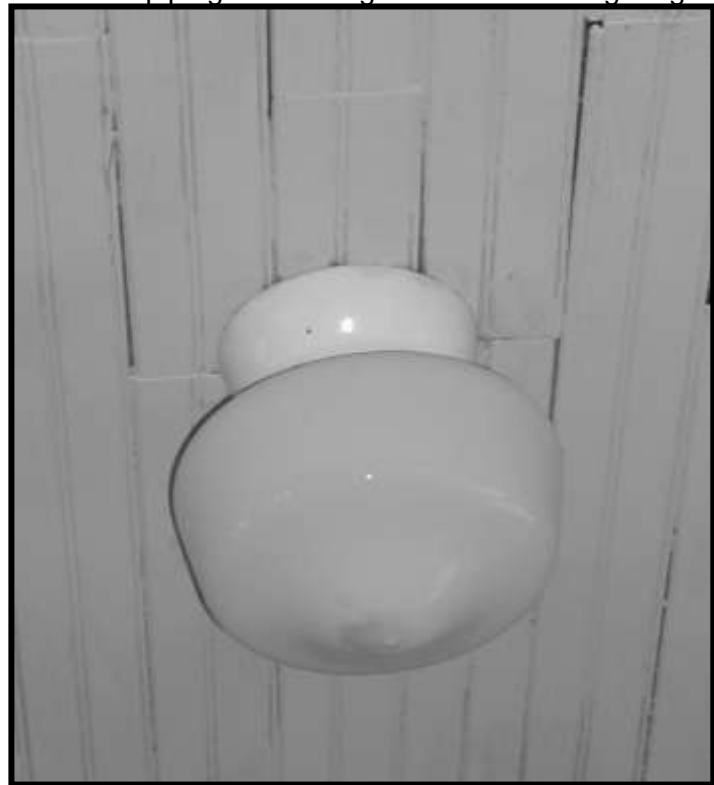
Figure 81. Schoolroom Globe from Tarryall School, Park County.

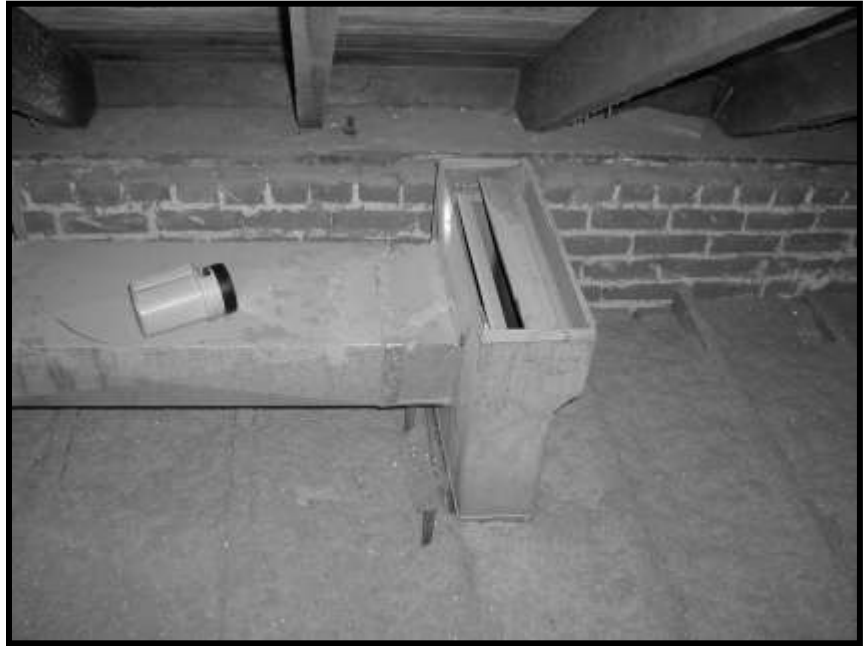
Figure 83. Ventilation duct in attic with damper.
