HISTORIC STRUCTURE ASSESSMENT

**EDGAR KESNER
MEMORIAL BUILDING**

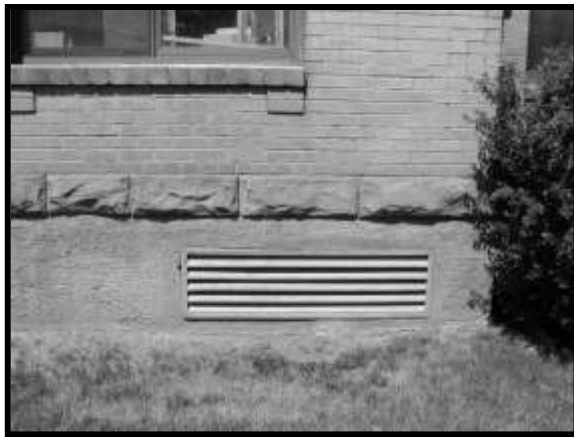
Figure 84. One of two large air intake vents on east wall.

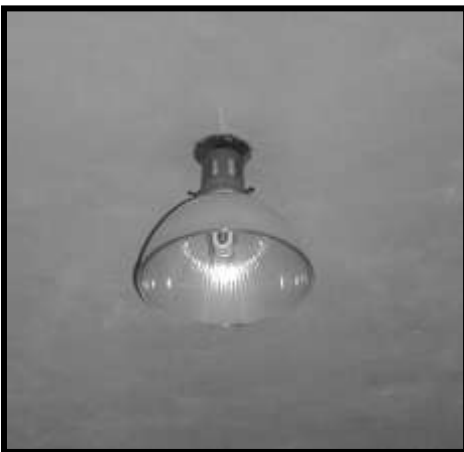
Figure 86. Original light fixture in the janitor's supply closet.

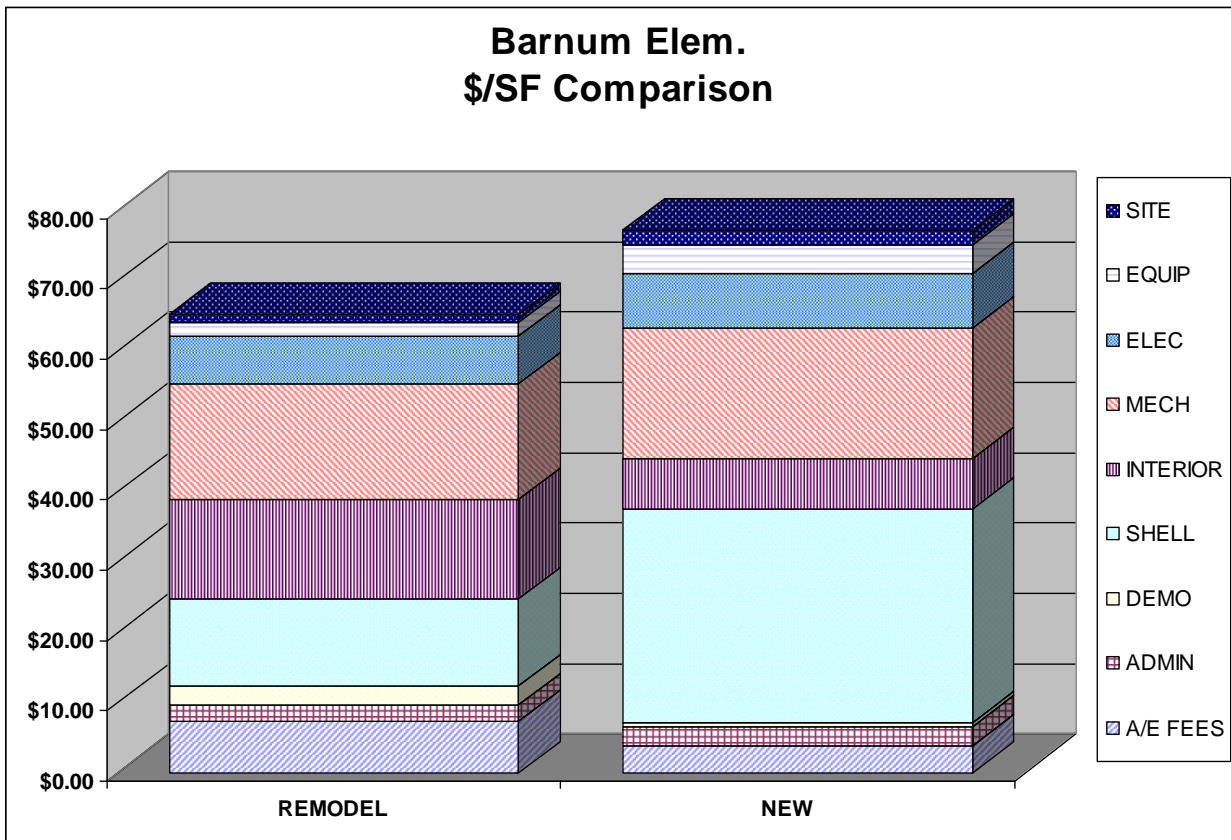
but the energy embodied in the original structure is retained, and fewer newly manufactured materials are required.

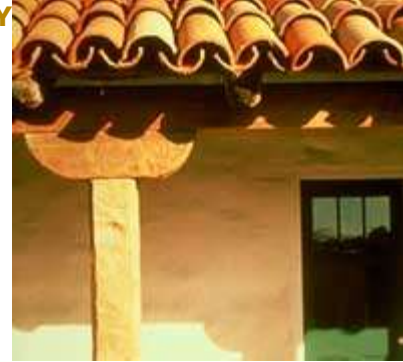
A NOTE TO OUR USERS: The web versions of the **Preservation Briefs** differ somewhat from the printed versions. Many illustrations are new, captions are simplified, illustrations are typically in color rather than black and white, and some complex charts have been omitted.

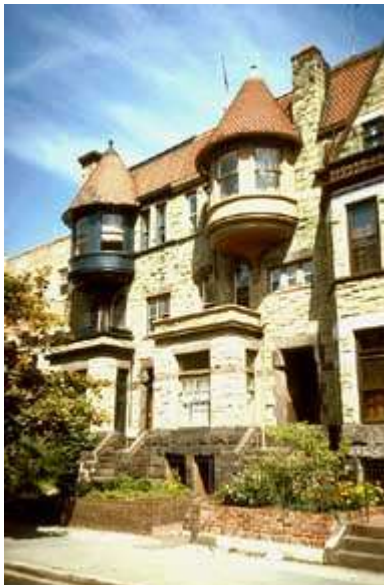
Clay tile was a popular roofing material for residential structures during the Romanesque Revival period. Photo: NPS files.

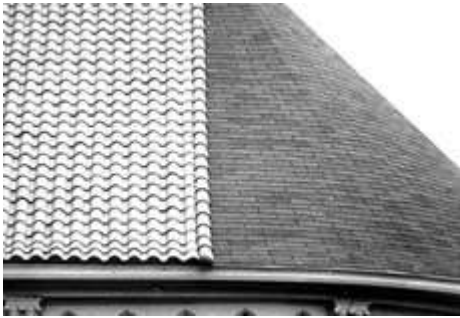
Asphalt shingles are an incompatible replacement substitute for the original Spanish clay tiles. Photo: NPS files.

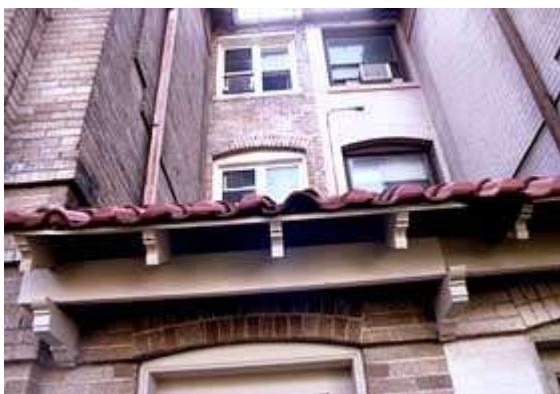
An eave closure or *birdstop* to keep out birds is notably absent from the replacement tile in the center of the bottom row. Photo: NPS files.

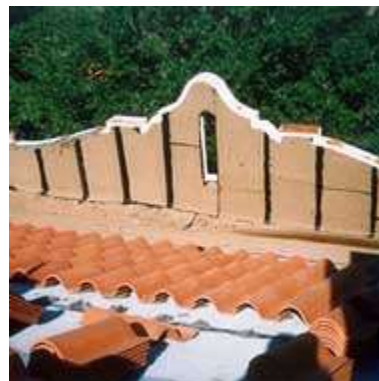
Projections on the underside of these replacement Spanish clay tiles help them adhere to the cement mortar on the roof sheathing. Photo: NPS files.
