HISTORIC STRUCTURE ASSESSMENT
**PONCHA SPRINGS
SCHOOL**

Figure 1. Poncha Springs School

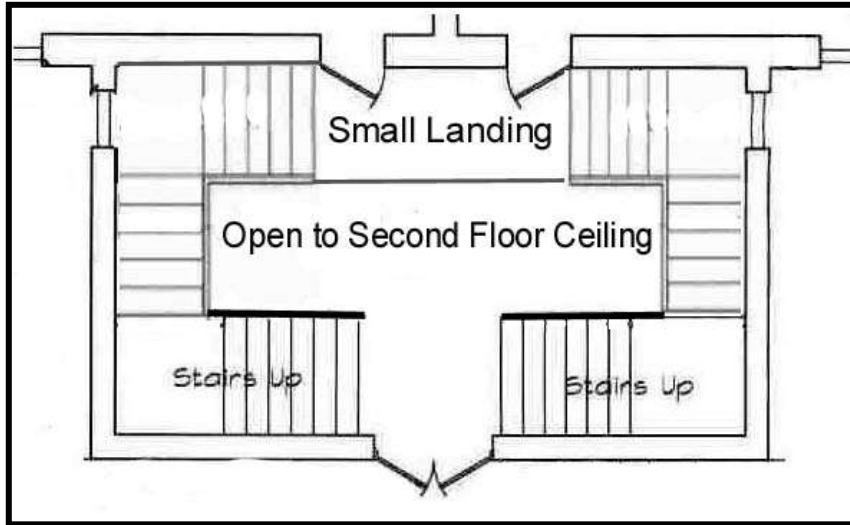
Figure 8. **Scenario A.** The stairs are open all the way up to a small landing in front of the two doors. This landing could have been partitioned so each stair would access only one of the planned classrooms. This symmetrical, open stair could be expected with this style of building. It would also have allowed more light into the space from the south windows above. However, no direct evidence has been found that supports this scenario.

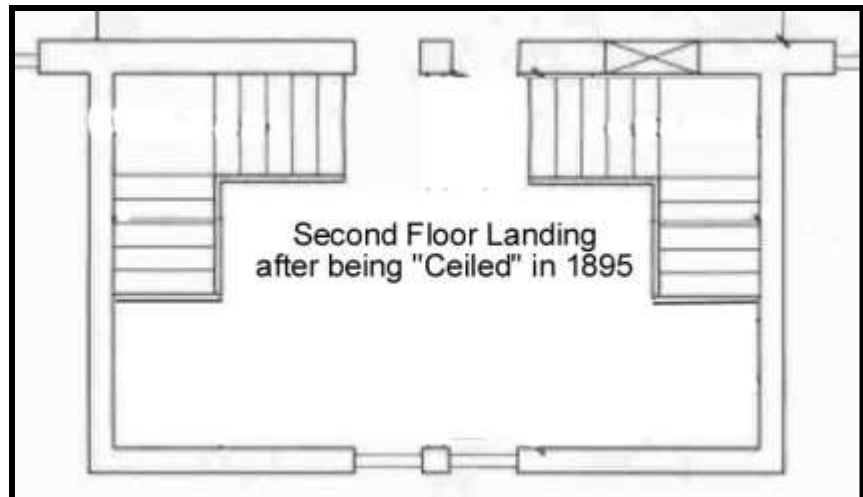
Figure 9. **Scenario B.** This could have been the original configuration of the entry, and the ceiling installed in 1895 could have been another step in the gradual completion of the building -- covering the exposed joists on the underside of the second floor landing. Bead board also covers the underside of the stairs. The under-stair areas could have remained open to the larger space until the restrooms were installed between 1922 and 1949.

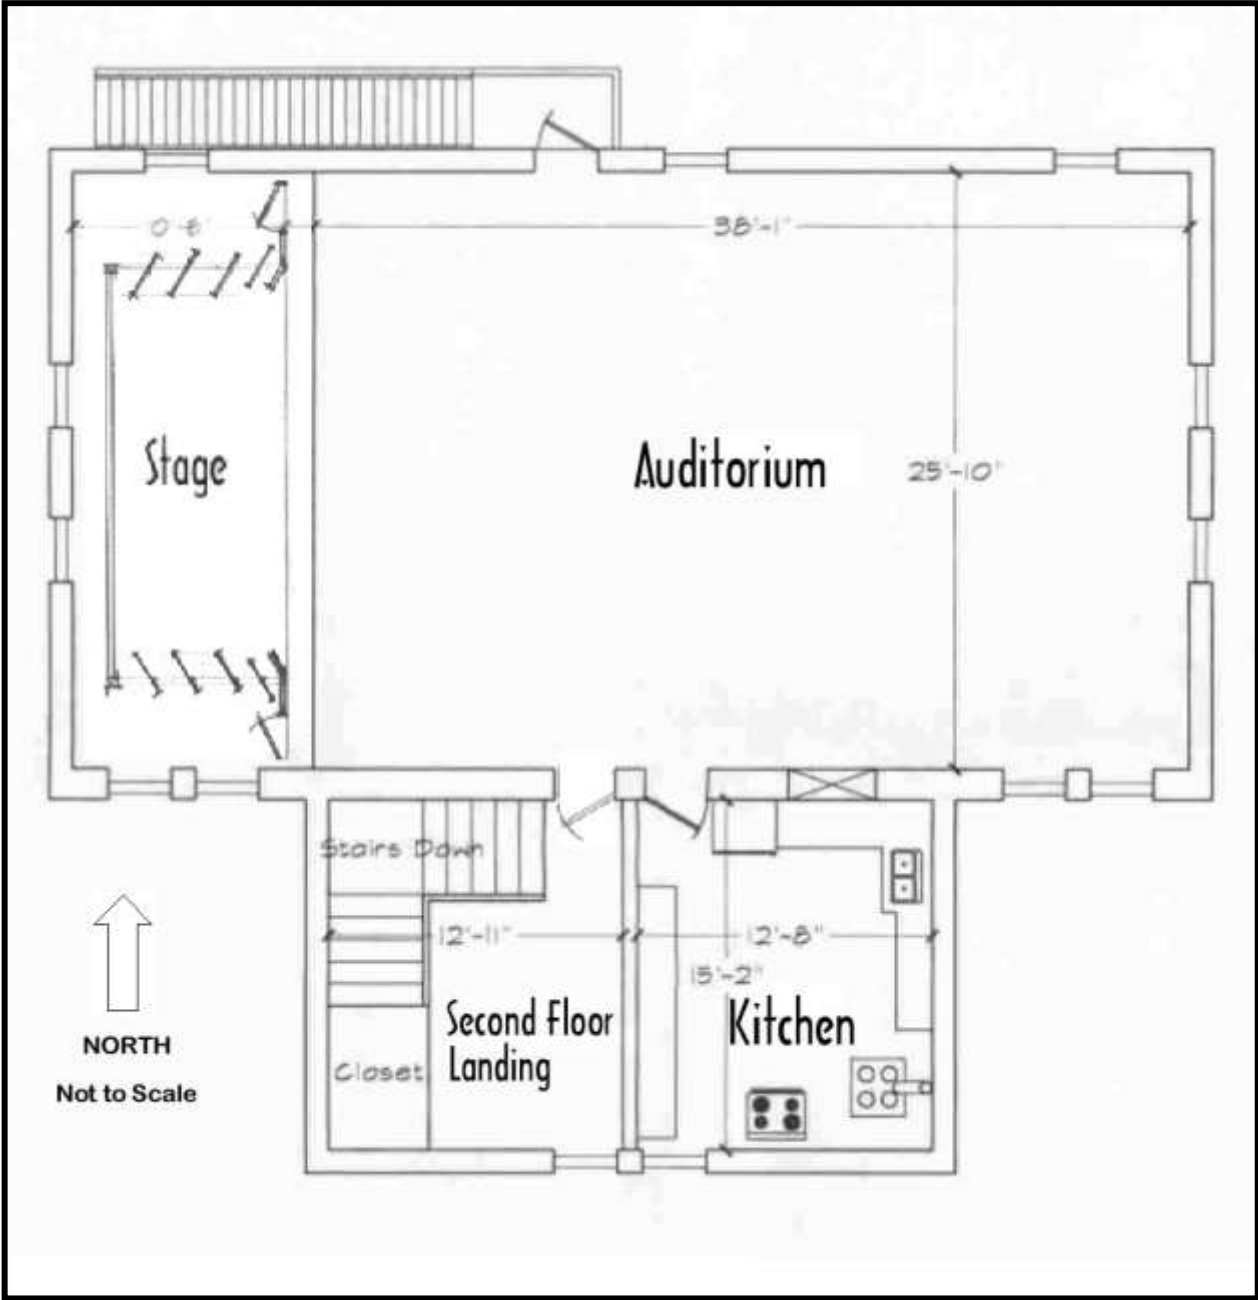
STRUCTURE CONDITION ASSESSMENT

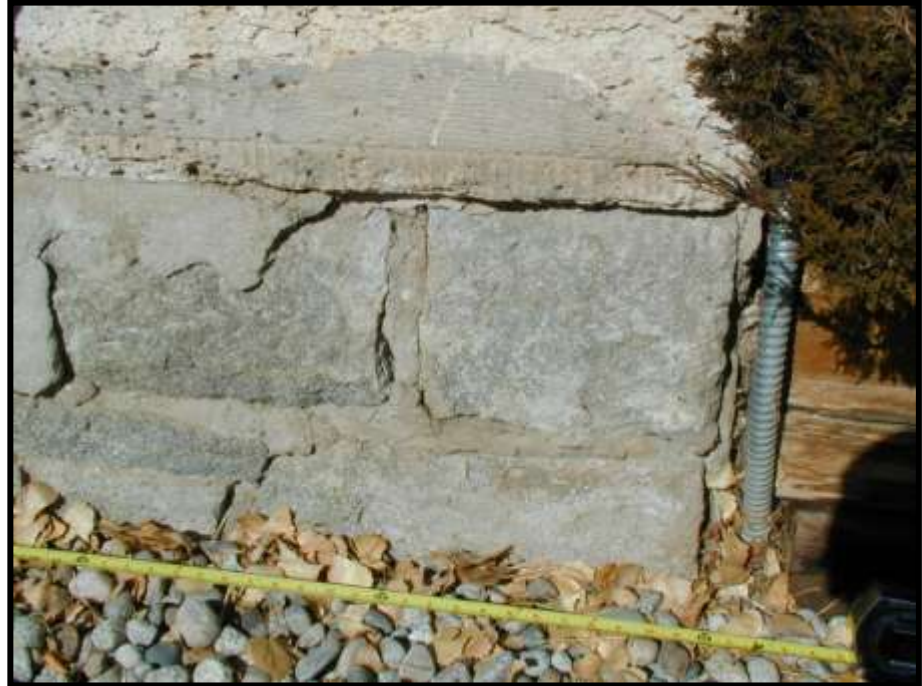
Figure 10. Foundation. Note loose parget coat at left, and deteriorating stone water table above foundation.

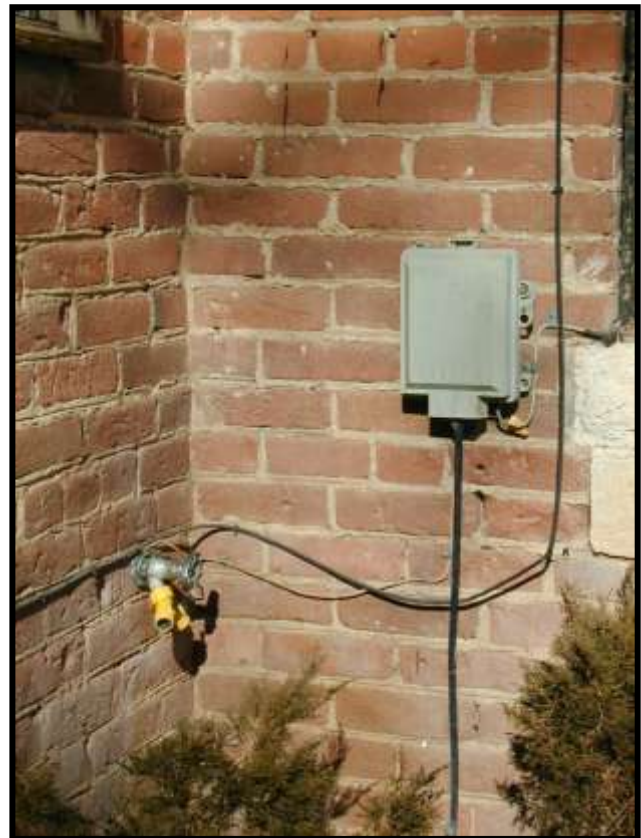
Figure 11. Looking northwest at corner of east Entry wall and South Main Building wall, across planting bed. Note wide area of lighter color brick and eroded brick beneath faucet.

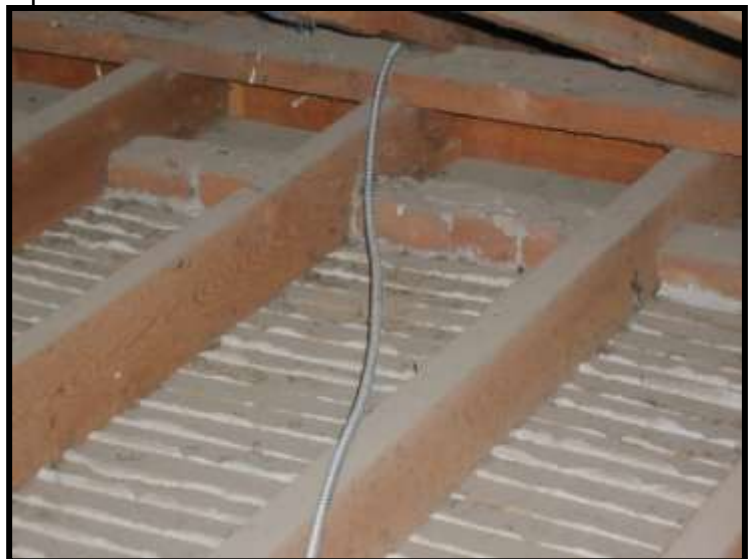
Figure 12. Roof and ceiling framing at exterior wall plate. Note bricks between ceiling joists.

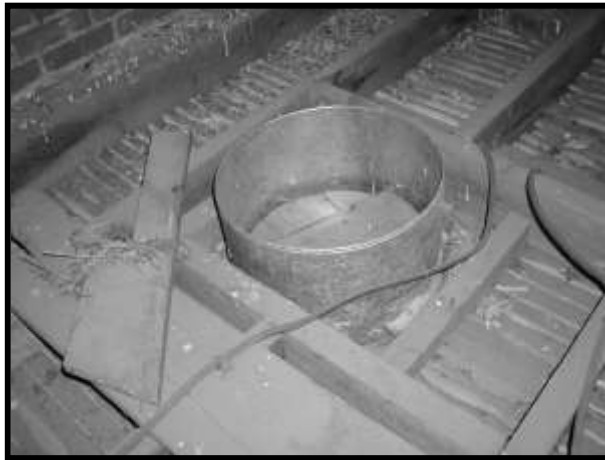
Figure 20. Pipe at ceiling penetration.

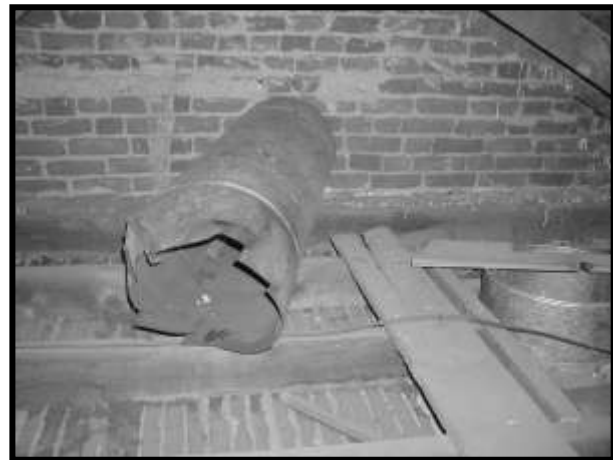
Figure 21. Loose pipe on ceiling at northwest corner of building.

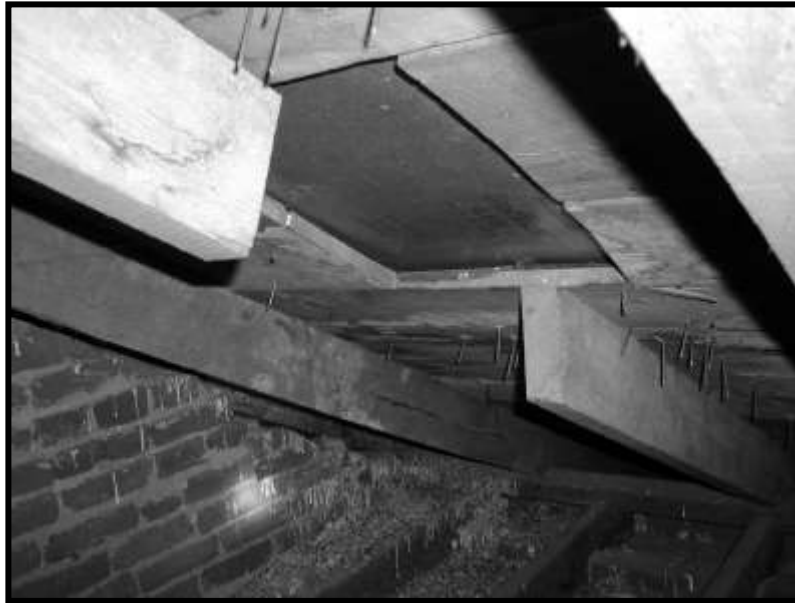
Figure 22. Roof rafter sawn through at location of 15" pipe penetration.

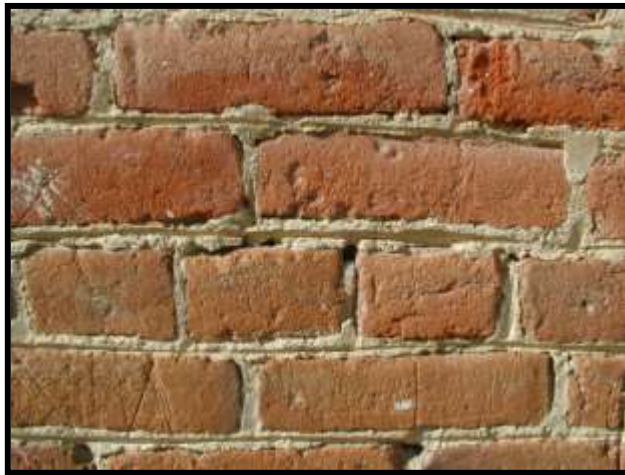
Figure 14. Grapevine brick pointing.

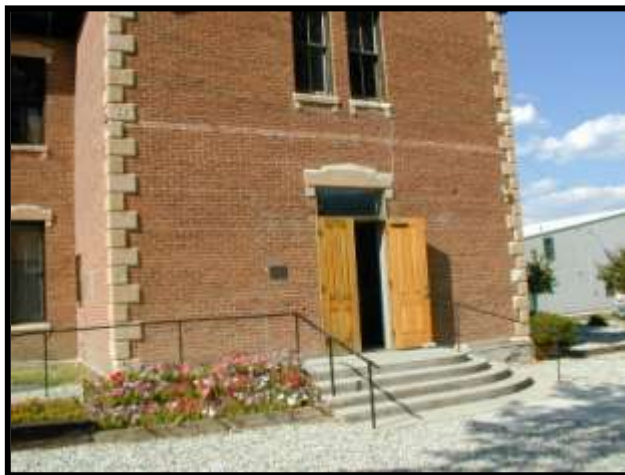
Figure 15. Note lighter colored brick course at tie rod above entry door. Looking northeast.

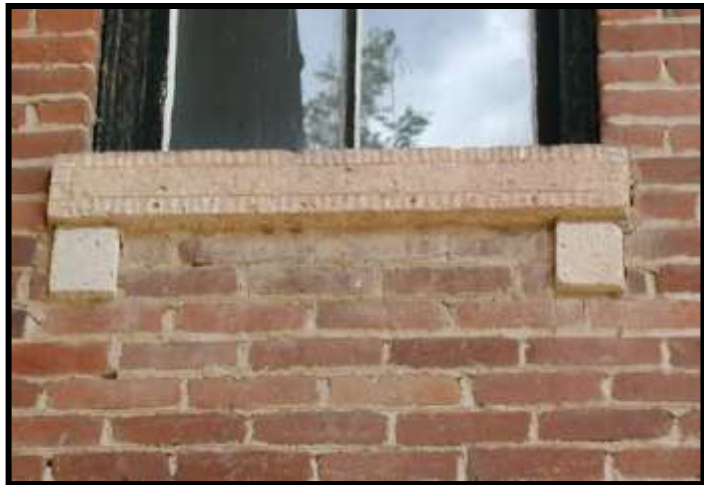
Figure 16. Window sill with dentil tool marks.

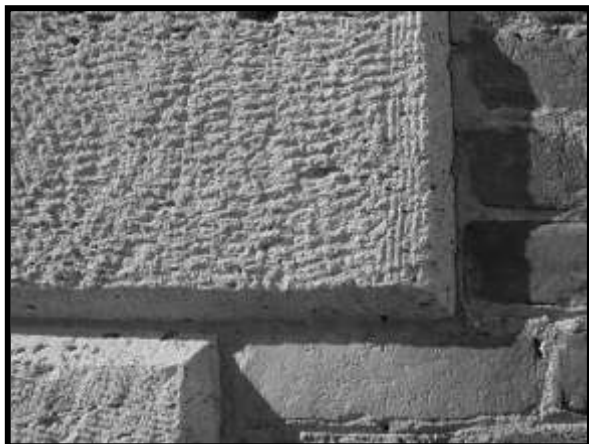
Figure 18. Quoin tooling, long face.

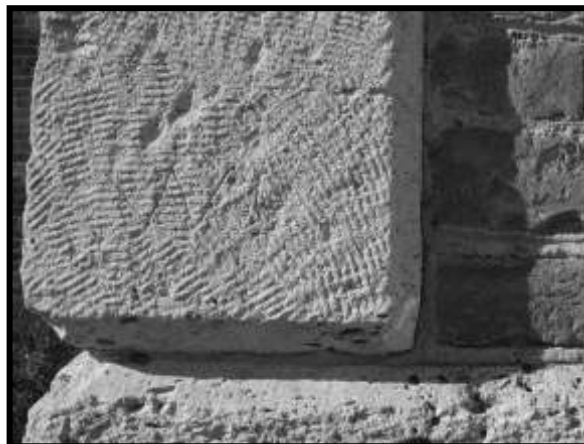
Figure 17. Quoin tooling, end face.

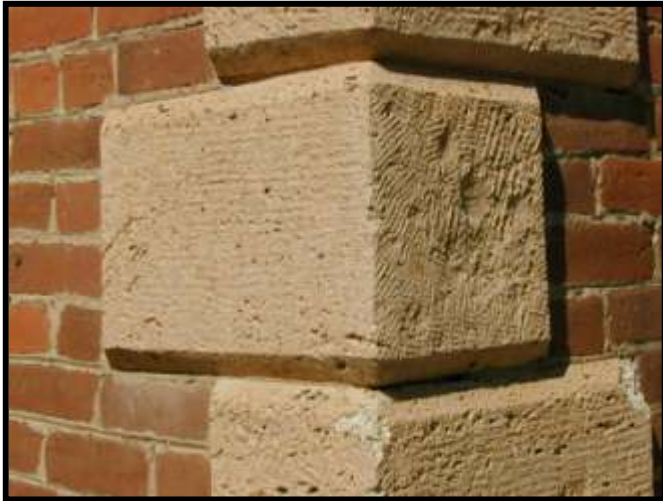
Figure 19. Quoin, good condition.

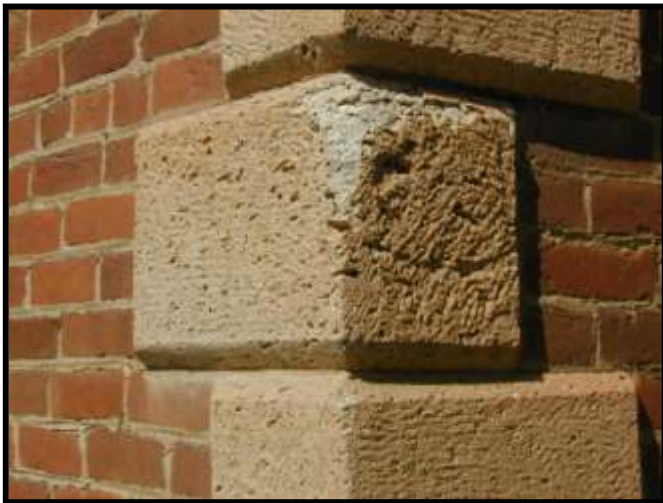
Figure 20. Quoin, fair condition.

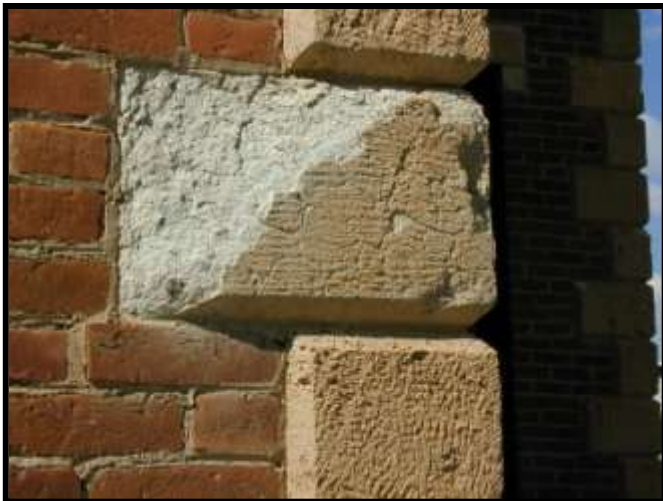
Figure 21. Quoin, poor condition.

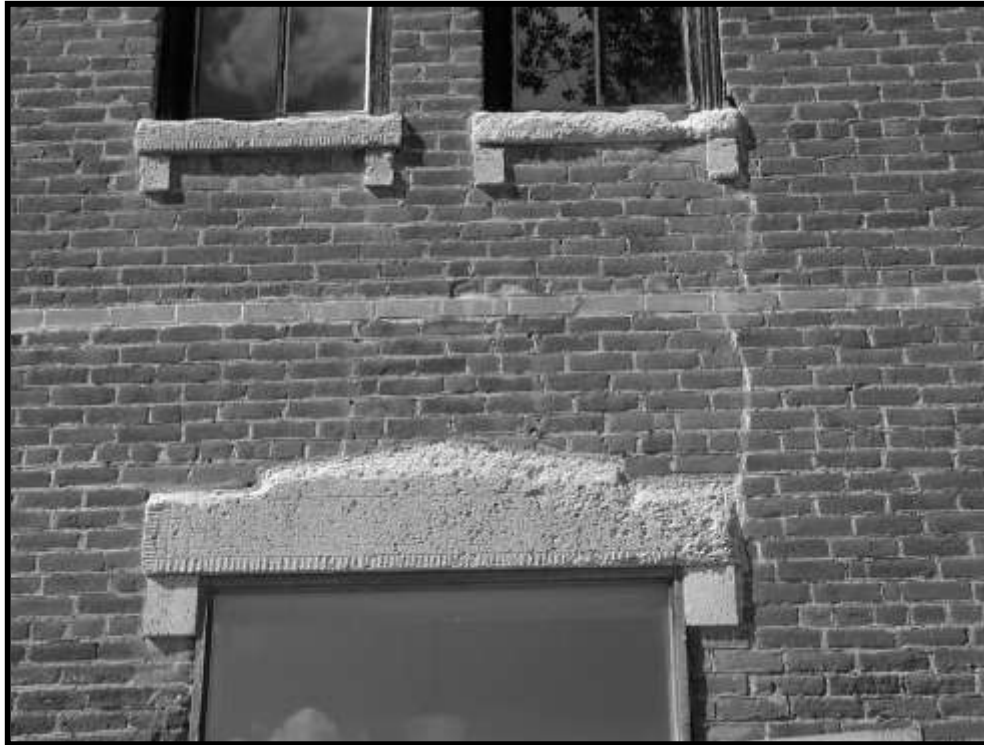
Figure 22. South façade, looking north. Decorative head at entry door, in poor condition. Left window sill above in fair condition. Right window sill above in poor condition.

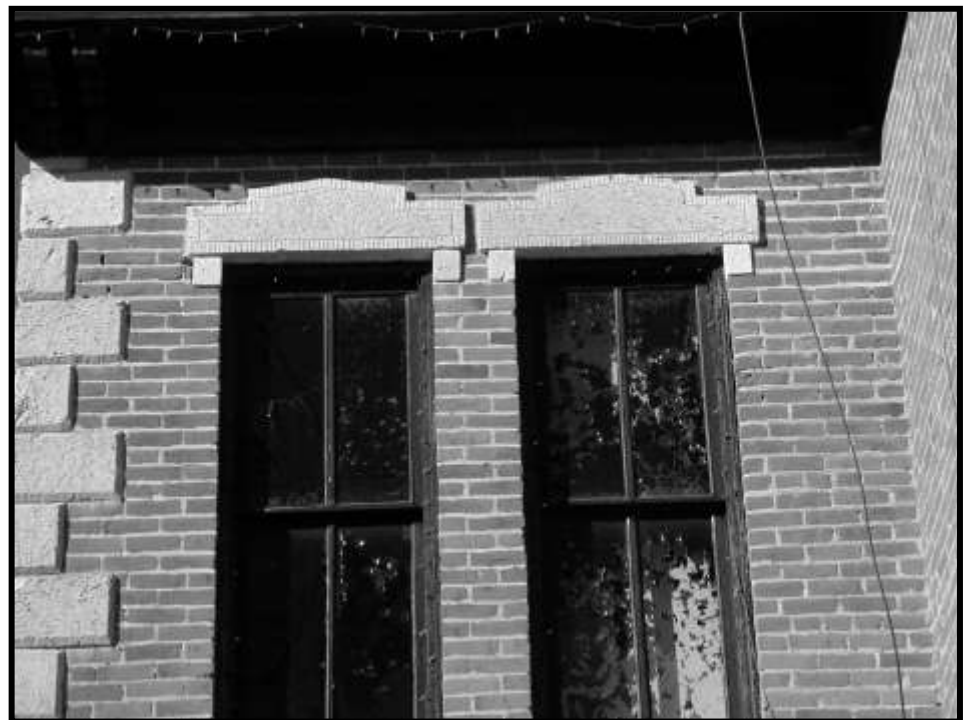
Figure 23. West pair of windows on south façade. Both window heads are in good condition.

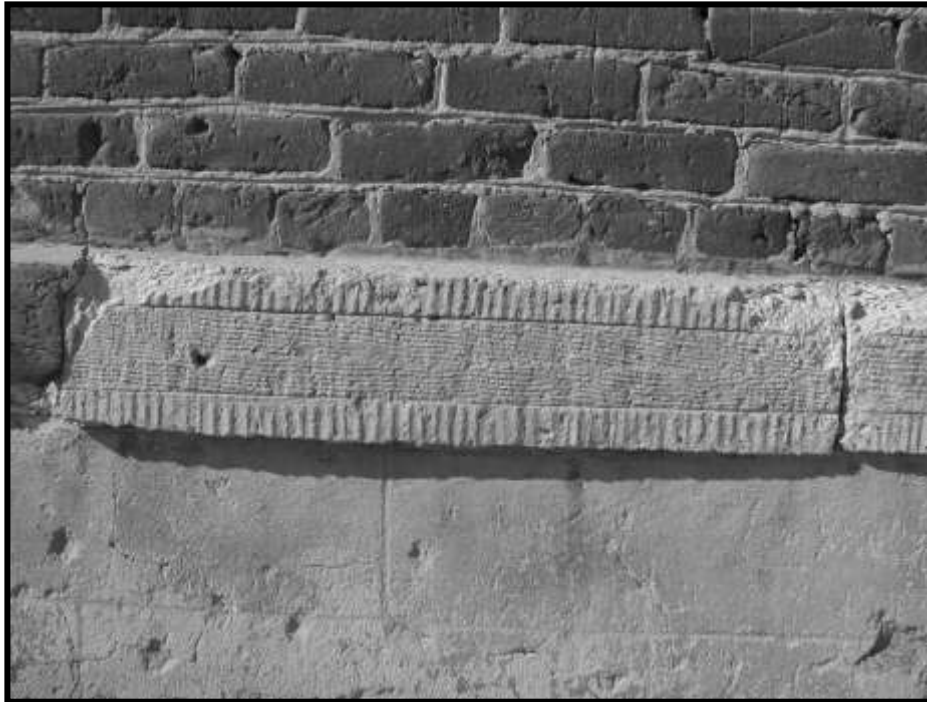
Figure 24. Watertable in fair condition. Note scored stucco parget coat below. This piece of watertable near the south end of the east well, main building, is a good candidate for use as a pattern for new watertable pieces.

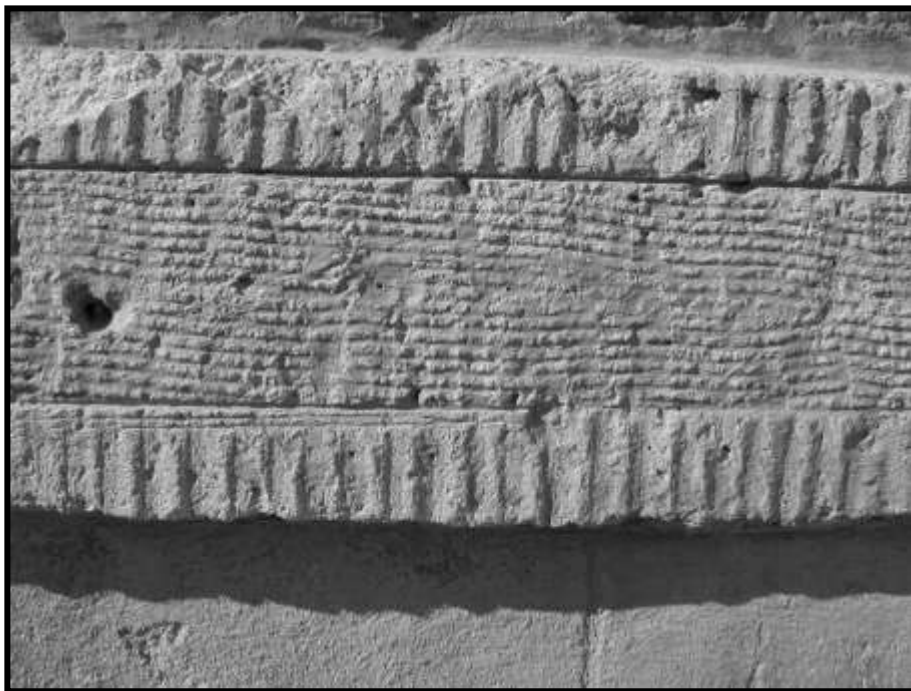
Figure 25. Close-up of watertable tooling.

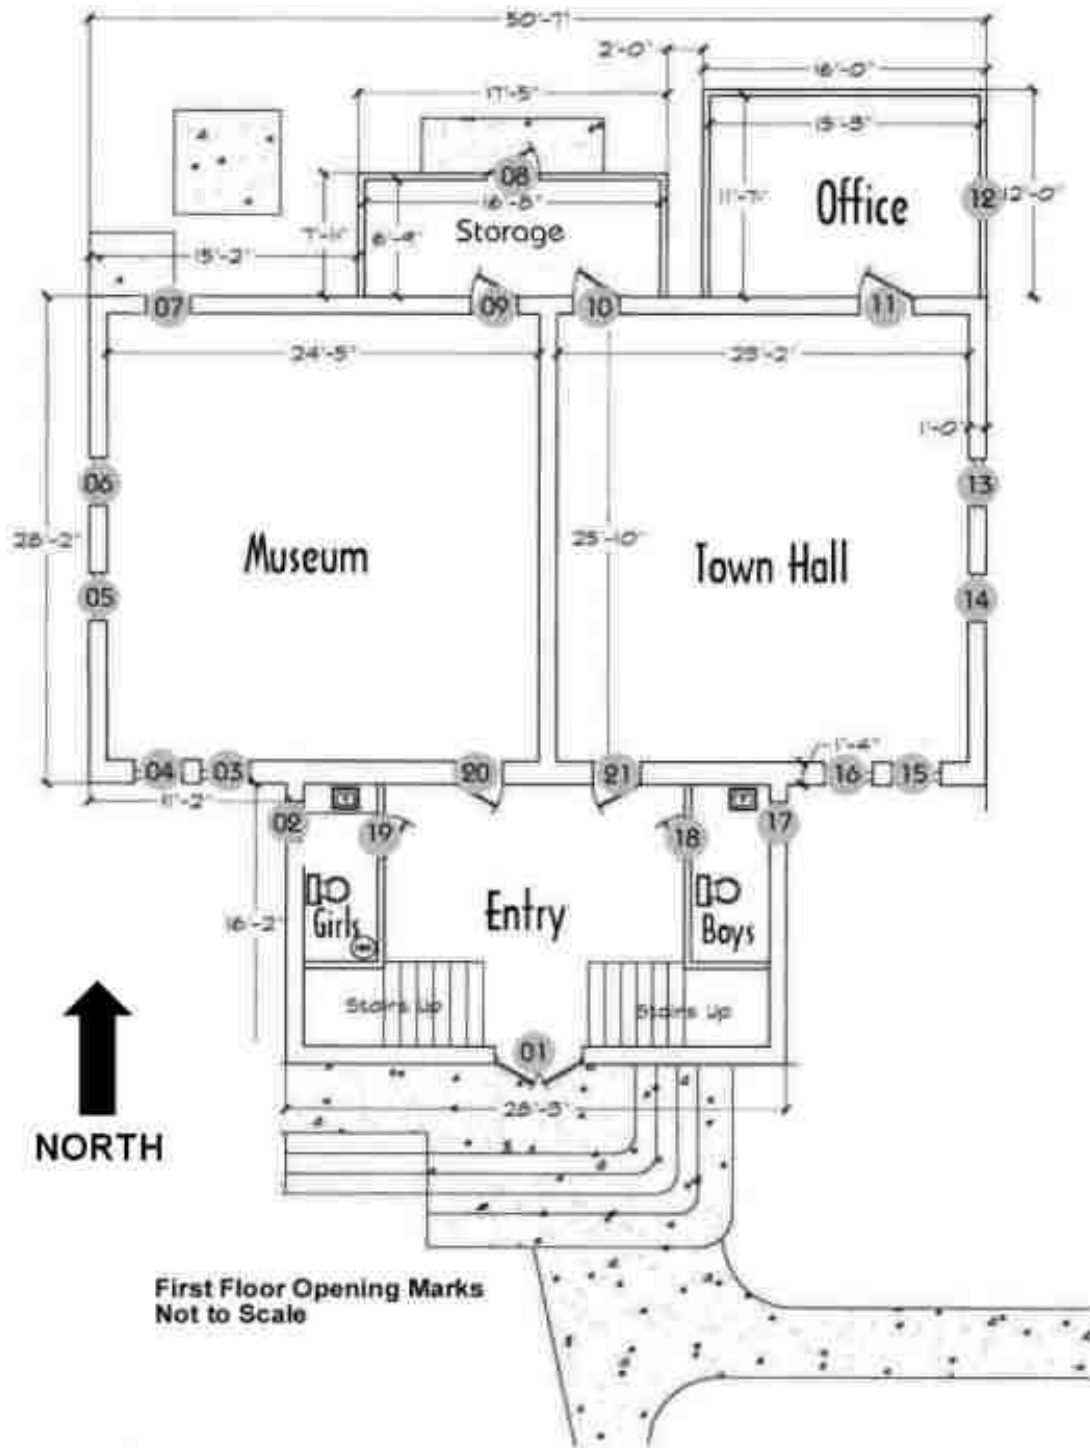
30	P	NA	NA	P	NA	NA	
31	G	NA	NA	P	NA	NA	
32	G	NA	NA	P	NA	NA	
33	P	NA	NA	P	NA	NA	Head cracked
34	G Dec	G	G	P	G	F	
35	G Dec	G	G	P	G	G	
36	NA	NA	NA	NA	NA	NA	Interior
37	NA	NA	NA	NA	NA	NA	Interior
38	NA	NA	NA	NA	NA	NA	Interior
39	NA	NA	NA	NA	NA	NA	Interior

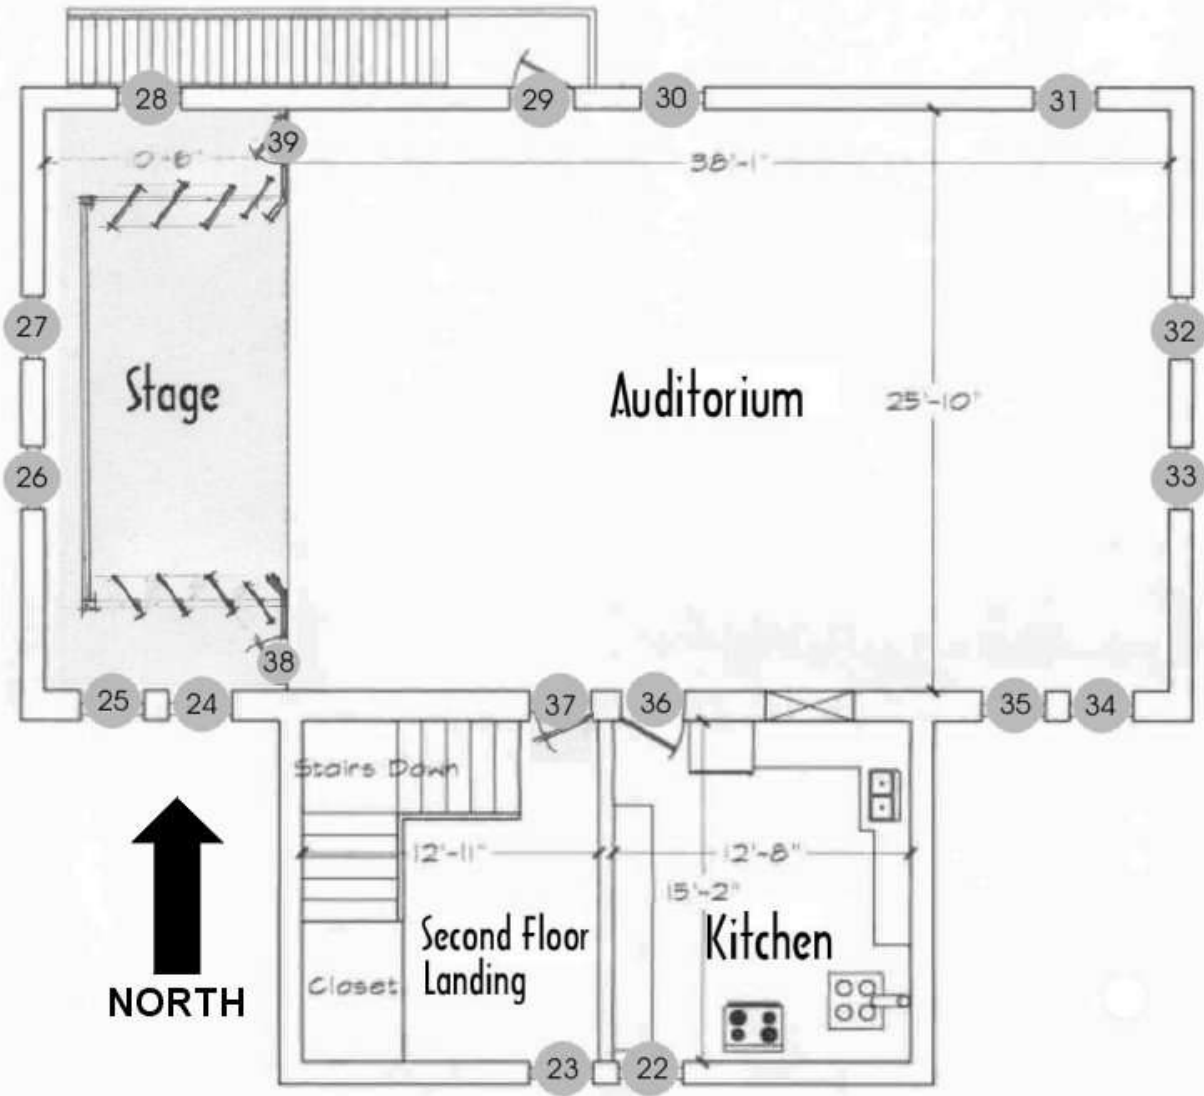
**Second Floor Opening Marks
Not To Scale**

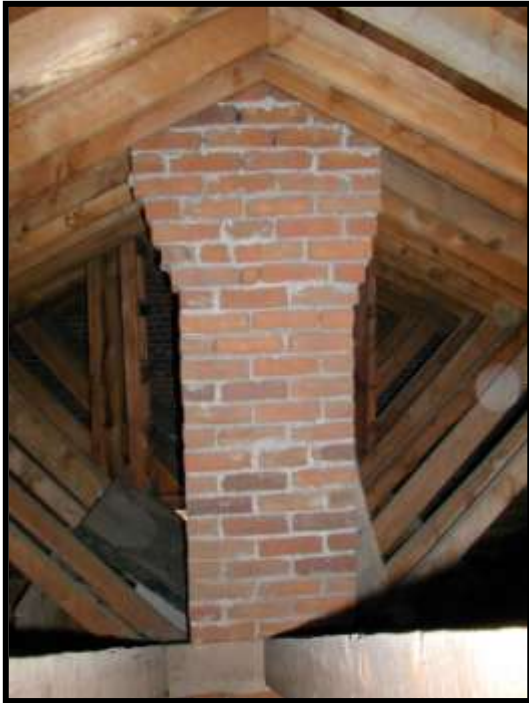
Figure 27. Center chimney in attic. Note corbelling.

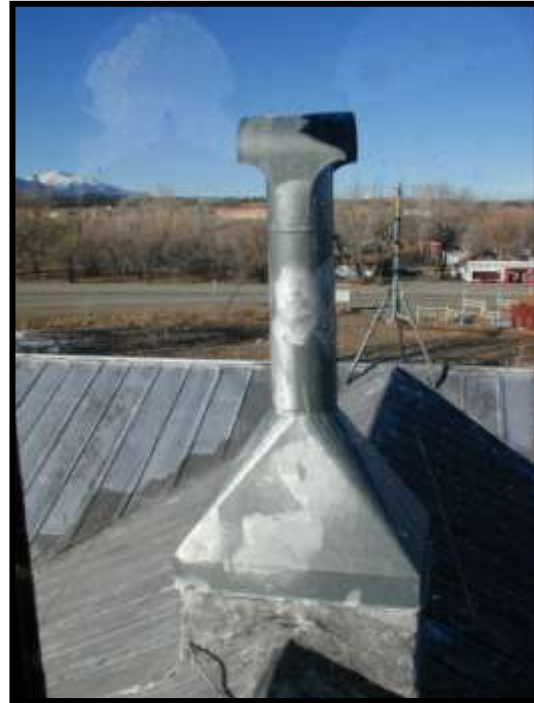
Figure 26. Center chimney above roof looking north from Cupola. Note silver paint on brick and cracked roofing cement.

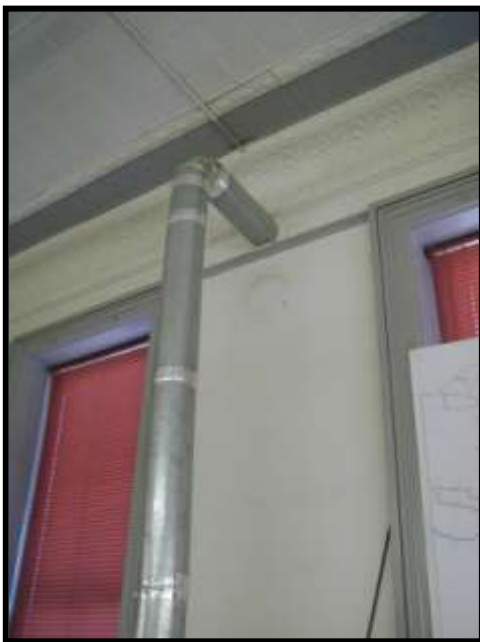
Figure 28. Stovepipe in Museum. Note stovepipe hole location below picture rail. Looking west.

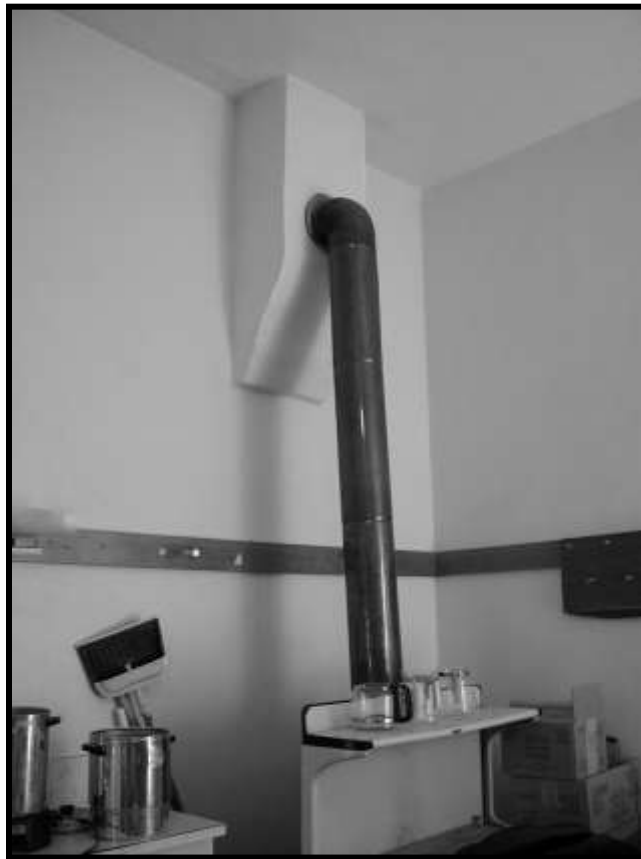
Figure 30. Stovepipe in east wall of Kitchen into retrofit chimney. Looking southeast.

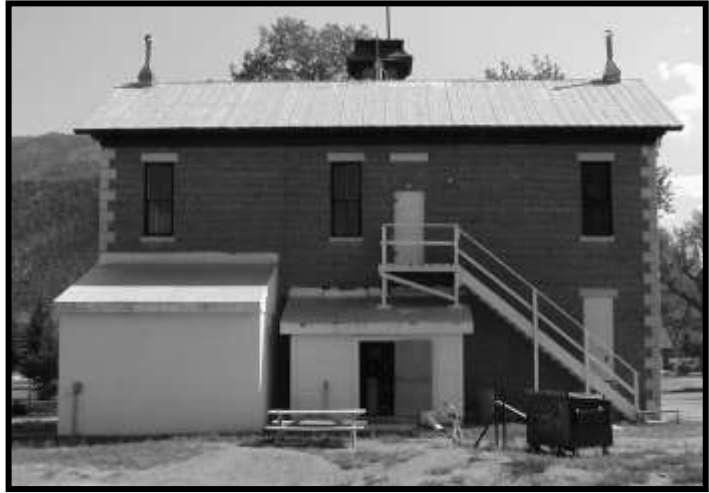
Figure 31. Rear (north) elevation, facing south. Three appendages, left to right: concrete block vault, now the Town Administrator's Office, storage shed, and exterior exit stair.

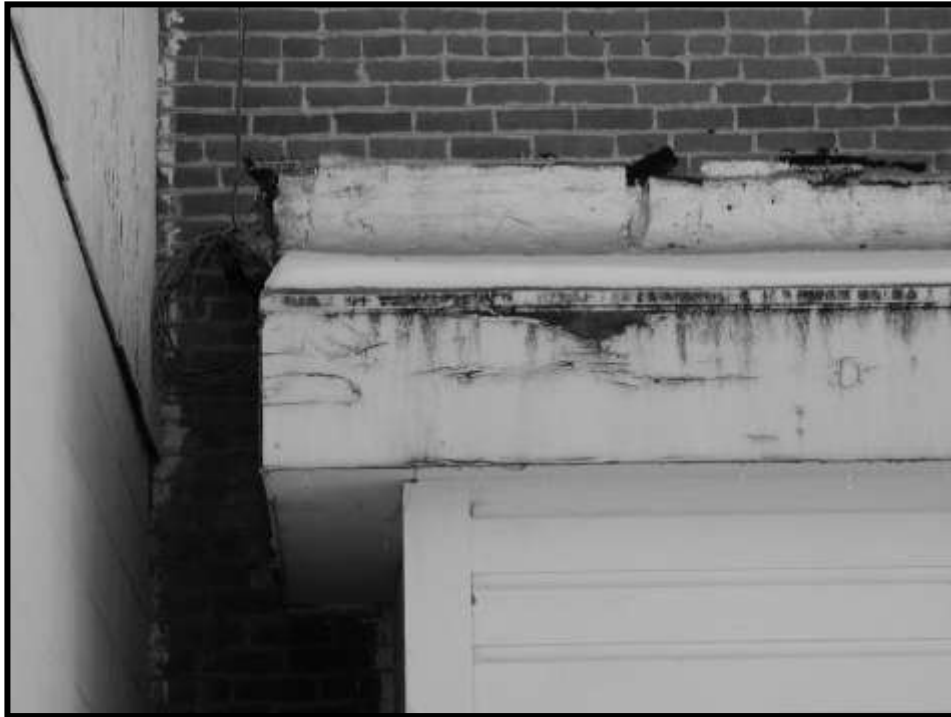
Figure 33. Storage Room, fascia and flashing. Northeast corner of Storage Room, looking south.

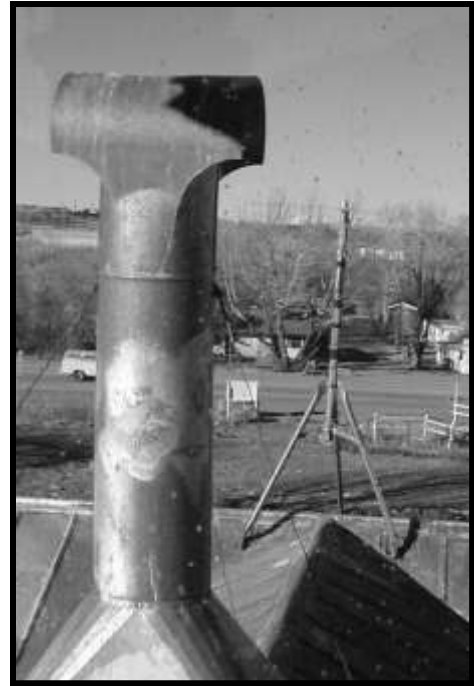
Figure 36. Tipped roof antenna, to right of chimney cap. Looking north.

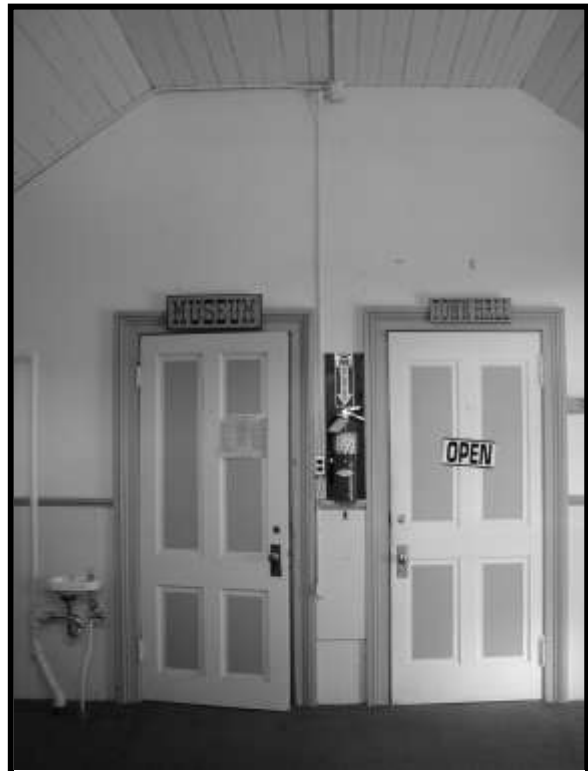
Figure 37. Doors to Town Hall (right) and Museum (left). Looking north.

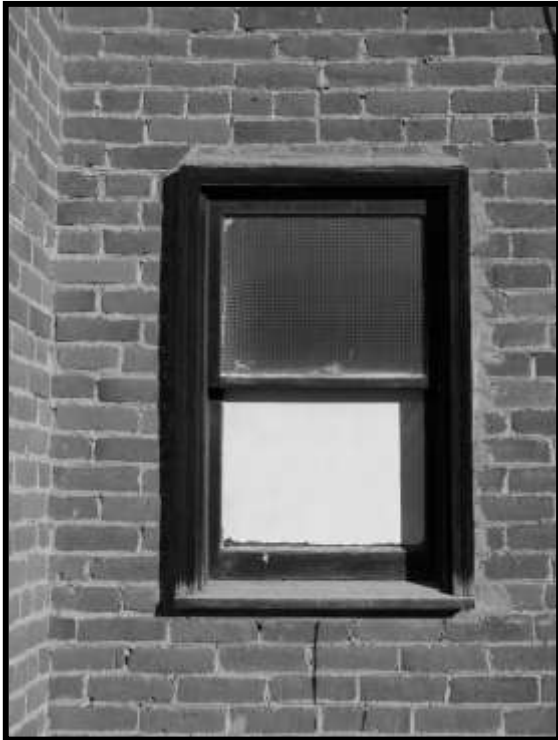
Figure 42. Girls Room window from exterior, looking east.

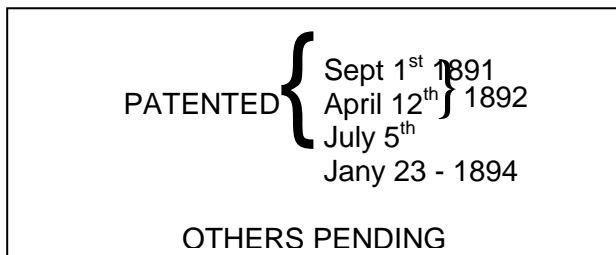
Inside the door to the firebox is a hinged panel with the following:

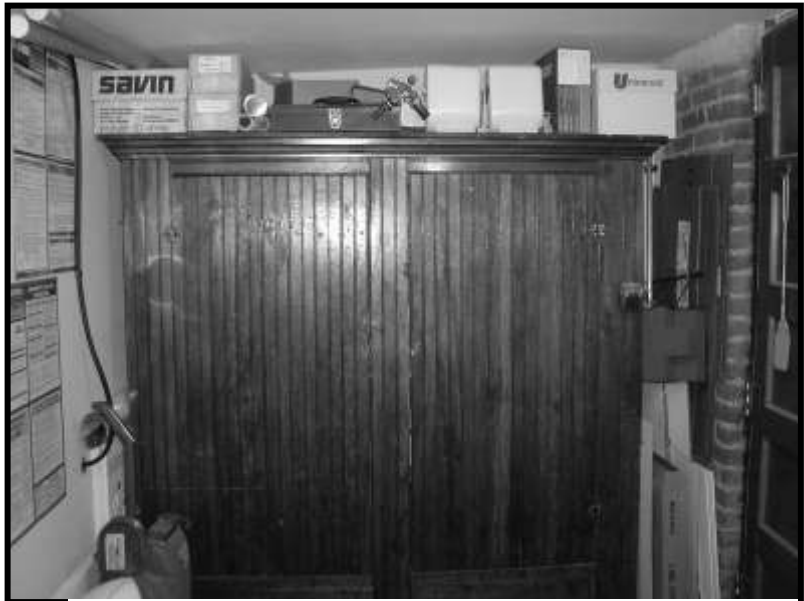
Figure 44. Storage room, looking east. Note brick at right.

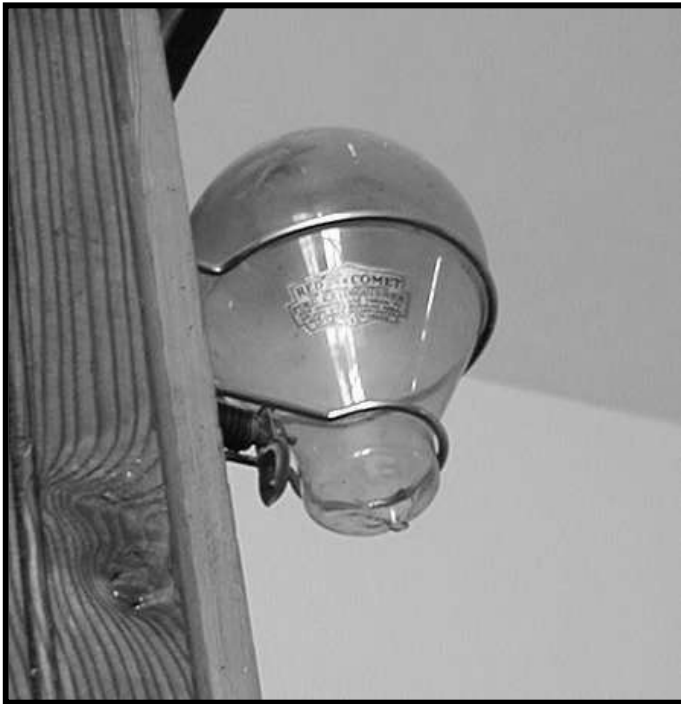
Figure 45. Fire extinguisher. Another of these is found on shelves in the north wing of the Stage.

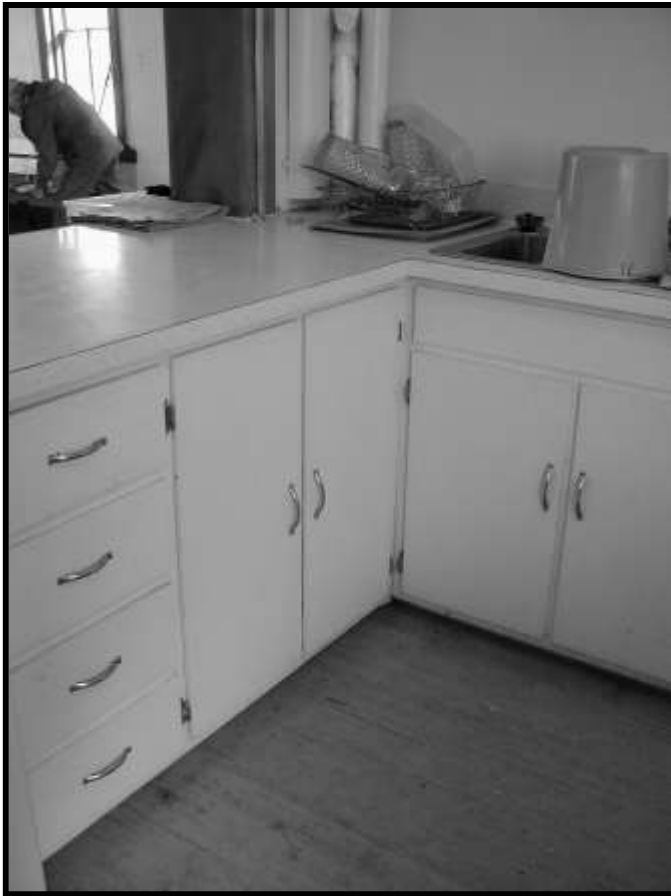
Figure 61. Kitchen cabinetry, looking northeast.

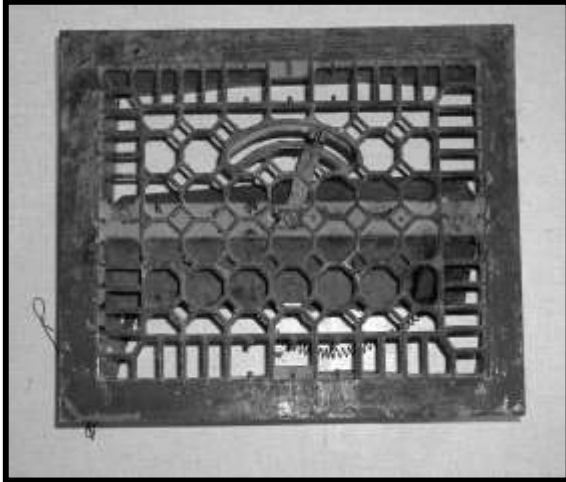
Figure 46. Floor grate found under the Stage.

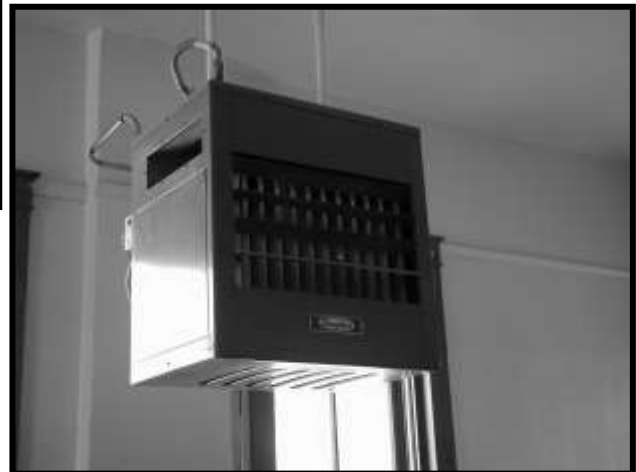
chimney at the east wall that extends 4" into the room. This heater is better suited to an auto repair shop or warehouse space. Ventilation is through operable windows.

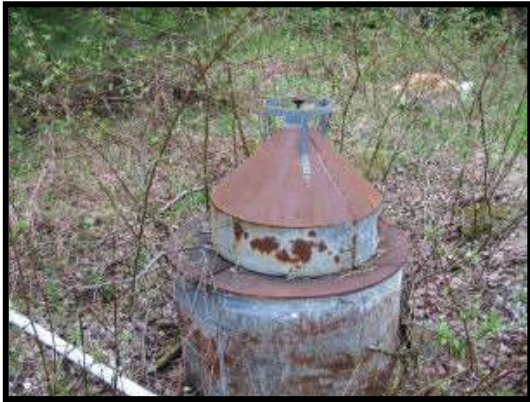
Figure 66. An in-ground carbide generator. (Photo by Robin DeLoria.)

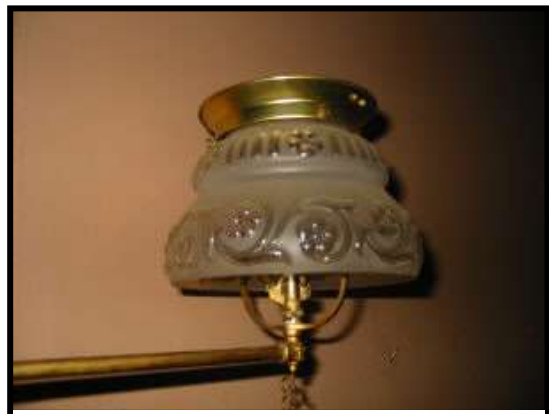
Figure 49. A carbide lamp. (Photo by Robin DeLoria.)

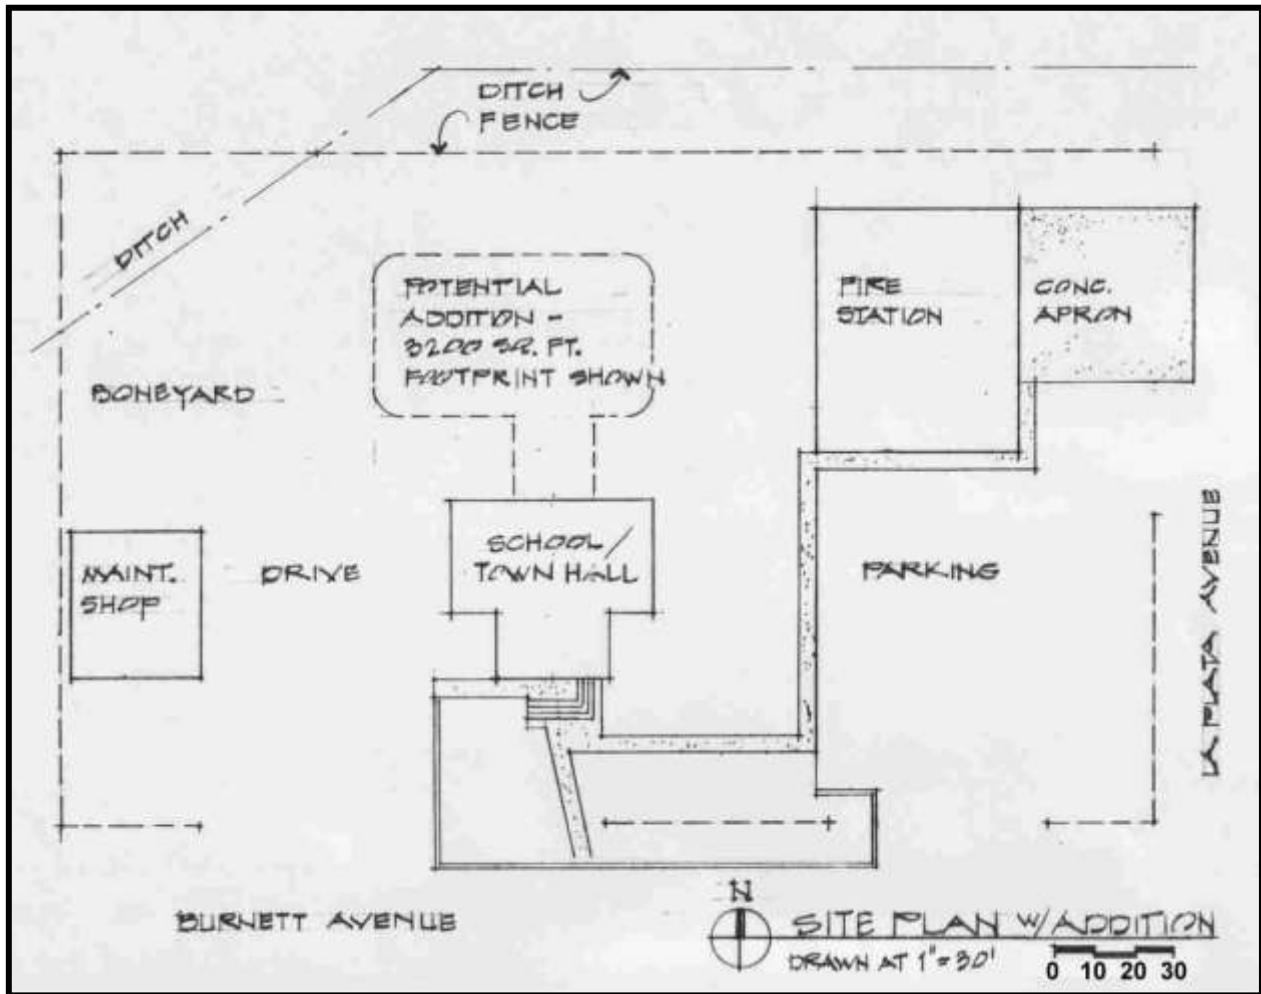
PRIORITIZED AND PHASED WORK
