HISTORIC STRUCTURE ASSESSMENT VALLEY VIEW SCHOOL

County Road 140, Chaffee County, Colorado

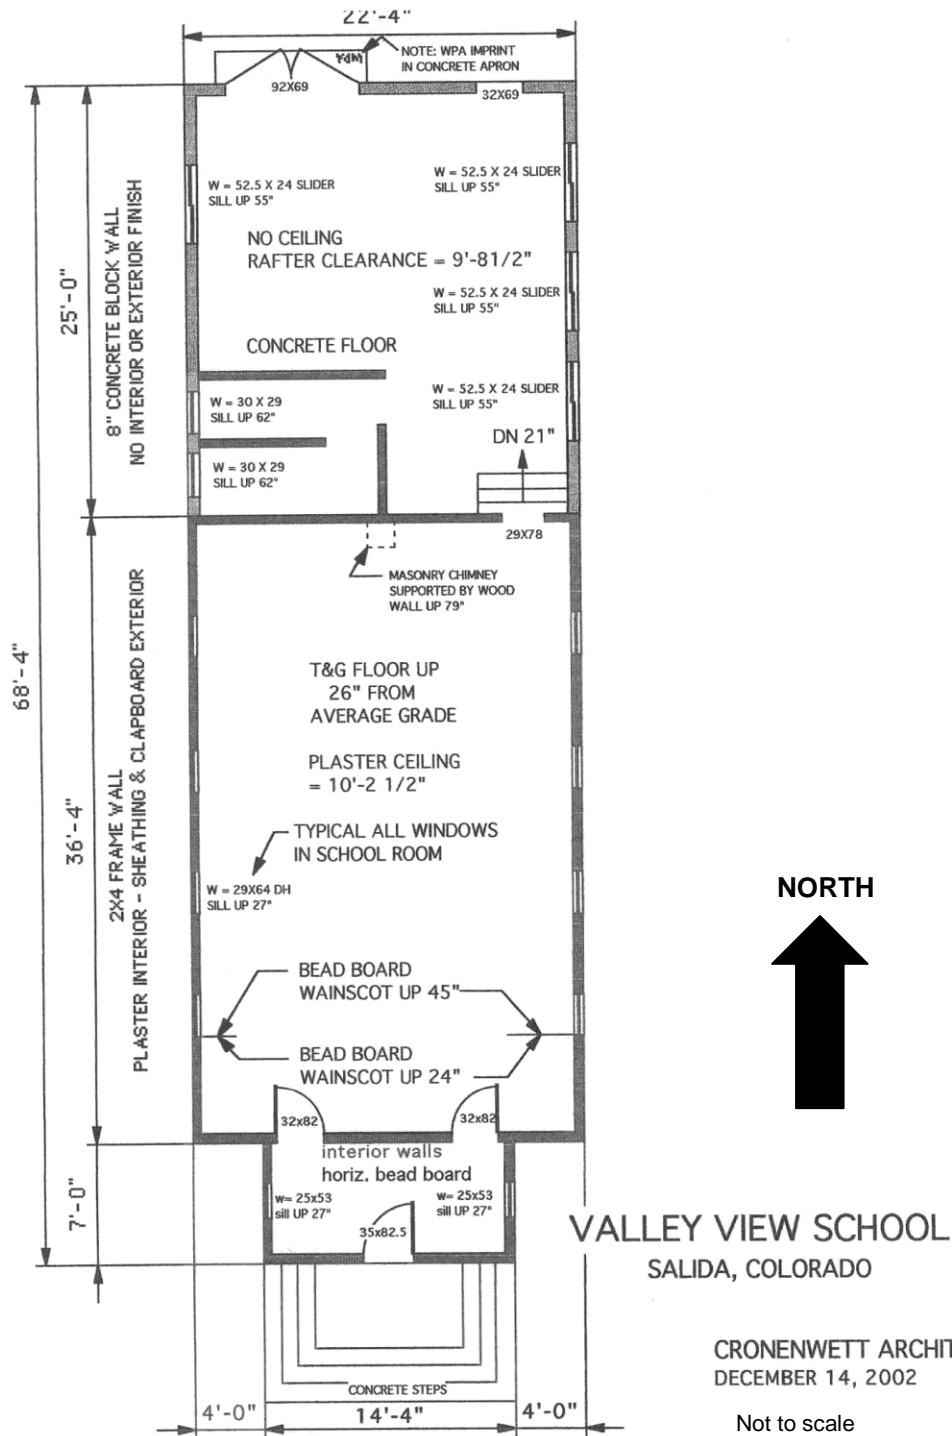
CHARACTER-DEFINING ELEMENTS

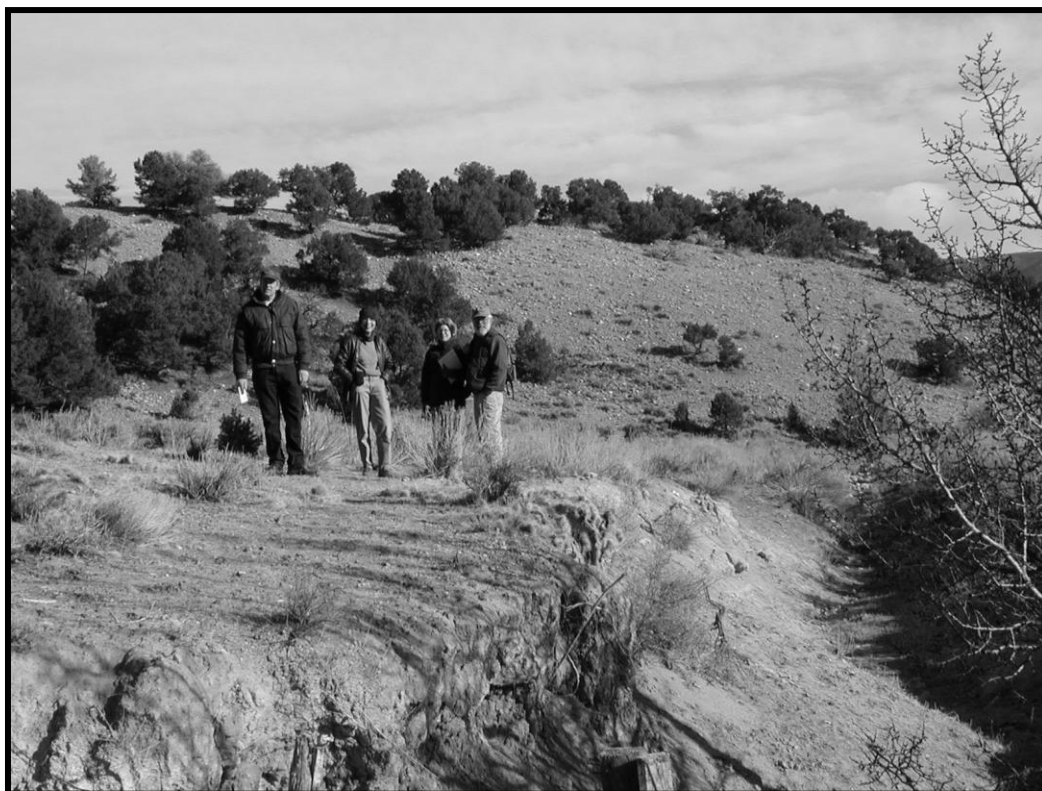
Figure 3 Figures are standing on the edge of the eroded irrigation ditch that runs from the east side of the property gate to the stock pond. Looking northeast. Tree at far right is hardy apricot.

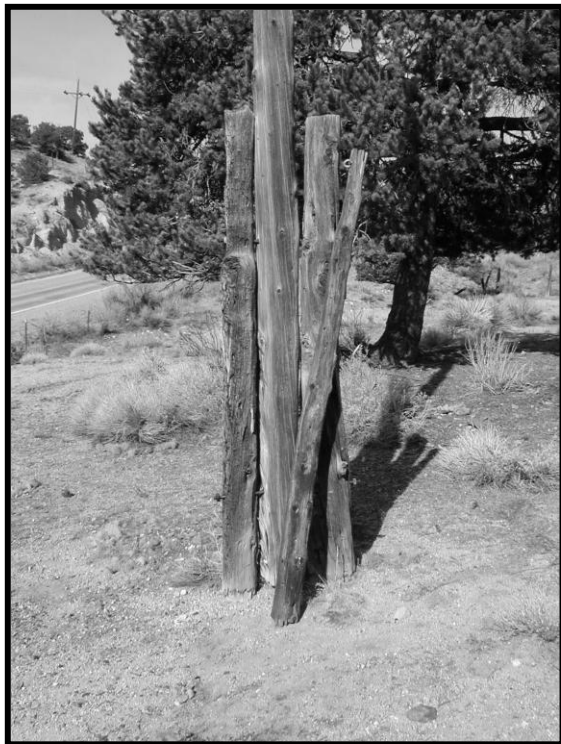
*Figure 4. Flagpole base, looking west.
Diagonal element is top of flagpole,
broken off. Note screw eye at top left of
this piece.*

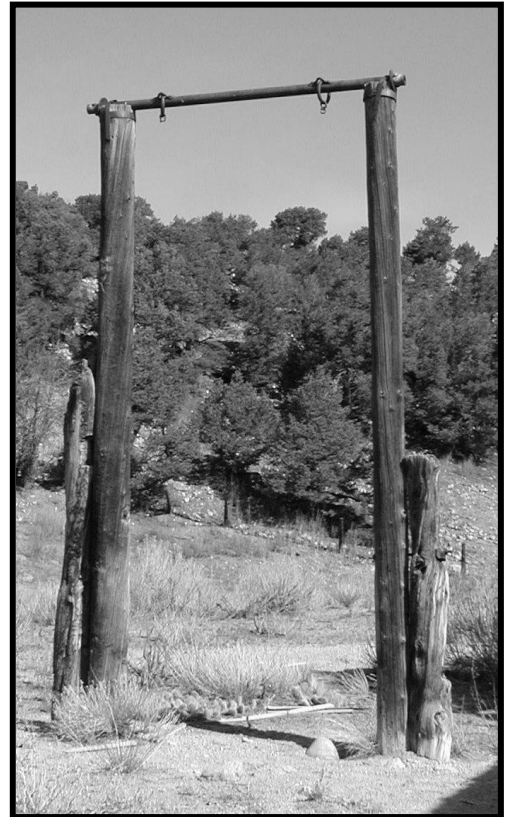
*Figure 5. Swing Frame, looking
northwest.*

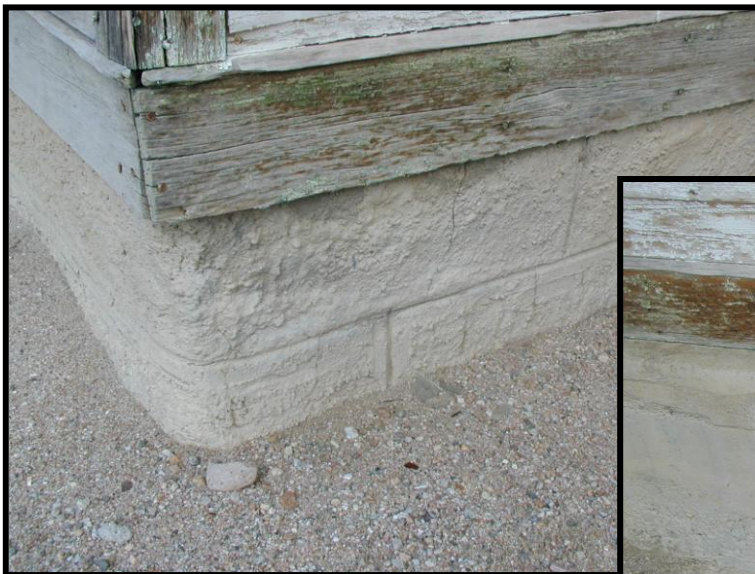
Figure 7 (left). Foundation with pebbledash stucco. Note scoring to imitate ashlar laid stone. Looking northeast.

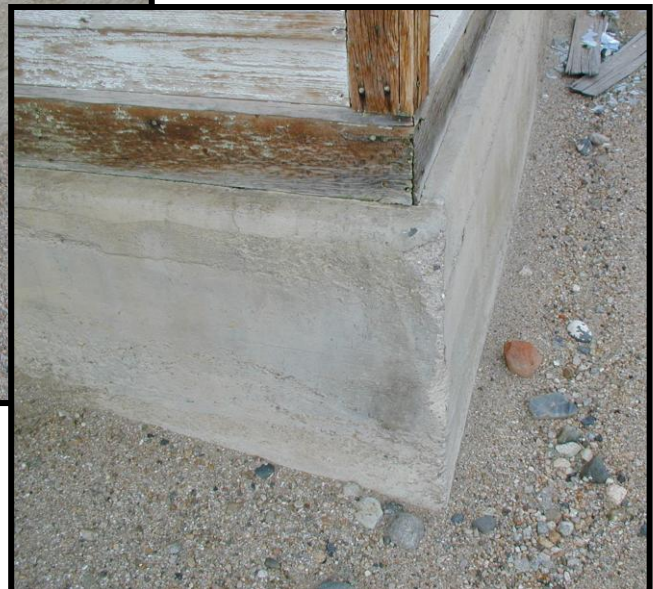
Figure 8 (right). South and east walls, showing layer of concrete over stucco. Looking north.

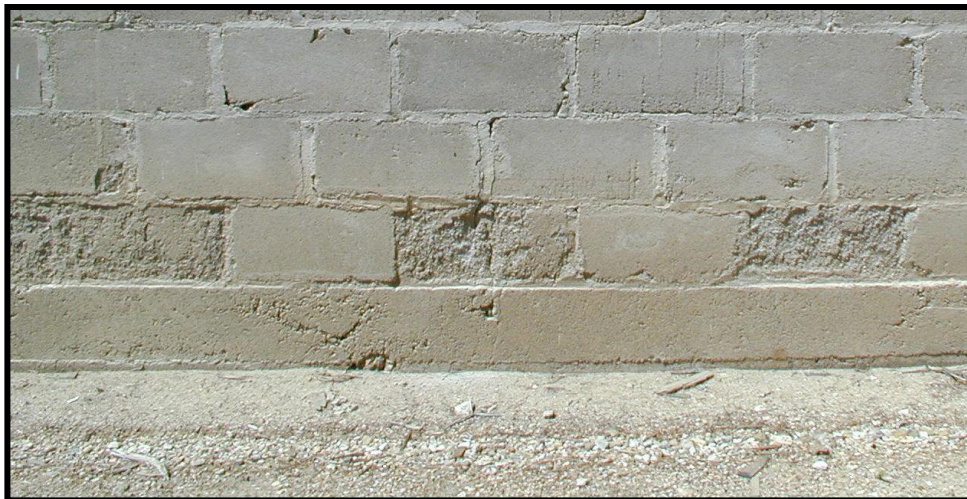
Figure 11. Concrete blocks on WPA addition, showing spalling on first course. Looking west.

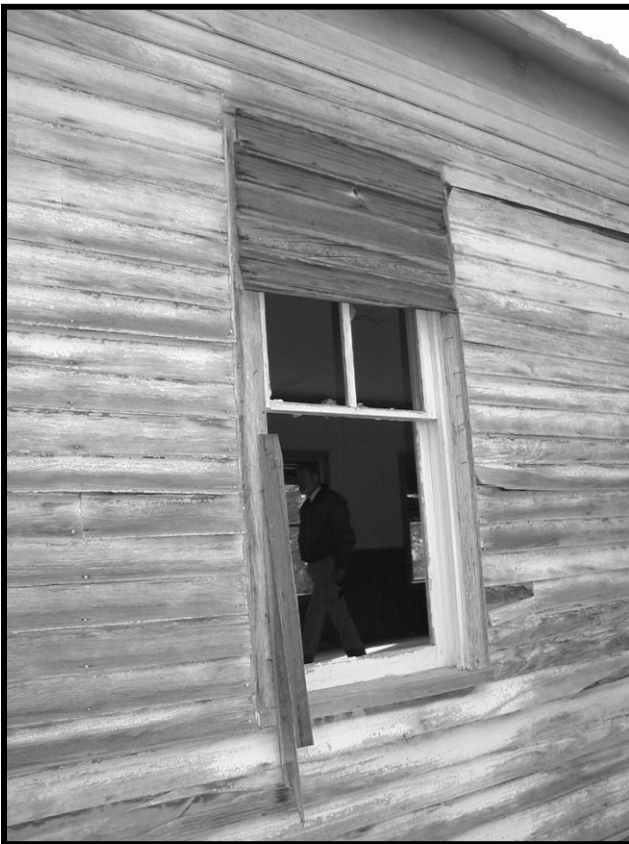
ORIGINAL SCHOOL, INCLUDING VESTIBULE

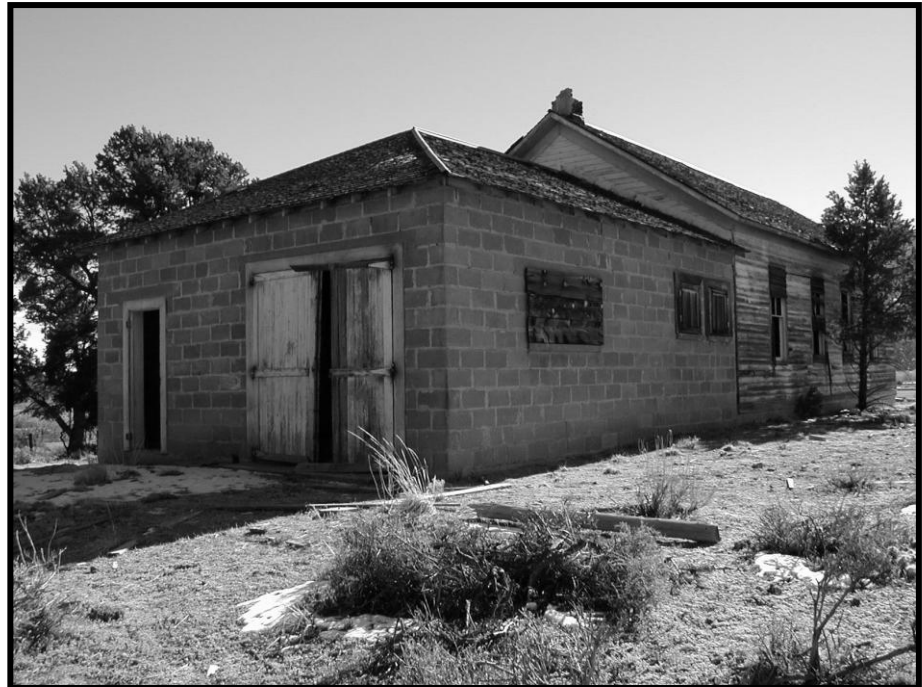
*Figure 13. North (left) and west (right) facades of WPA addition.
Note chimney remnant at north end of original school ridge.
Looking southeast.*

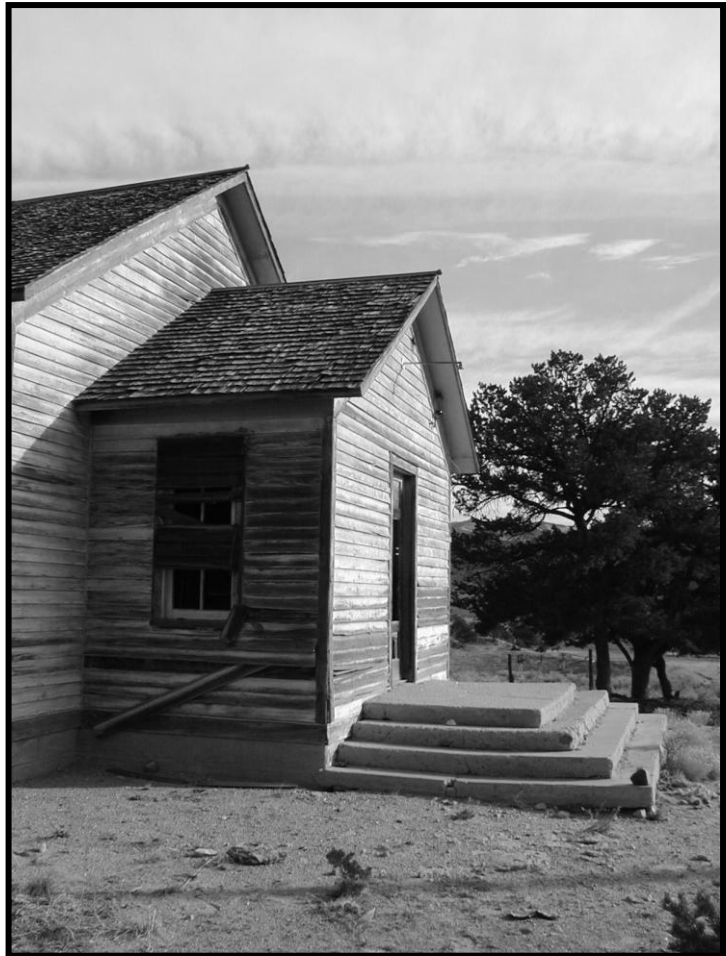
Figure 14. Vestibule and front stoop. .Looking east-northeast.

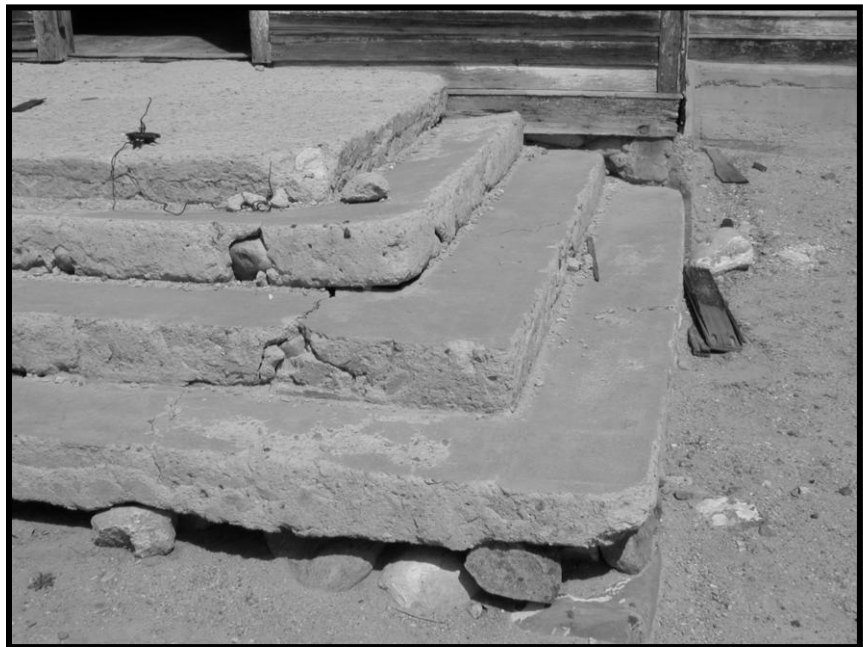
Figure 15. Front stoop. Looking north at southeast corner.

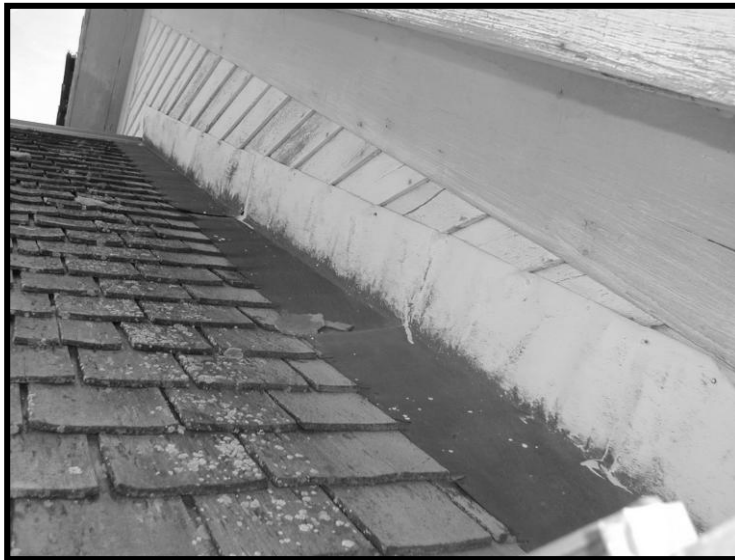
*Figure 16. Vestibule roof where it joins main building.
Note flashing. Looking northwest.*

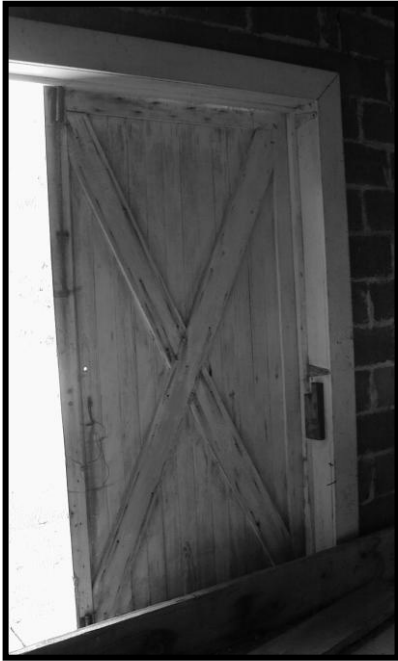
Figure 18. East leaf of vehicle door on north wall of WPA addition. Looking northeast.

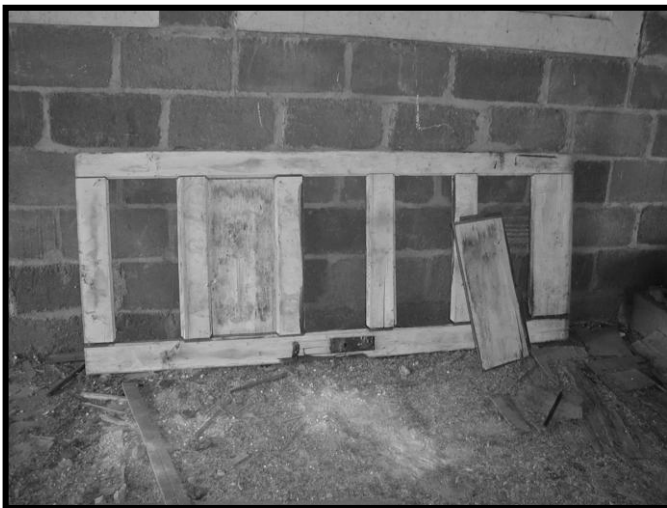
Figure 20. Probable exterior person door to WPA addition.

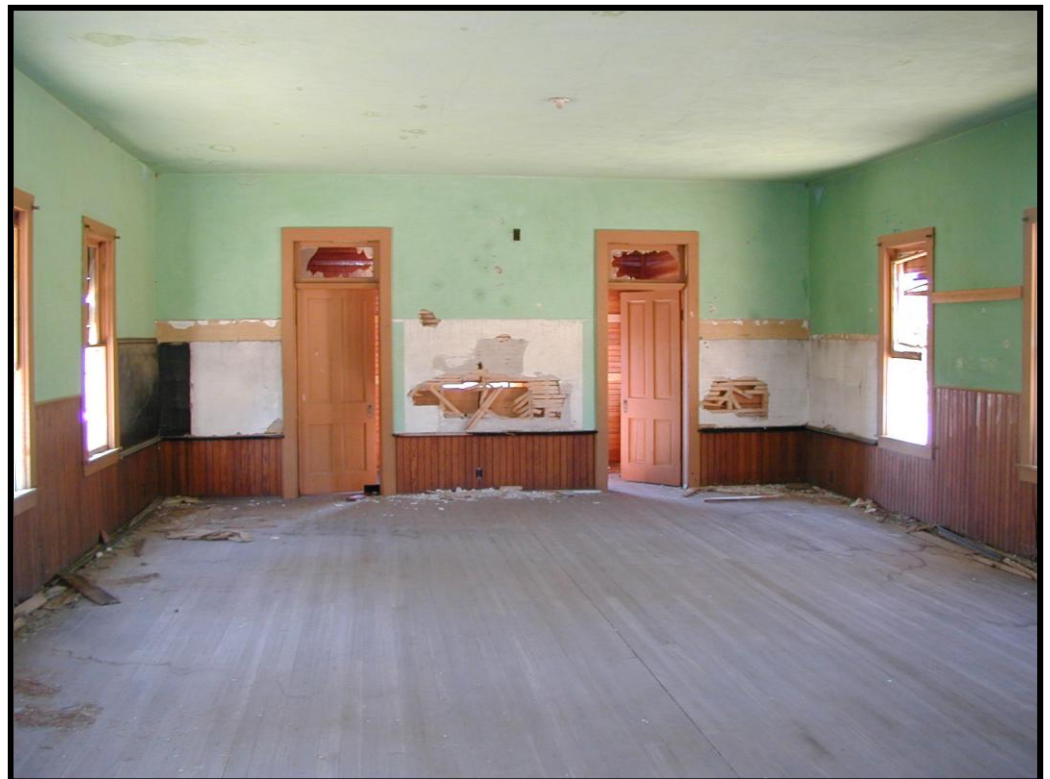
Figure 26. Schoolroom, looking south. Note four-panel doors from vestibule. Also note blackboards – extant at left, and missing at center and right.

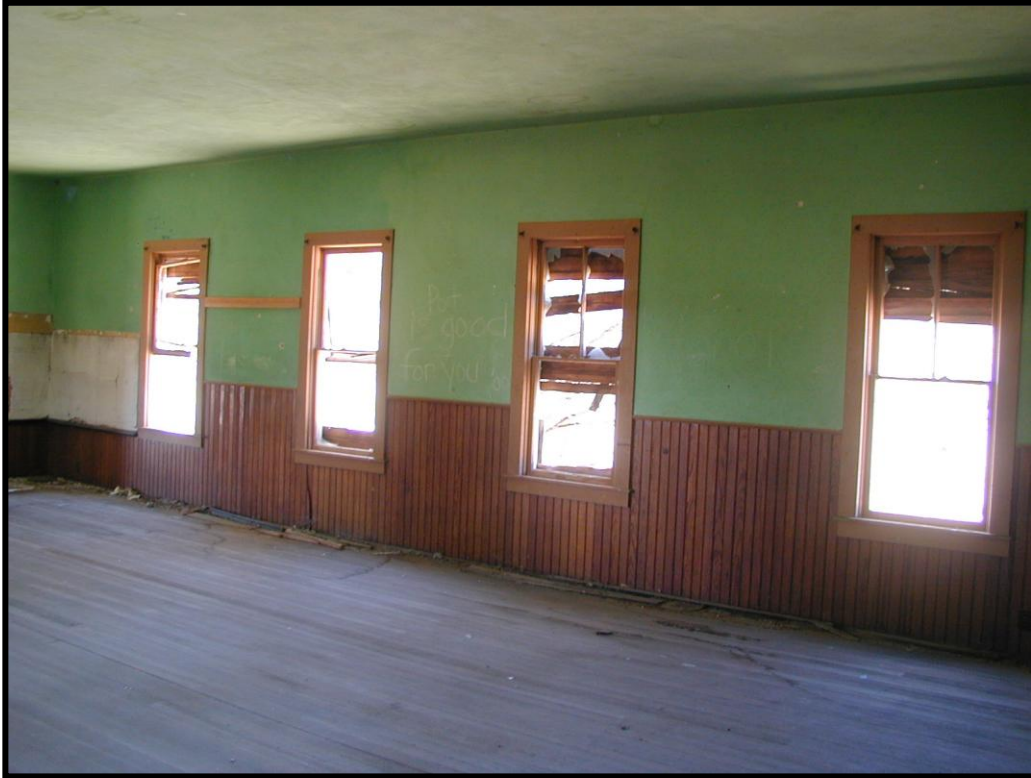
Figure 27. West wall of schoolroom, looking southwest.

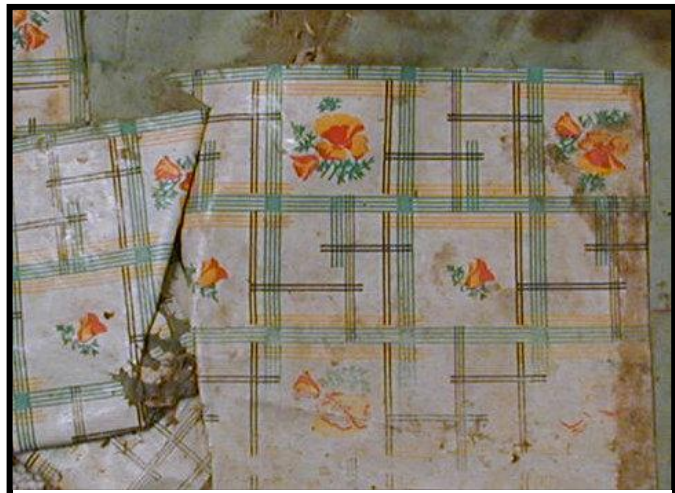
Figure 31. Oil cloth remnant that may be from vestibule shelf.

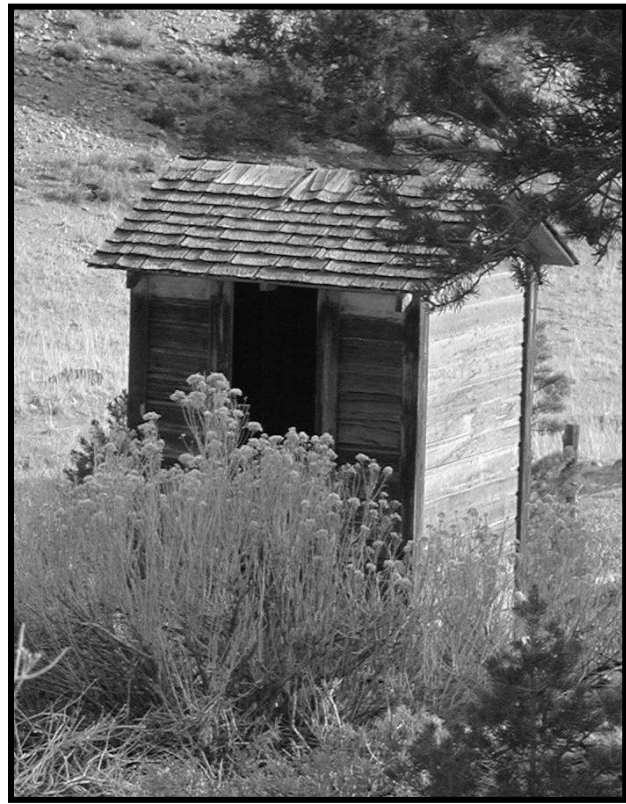
Figure 33. Girls privy, looking northeast.

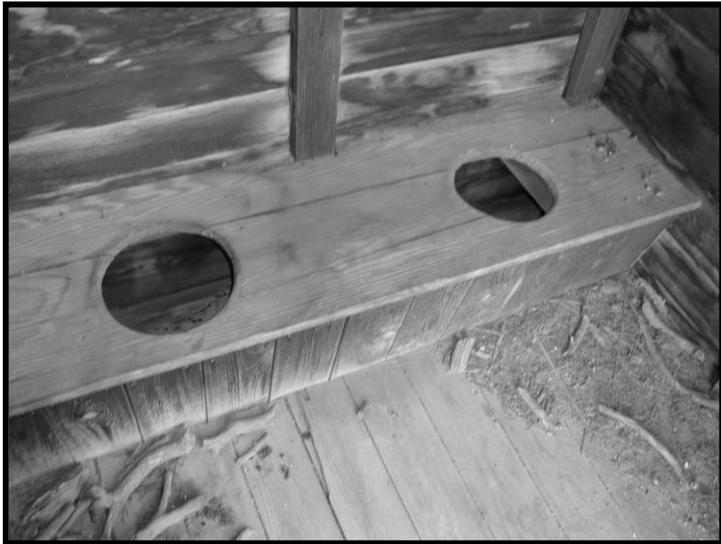
*Figure 34. Seats, Girls privy.
Looking southeast.*

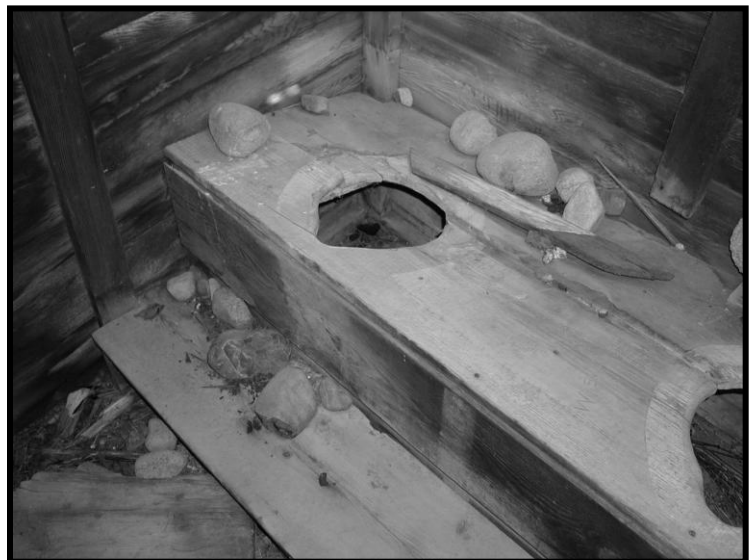
PART IV – ANALYSIS AND COMPLIANCE

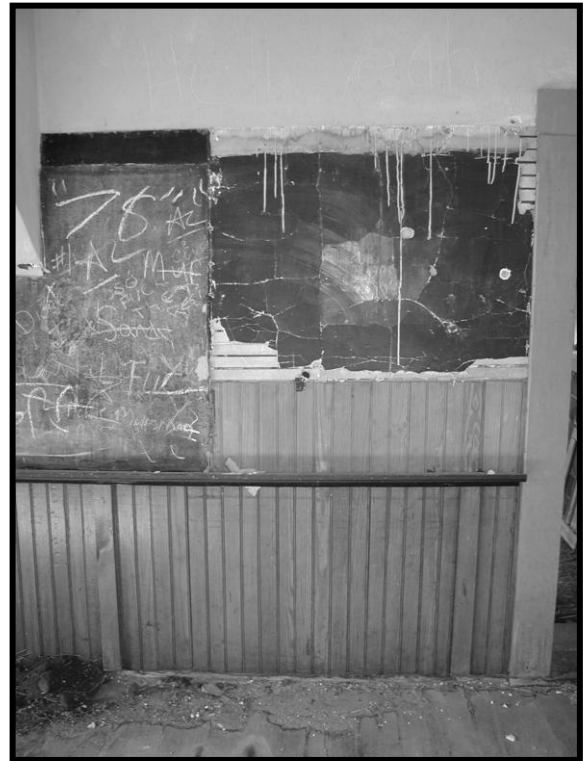
Figure 36. Blackboards. Right portion is "slating" or paint on smooth plaster. Left is either Hyloplate or a similar material.

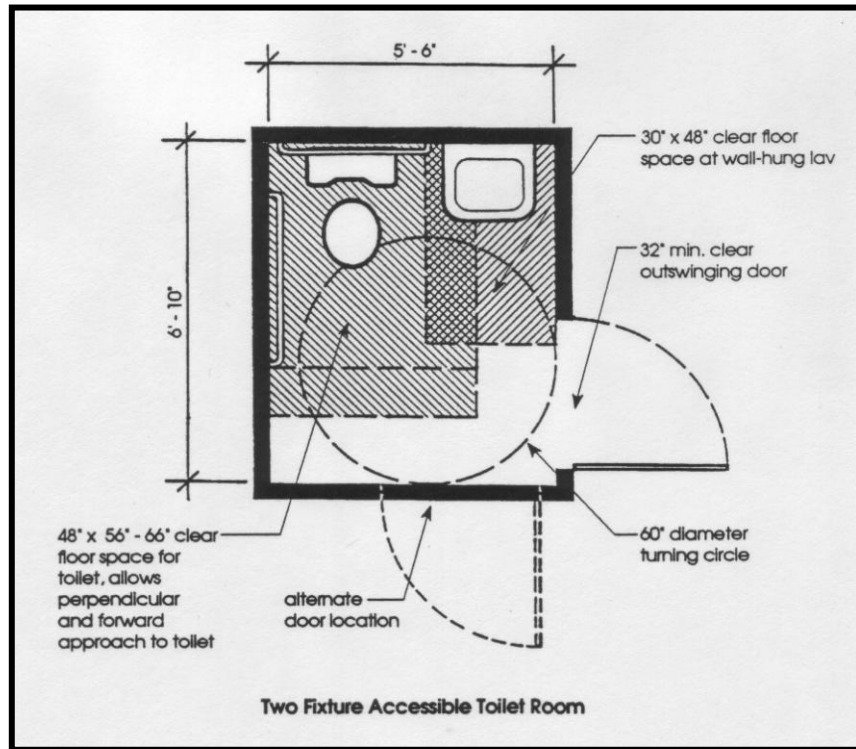
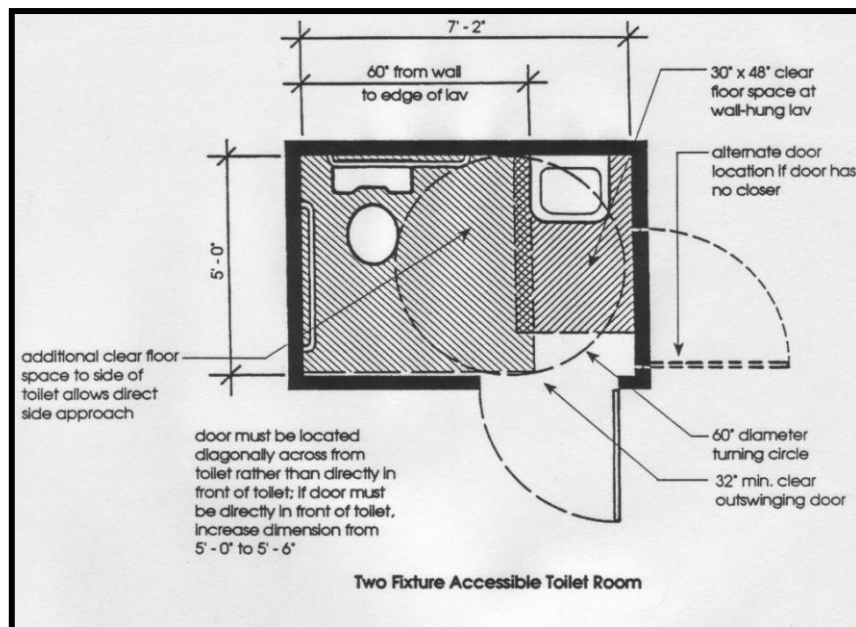
PART V—PRESERVATION PLAN
