COLORADO CULTURAL RESOURCE SURVEY

Architectural Inventory Form

1. Resource Number: 5CF2052
2. Temporary Resource Number: 23
3. County: Chaffee
4. City: Salida
5. Historic Building Name: Lee/Davis House
6. Current Building Name: Mills House
7. Building Address: 110 E. Fourth St.
8. Owner Name and Address: MILLS SUSAN C, 110 E 4TH STREET, SALIDA, CO 81201

48. Report Title: Salida, Colorado, Historic Buildings Survey, 2005-06

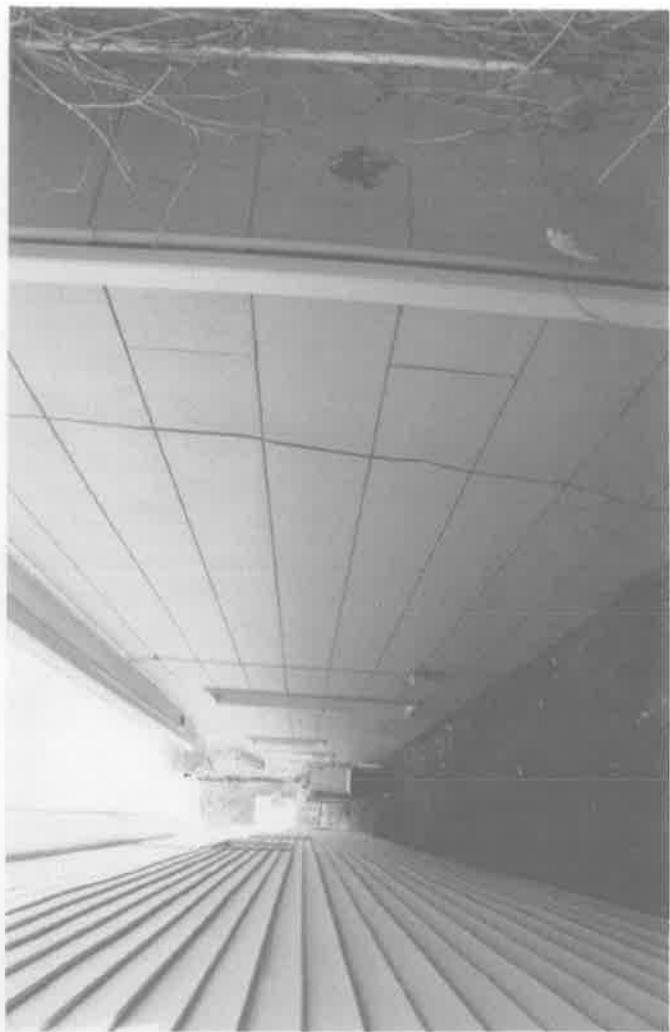
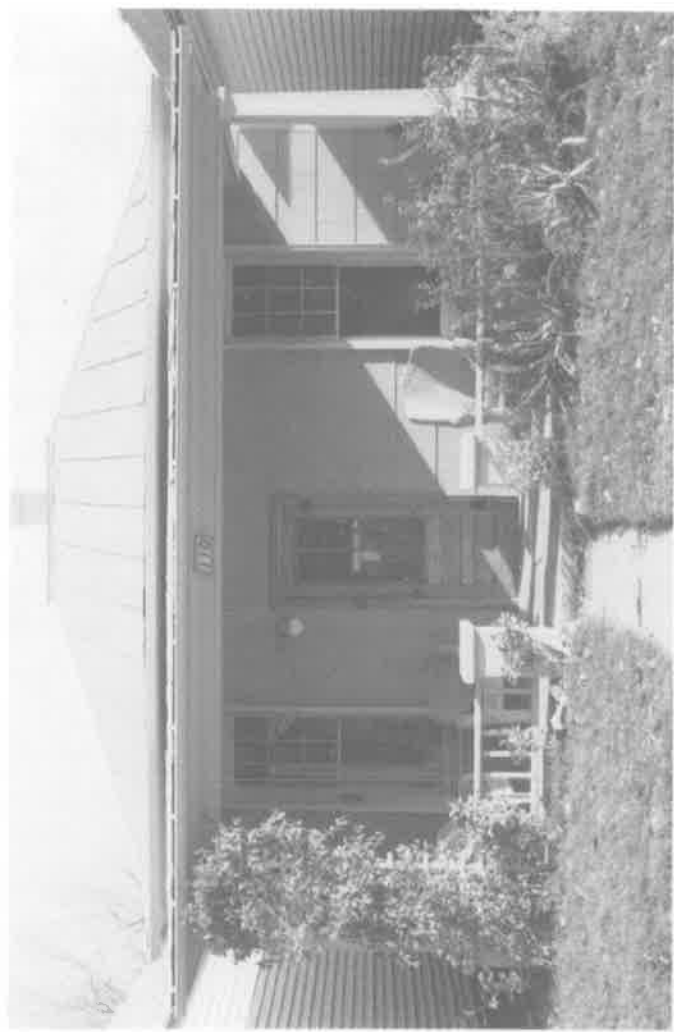
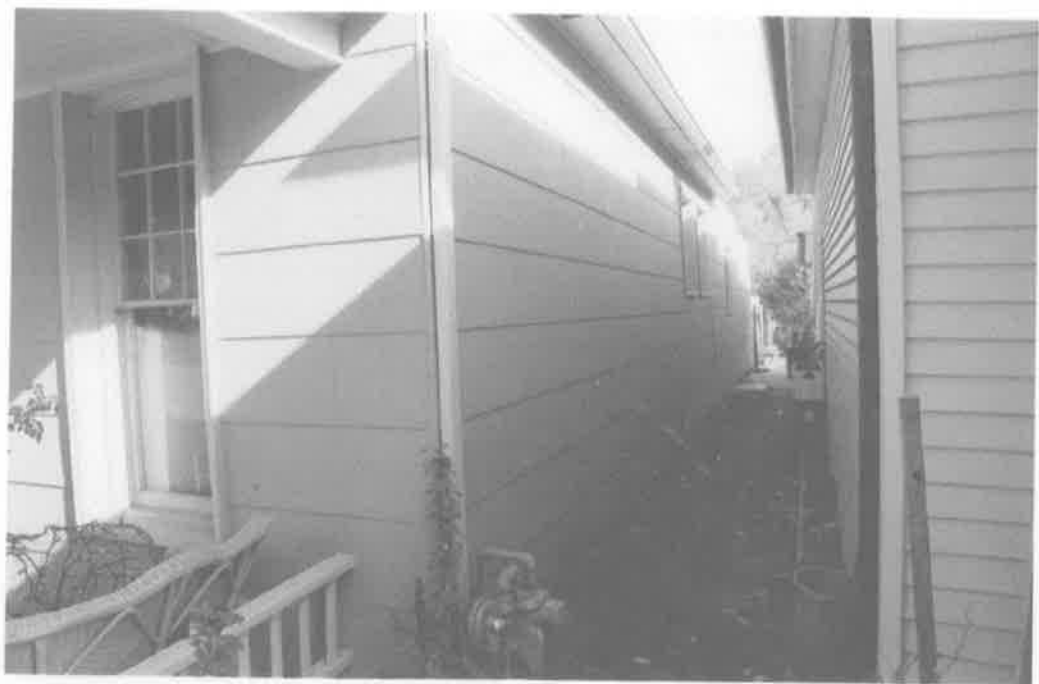
47. Photographic Reference(s): 2: 19, 21, 23

21. General Architectural Description:
One-story frame dwelling with hipped roof with center deck with painted brick chimney and with flared, overhanging eaves. Standing seam metal roofing. Walls clad with asbestos shingles have corner boards. Symmetrical facade (south) with center entrance with paneled and glazed door flanked by tall, narrow, 9/1-light double-hung sash windows. The inset windows have segmental arch molding set in a flat arch aperture. The sides of the house are close to the walls of the adjoining houses and have a wide expanse of blank wall toward the front and windows toward the rear.
