COLORADO CULTURAL RESOURCE SURVEY

Architectural Inventory Form

1. Resource Number: 5CF406.73
2. Temporary Resource Number: 98
3. County: Chaffee
4. City: Salida
5. Historic Building Name: Doctors' Office
6. Current Building Name: KSBV Radio Station
7. Building Address: 115 E. 2nd St.
8. Owner Name and Address: Wentz Family Limited Partnership, P.O. Box 456, Salida, CO 81201

48. Report Title: Downtown Salida Historic Buildings Survey, 2001-02

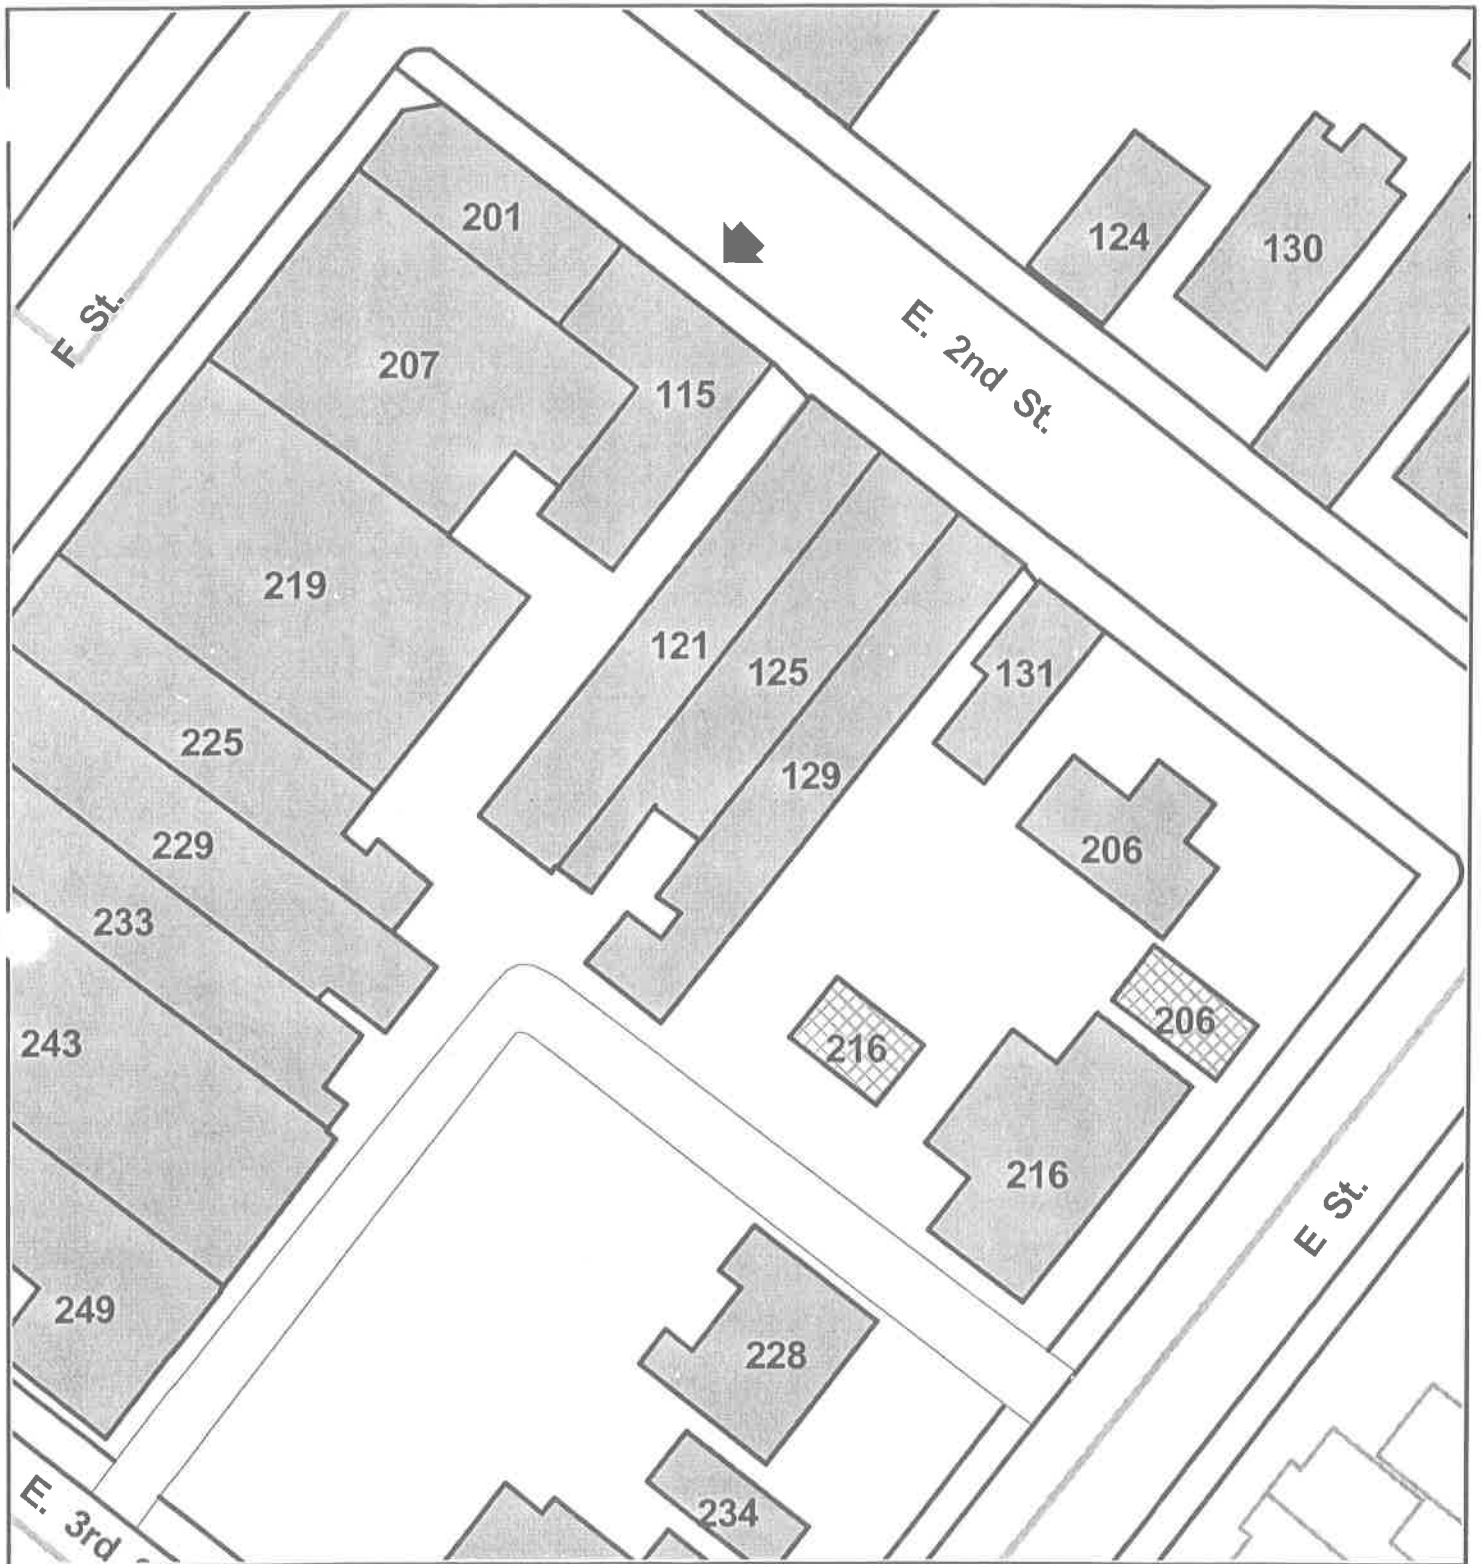
115 E. 2nd Street, 5CF406.73

One-story L-shaped commercial building with flat roof. Façade of building is CU-style sandstone in layers with pieces of varied length and width. Slightly off-center inset entrance flanked by stone piers has stone panel above glazed metal frame door surrounded by glass blocks. Flanking entrance are rectangular plate glass windows. Stone end piers. Concrete block walls on east and rear. East wall has five large panels of glass block with air conditioners at center. Two central doors on rear wall.
