COLORADO CULTURAL RESOURCE SURVEY

Architectural Inventory Form

1. Resource Number: 5CF1595
2. Temporary Resource Number: 120
3. County: Chaffee
4. City: Salida
5. Historic Building Name:
6. Current Building Name: Colorado Department of Revenue
7. Building Address: 120 W. 3rd St.
8. Owner Name and Address: Watkins, Jack, P.O. Box 99, Poncha Springs, CO 81242

48. Report Title: Downtown Salida Historic Buildings Survey, 2001-02

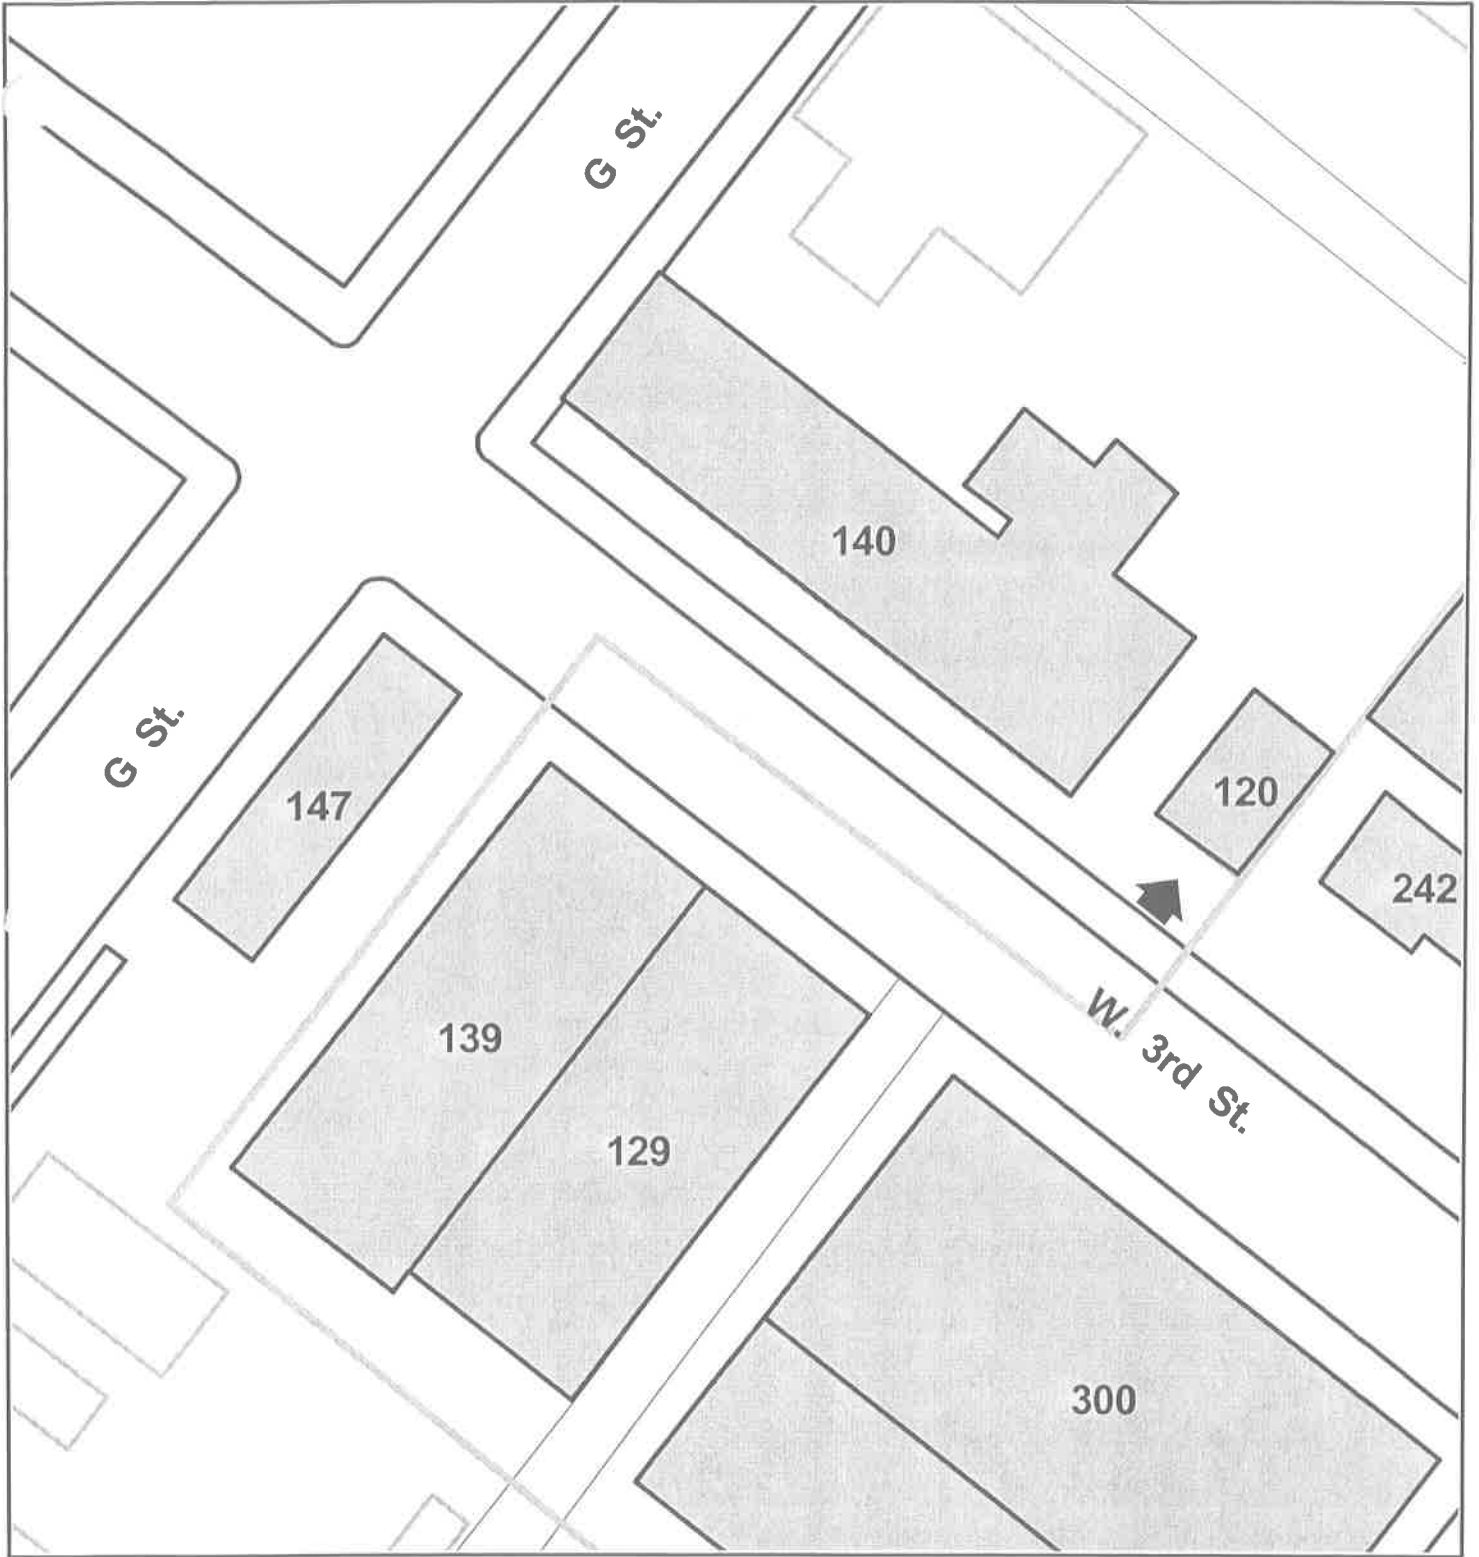
120 W. 3rd Street, 5CF1595

One-story rectangular building with flat roof stepped down toward rear and smooth stucco walls. Bulge at top of wall appears to be stuccoed cornice. Projecting horizontal band on upper façade. Off-center entrance with wood door with large rectangular light. Two rectangular plate glass windows on façade. West wall has one 1/1-light double-hung sash window, while the east has two two-part windows.
