COLORADO CULTURAL RESOURCE SURVEY

Architectural Inventory Form

1. Resource Number: 5CF406.54
2. Temporary Resource Number: 36
3. County: Chaffee
4. City: Salida
5. Historic Building Name: Caulfield Saloon
6. Current Building Name: Salida Mercantile Museum
7. Building Address: 121 N. F St.
8. Owner Name and Address: Chivvis, John N. & Lovell, Linda M., 148 N. F Street, Salida, CO 81201

48. Report Title: Downtown Salida Historic Buildings Survey, 2001-02

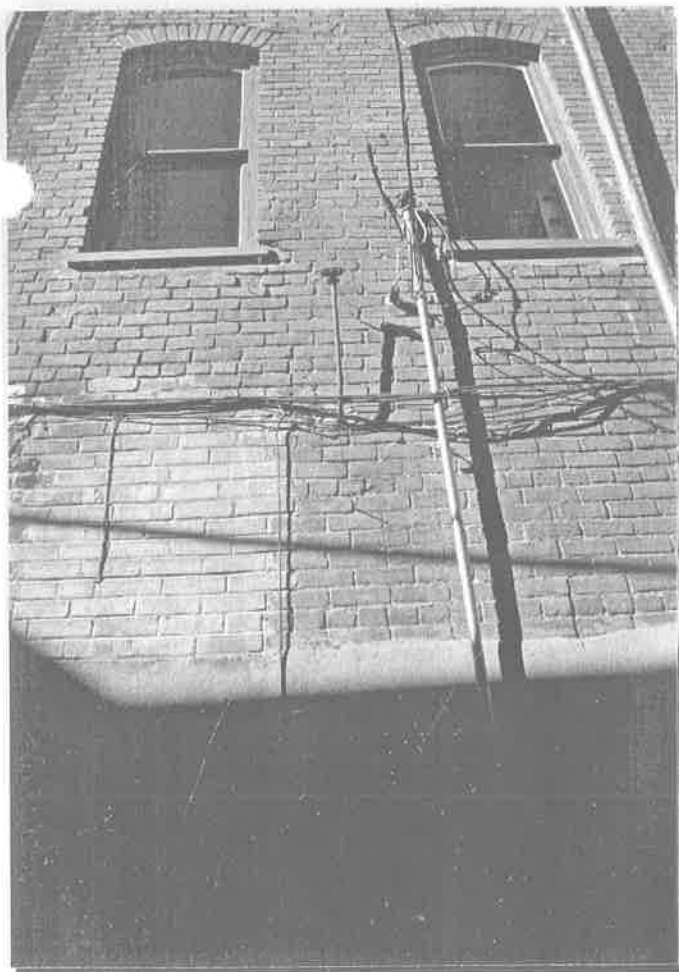
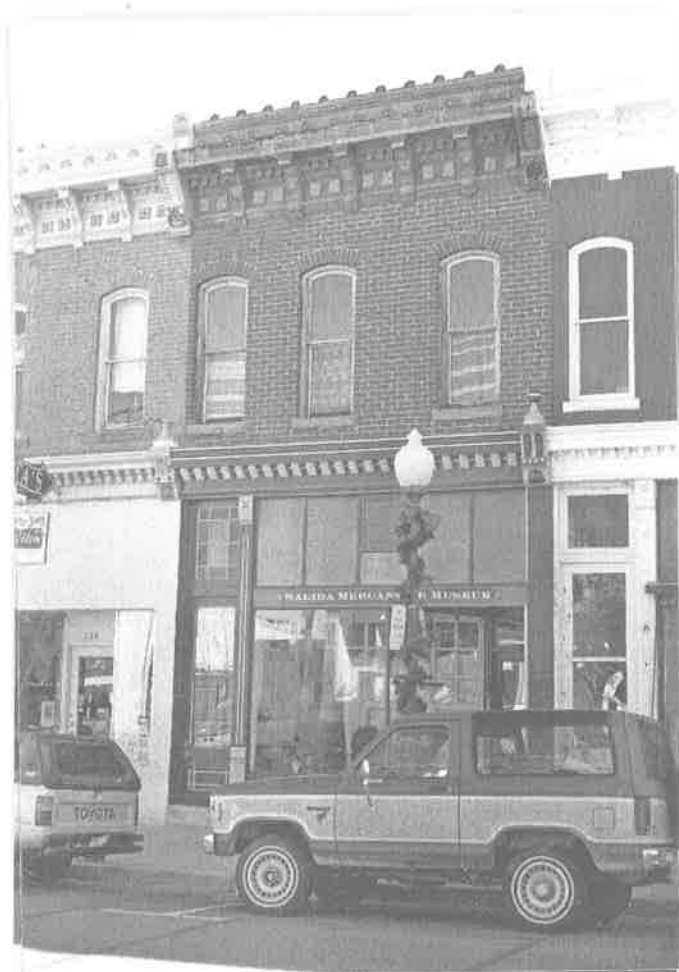
47. Photographic Reference(s): 22: 28; 23: 3.

Two-story red brick commercial building with flat roof with wide projecting double cornice with molding, floral ornaments, and rounded cresting; frieze with brackets with foliate decorations, dentil molding, and ornamented panels, and end brackets. Second story is brick and has three tall, narrow, double-hung sash, segmental arched windows with gauged brick lintels and painted rock-faced stone sills. Storefront molded cornice with end brackets topped by urn shaped finials and frieze ornamented with brackets. Band of rectangular-light clerestory windows above storefront. Narrow signband under clerestory windows. Off-center entrance with tall paneled and glazed

door with large rectangular light at north end of building. Stained glass overdoor above entrance and slender fluted and ornamented column adjacent to entrance. Metal frame plate glass display windows; angled wall next to south entrance. Glazed dark brown brick with white brick insets under windows. Inset entrance with paneled and glazed door with rectangular light and transom at south end of building.

This building displays substantial integrity. Alterations include the nonoriginal brick under the display windows and modification of one clerestory light.
