COLORADO CULTURAL RESOURCE SURVEY
Architectural Inventory Form

1. Resource Number: 5CF406.126
2. Temporary Resource Number: 79
3. County: Chaffee
4. City: Salida
5. Historic Building Name: John Sweeney Saloon Beer Storage Building
6. Current Building Name:
7. Building Address: 122 1/2 W. 1st St.
8. Owner Name and Address: Cicerelli, Larry A. & Merrilou K., 532 E. 3rd St., Salida, CO 81201

48. Report Title: Downtown Salida Historic Buildings Survey, 2001-02

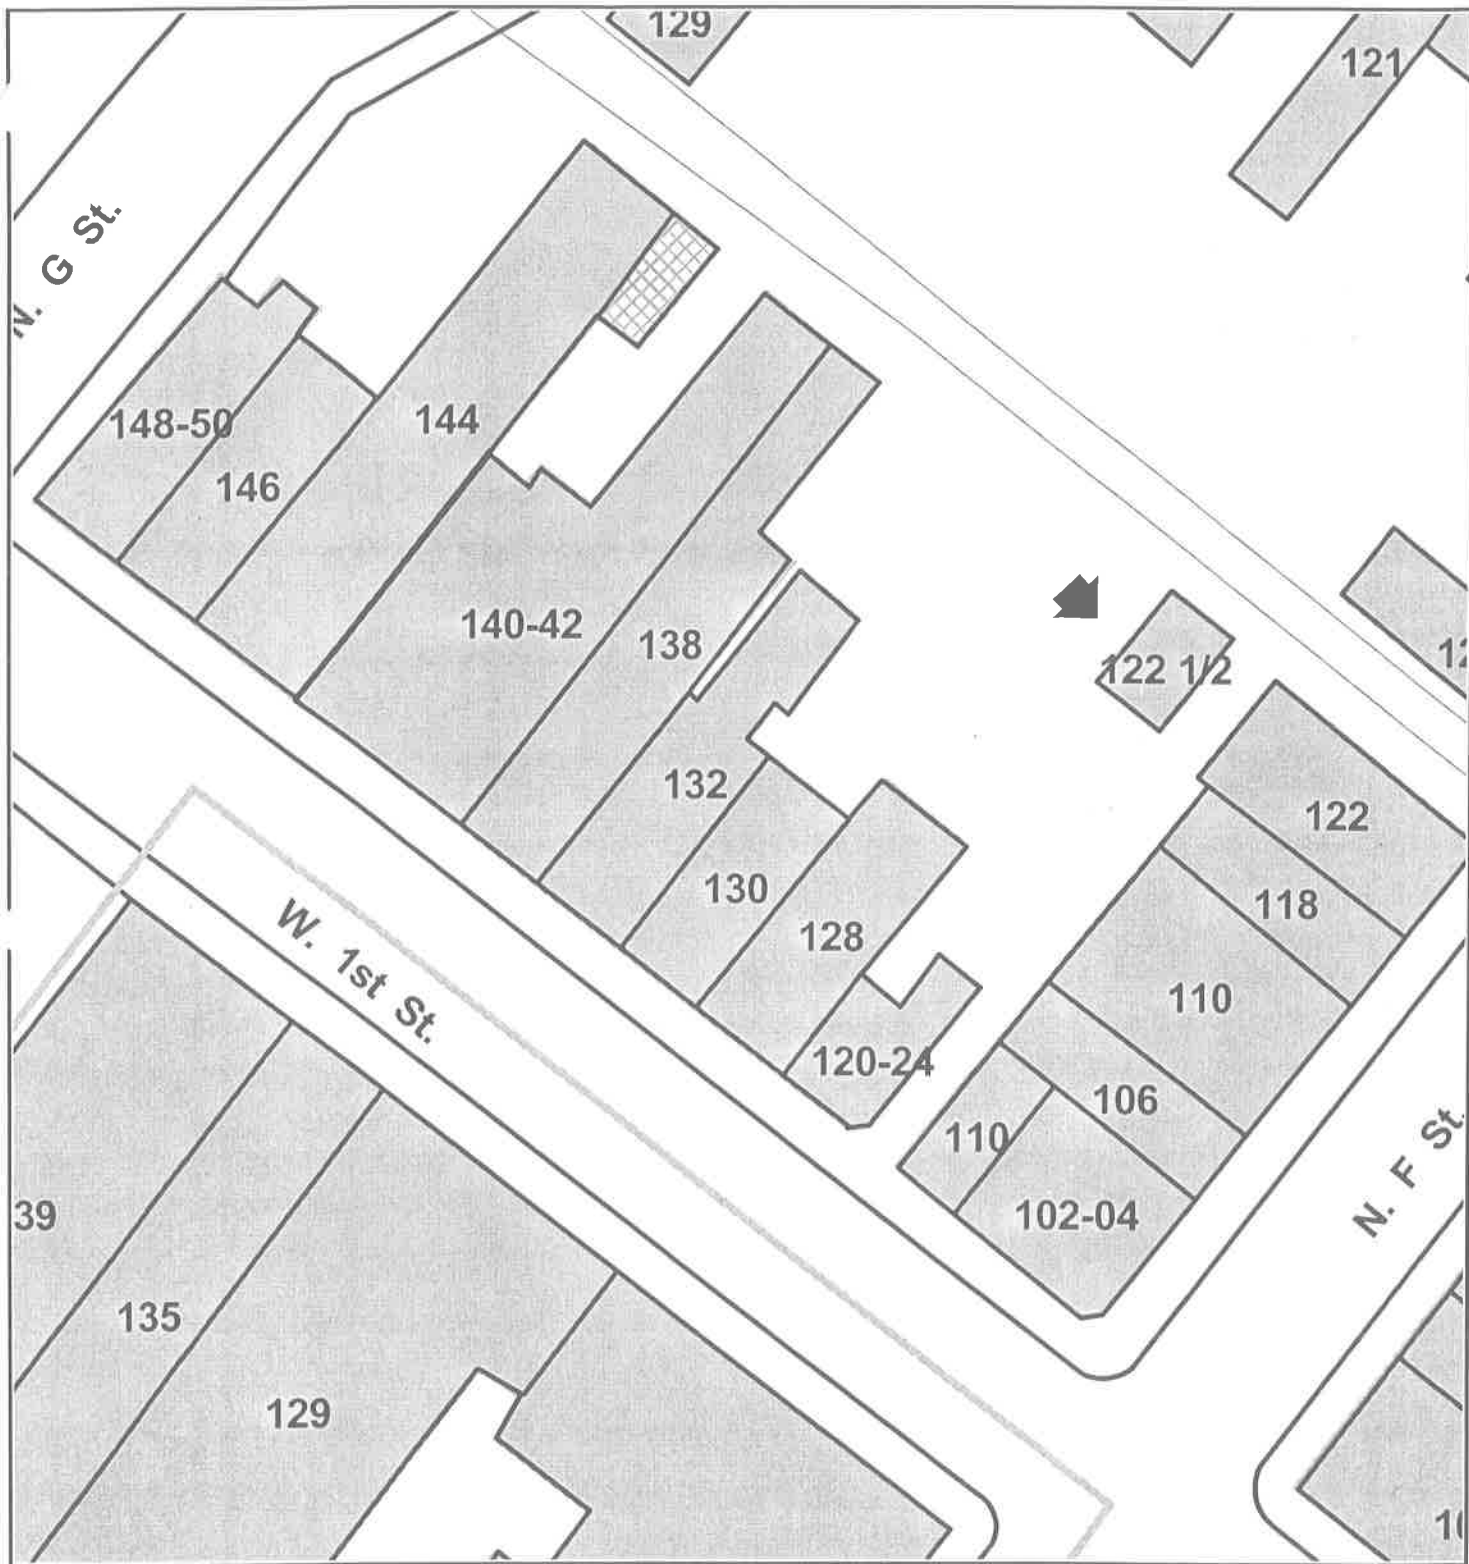
122 1/2 W. 1st Street, 5CF406.126

21. General Architectural Description:
One-story rectangular building with front gable roof with overhanging eaves. Building is clad with corrugated metal siding and has metal roofing. South wall has louvered vent near apex of gable. Two paneled doors flanked by small window with security bars on façade. Rear wall also has louvered vent and has paneled and glazed double doors at center. Deteriorated center brick chimney.
