COLORADO CULTURAL RESOURCE SURVEY

# Architectural Inventory Form

1. Resource Number: 5CF406.92
2. Temporary Resource Number: 99
3. County: Chaffee
4. City: Salida
5. Historic Building Name: Dr. Jessine M. Hartwell Residence
6. Current Building Name: Edward Jones Investments
7. Building Address: 124 E. 2nd St.
8. Owner Name and Address: Boston, Edward & Joan L., P.O. Box 861, Salida, CO 81201

**48. Report Title:** Downtown Salida Historic Buildings Survey, 2001-02

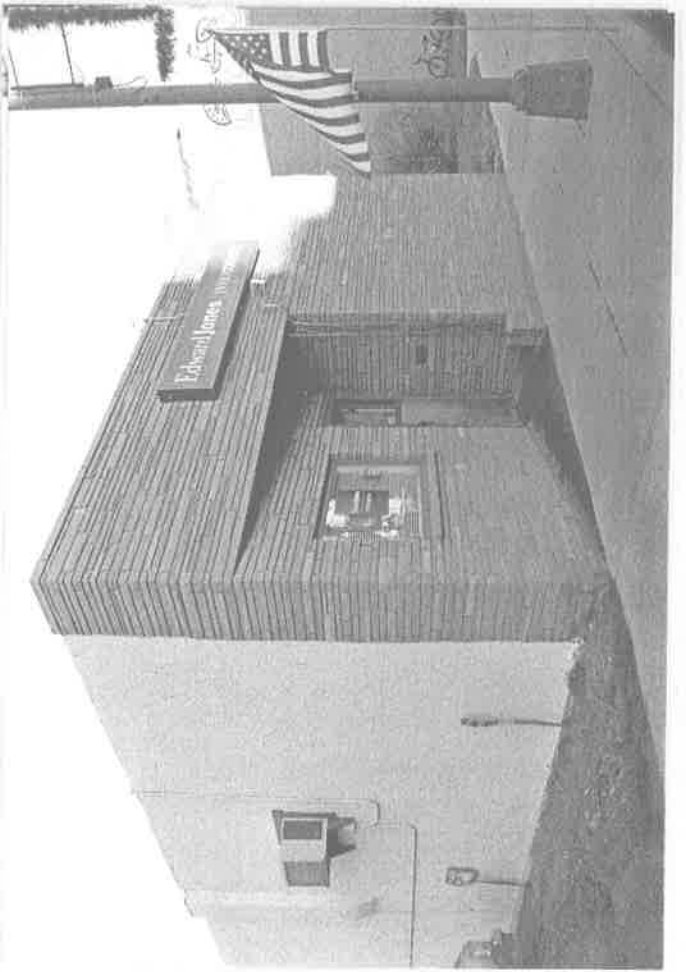
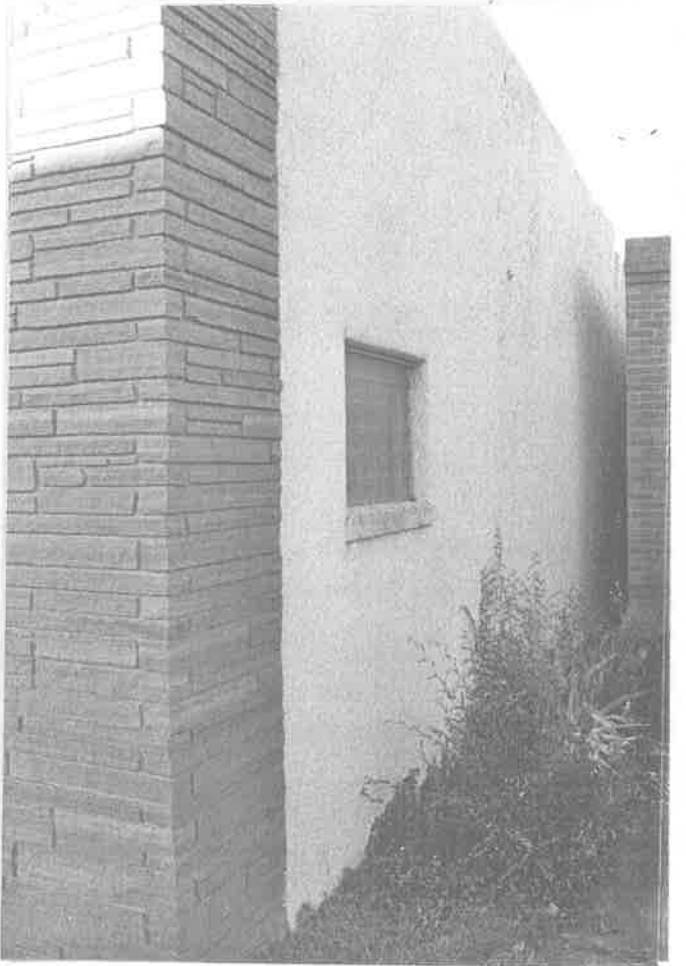
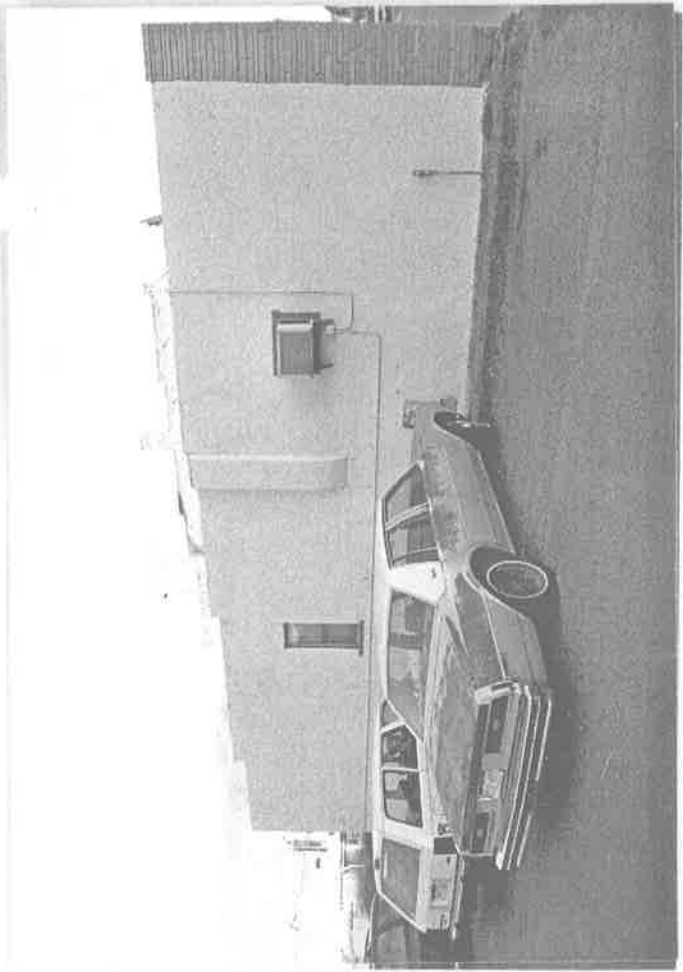
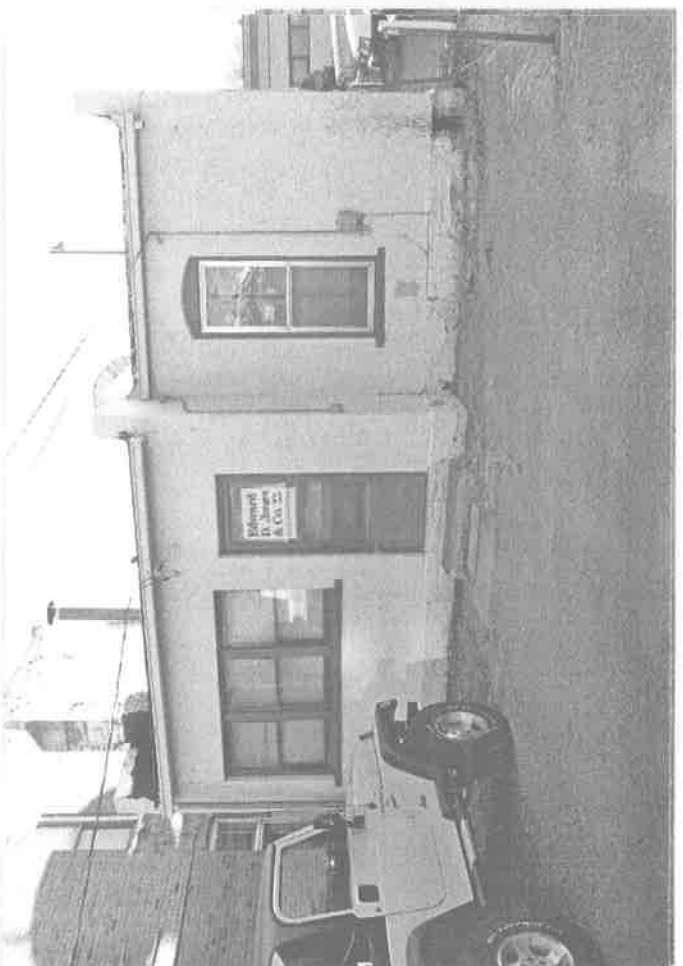
**47. Photographic Reference(s):** 12: 27, 29, 31, 34.

One-story rectangular commercial building with flat roof stepped down toward rear. Façade clad with University of Colorado style sandstone laid in pieces of varied length and width. Angled inset wall at west side of façade has plate glass window with stone sill and door. Wrought iron support at east end of inset. Wall west of inset has no openings. East and west walls are stuccoed. West wall has chimney projection without top, opening with air conditioner unit, and tall 1/1-light double-hung sash window. Rear wall has one segmental arched 2/2-light double-hung sash window, an entrance with paneled and glazed door, and triple window.

Rectangular brick garage with flat roof, triple paneled and glazed doors on west wall and modern overhead sectional door on east wall.
