COLORADO CULTURAL RESOURCE SURVEY

# Architectural Inventory Form

| 5. Historic Building Name: Fisher House and Boarding House | |
| 7. Building Address: 126-30 N. D Street | |

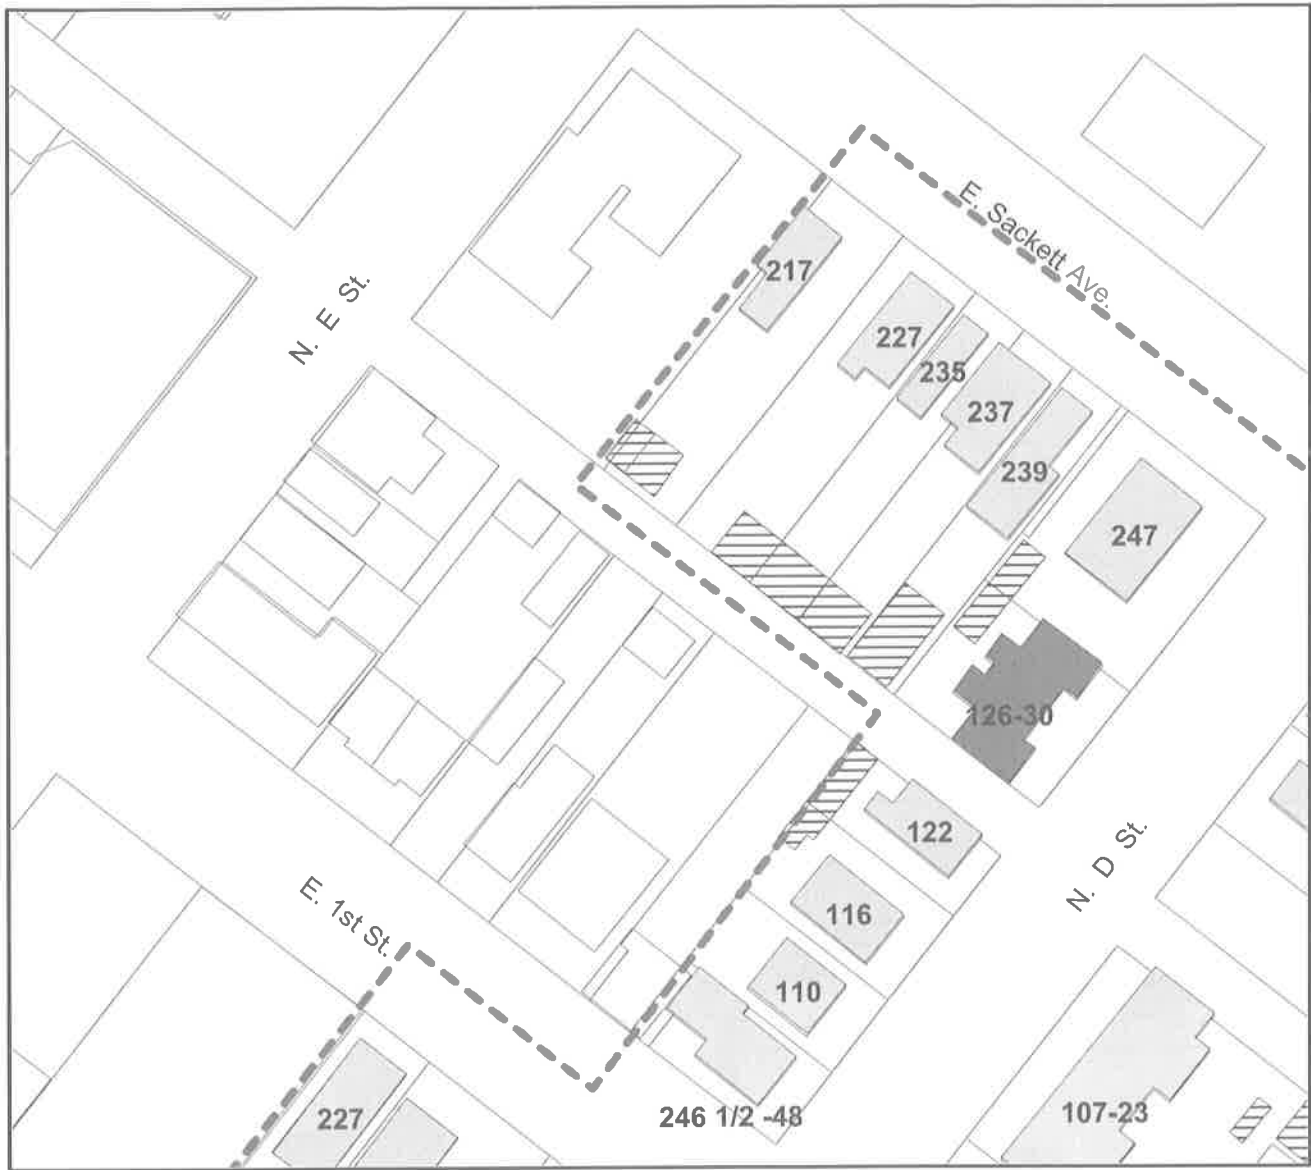
126-30 N. D Street

SOURCE: Building outlines from CAD file provided by City of Salida (and supplemented by fieldwork) and overlaid on parcels produced by Chaffee County. The resource described by this survey form is darkly shaded.
