COLORADO CULTURAL RESOURCE SURVEY  
**Architectural Inventory Form**

- 1. Resource Number: 5CF406.114
- 2. Temporary Resource Number: 121
- 3. County: Chaffee
- 4. City: Salida
- 5. Historic Building Name:
- 6. Current Building Name:
- 7. Building Address: 129 W. Sackett Ave. (rear)
- 8. Owner Name and Address: Mon-Ark Shrine Club Holding Corp., 337 Ouray Ave., Salida, CO 81201

**48. Report Title:** Downtown Salida Historic Buildings Survey, 2001-02

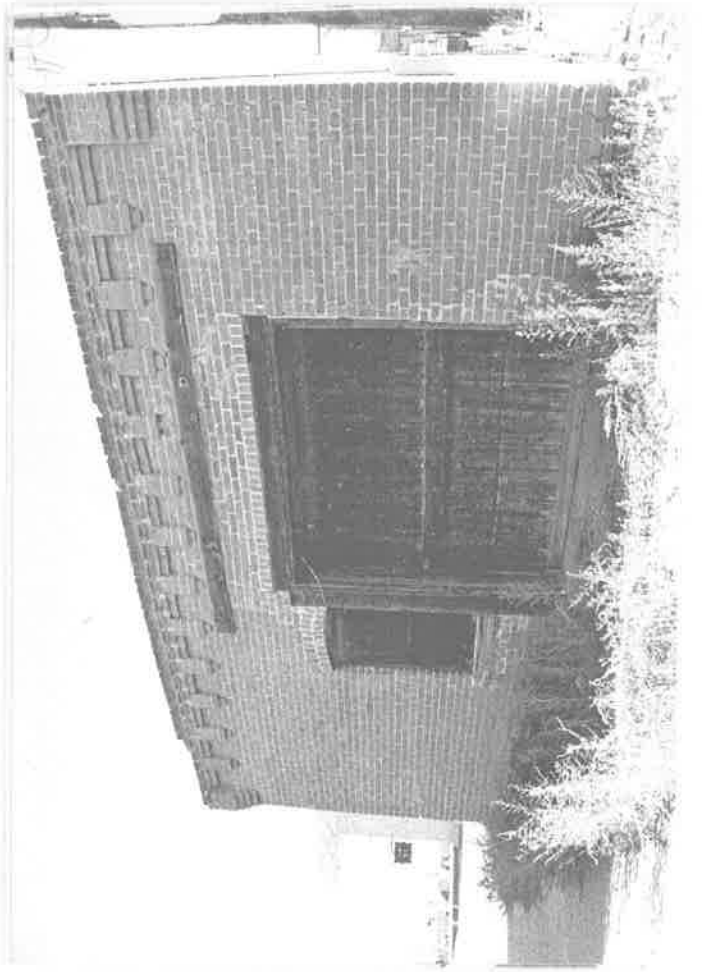
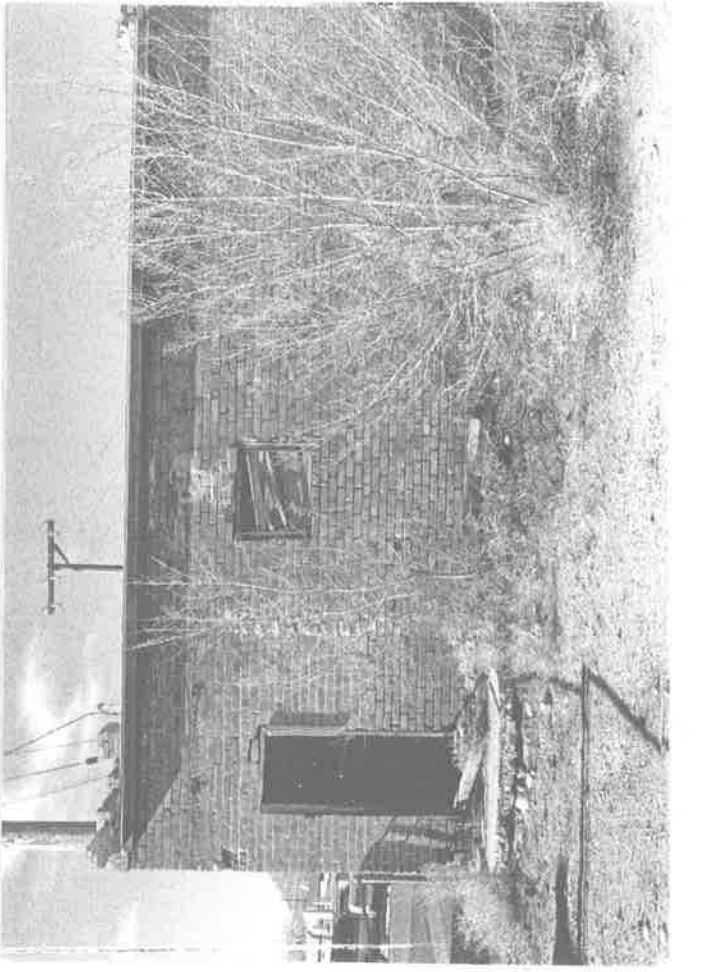
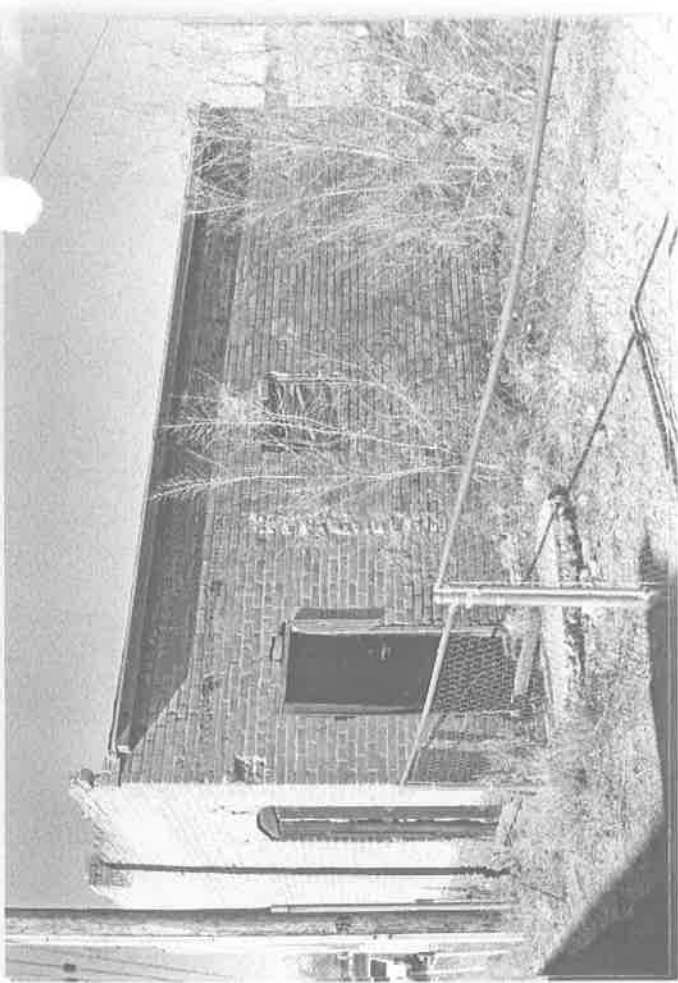
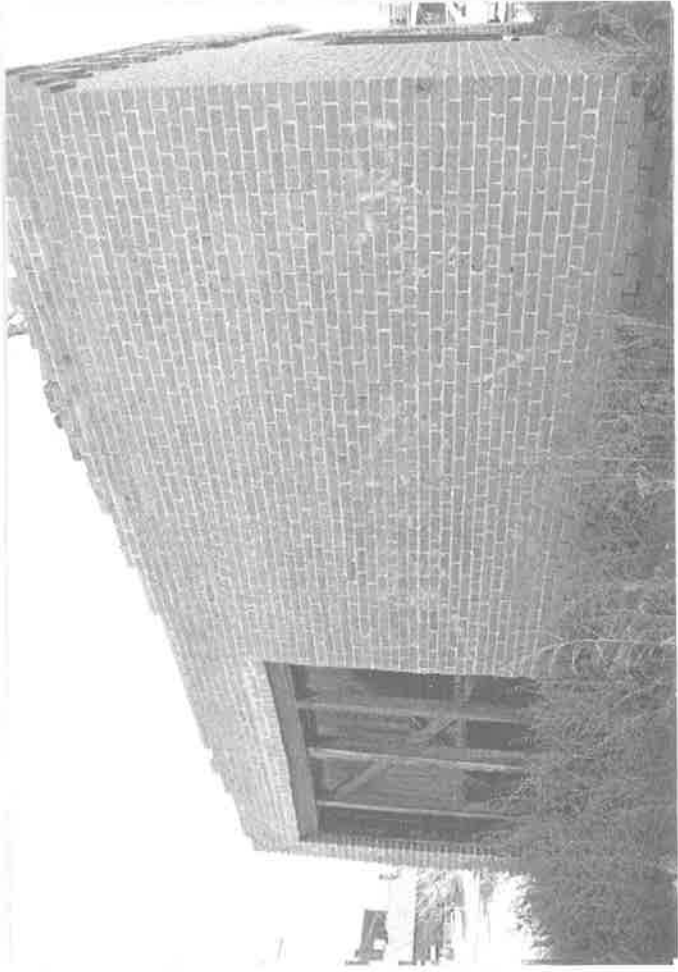
Photographic Reference(s): 4: 15, 17, 19, 21.

Small one-story deteriorated red-orange brick building on alley with flat roof, stepped down toward rear, and corbelled cornice. Foundation of bricks projecting outward. Horizontal timber below cornice. Slightly off-center entrance with brick lintel and vertical board garage door. Segmental arched window with brick lintel and wood sill adjacent door. South wall has segmental arched entrance with hinged vertical board door. North wall has vehicle sized opening toward east end that is filled in with wood. East wall has pedestrian door opening filled with wood and boarded up center window.

This building displays moderate historic physical integrity, although deterioration is affecting its appearance.
