COLORADO CULTURAL RESOURCE SURVEY

Architectural Inventory Form

1. Resource Number: 5CF406.62
2. Temporary Resource Number: 81
3. County: Chaffee
4. City: Salida
5. Historic Building Name: Union Block, Calvin Furniture & Second Hand Goods
6. Current Building Name: Vickan's Union Grill
7. Building Address: 130 W. 1st St.
8. Owner Name and Address: Lokey, Ernest F., III, Inc., 6400 Co. Rd. 105, Salida, CO 81201

49. Report Title: Downtown Salida Historic Buildings Survey, 2001-02

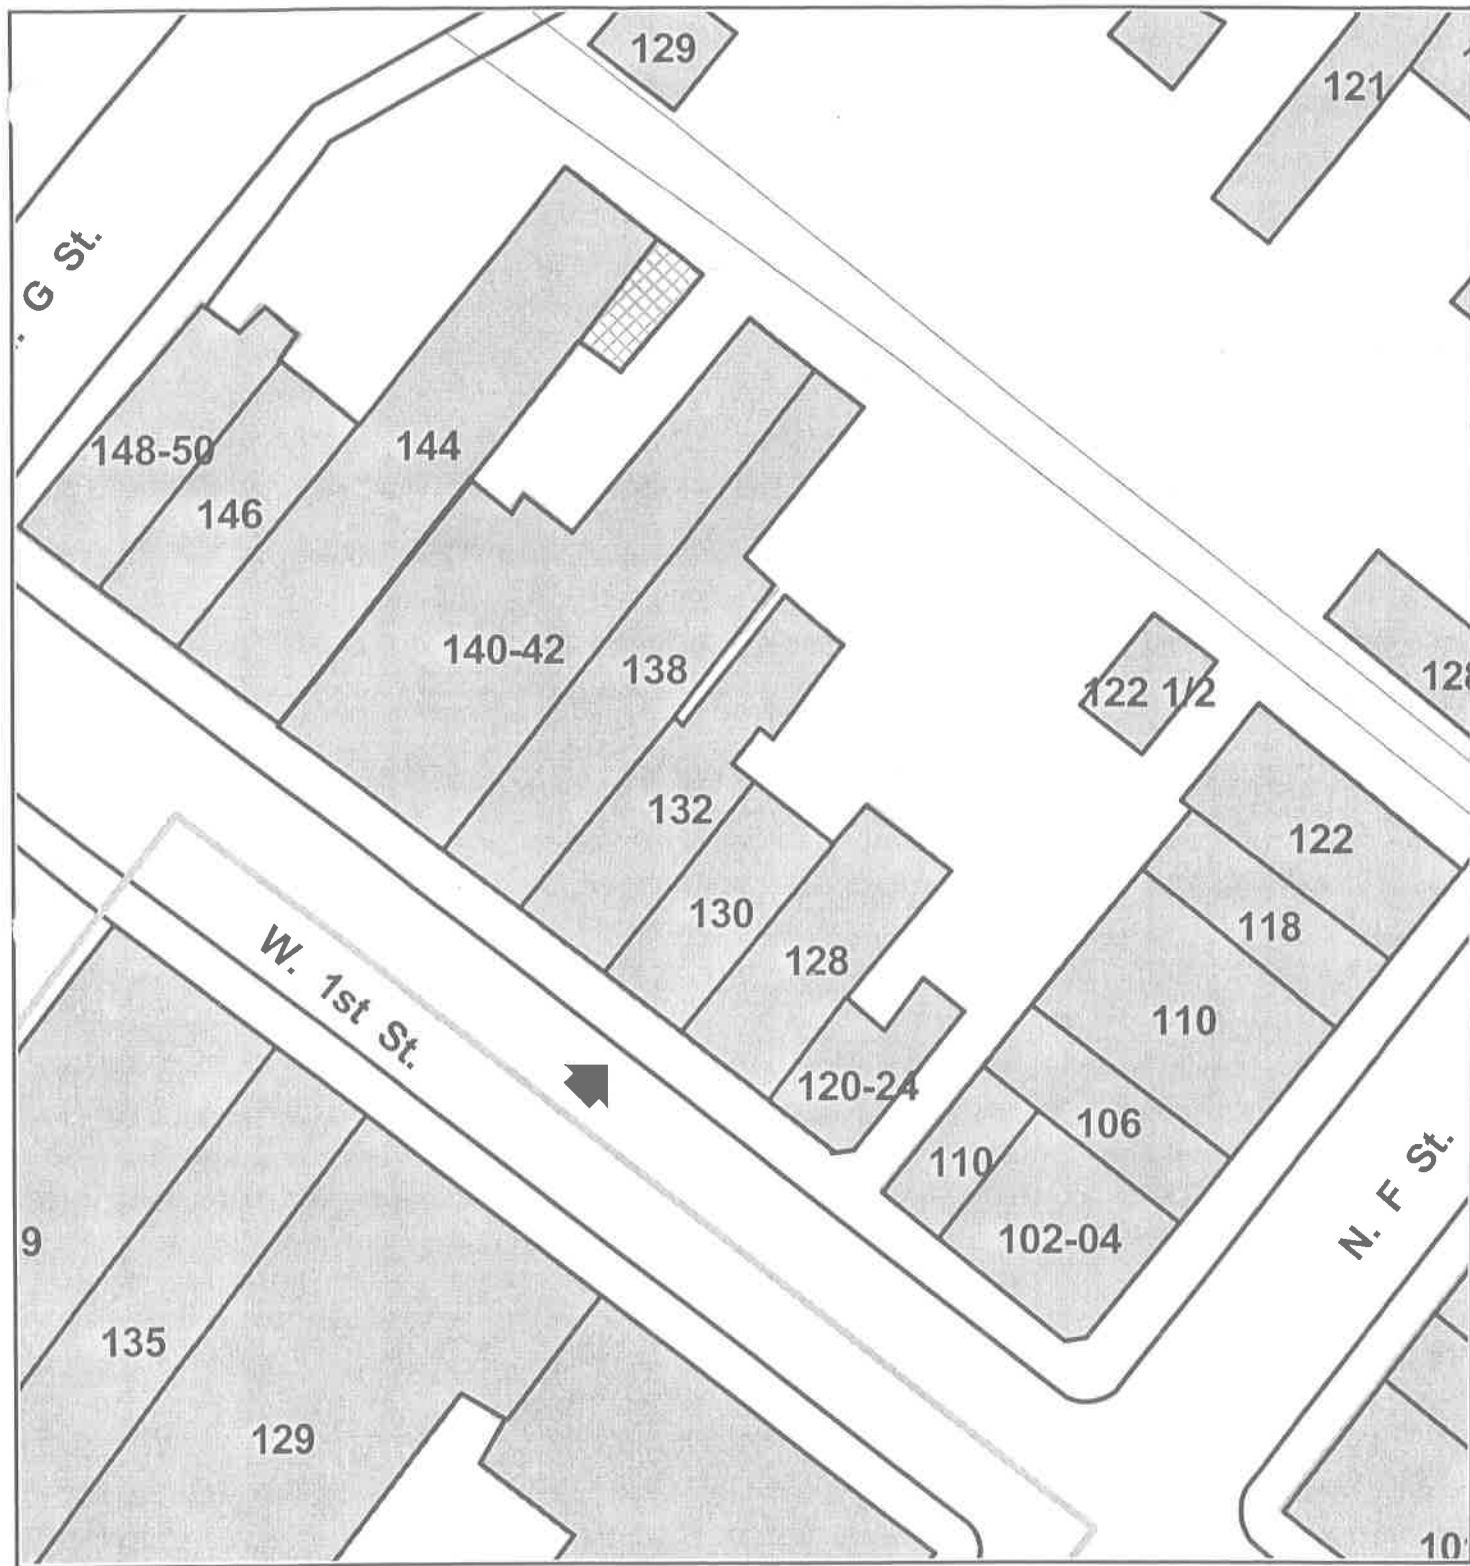
130 W. 1st Street, 5CF406.62

Two-story painted brick commercial building with projecting metal cornice with moldings, brackets, paneled frieze, and foliate ornaments. Second story enframed by brick pilasters capped by brackets has four tall, narrow, segmental arched, 1/1-light double-hung sash windows with rusticated sandstone sills. The window heads have incised ornament and there are brick hood molds. First story has a single storefront with band of clerestory windows (some with textured glass). The first story cornice and lintel areas are clad with wood. There is an inset entrance with a door with large rectangular light and a transom flanked by plate glass display windows; walls adjacent

entrance are angled inward. There is brick under the display windows. At the west end of the façade is a pedestrian entrance with a flush panel door, covered transom, and overlight. The entrance is set partially into the adjoining building.

The building displays moderate historic physical integrity. The cornice and upper story windows are intact, as well as the clerestory of the first story and the configuration of the storefront. The brick has been painted and the display windows and kickplates of the storefront have been modified since the building was constructed.
