COLORADO CULTURAL RESOURCE SURVEY  
**Architectural Inventory Form**

1. Resource Number: 5CF406.24
2. Temporary Resource Number: 112
3. County: Chaffee
4. City: Salida
5. Historic Building Name: Spencer Residence & Millinery, Slater Blacksmith Shop
6. Current Building Name: Soho Annex
7. Building Address: 131 E. 2nd St.
8. Owner Name and Address: Baranczyk, Merle J. & Mary K., 6945 Co. Rd. 111-C, Salida, CO 81201

**48. Report Title:** Downtown Salida Historic Buildings Survey, 2001-02**49. Date(s):** September 2002**50. Recorder(s):** R.L. Simmons/T.H. Simmons**51. Organization:** Front Range Research Associates, Inc.**52. Address:** 3635 W. 46th Ave.**53. Phone Number(s):** (303) 477-7597

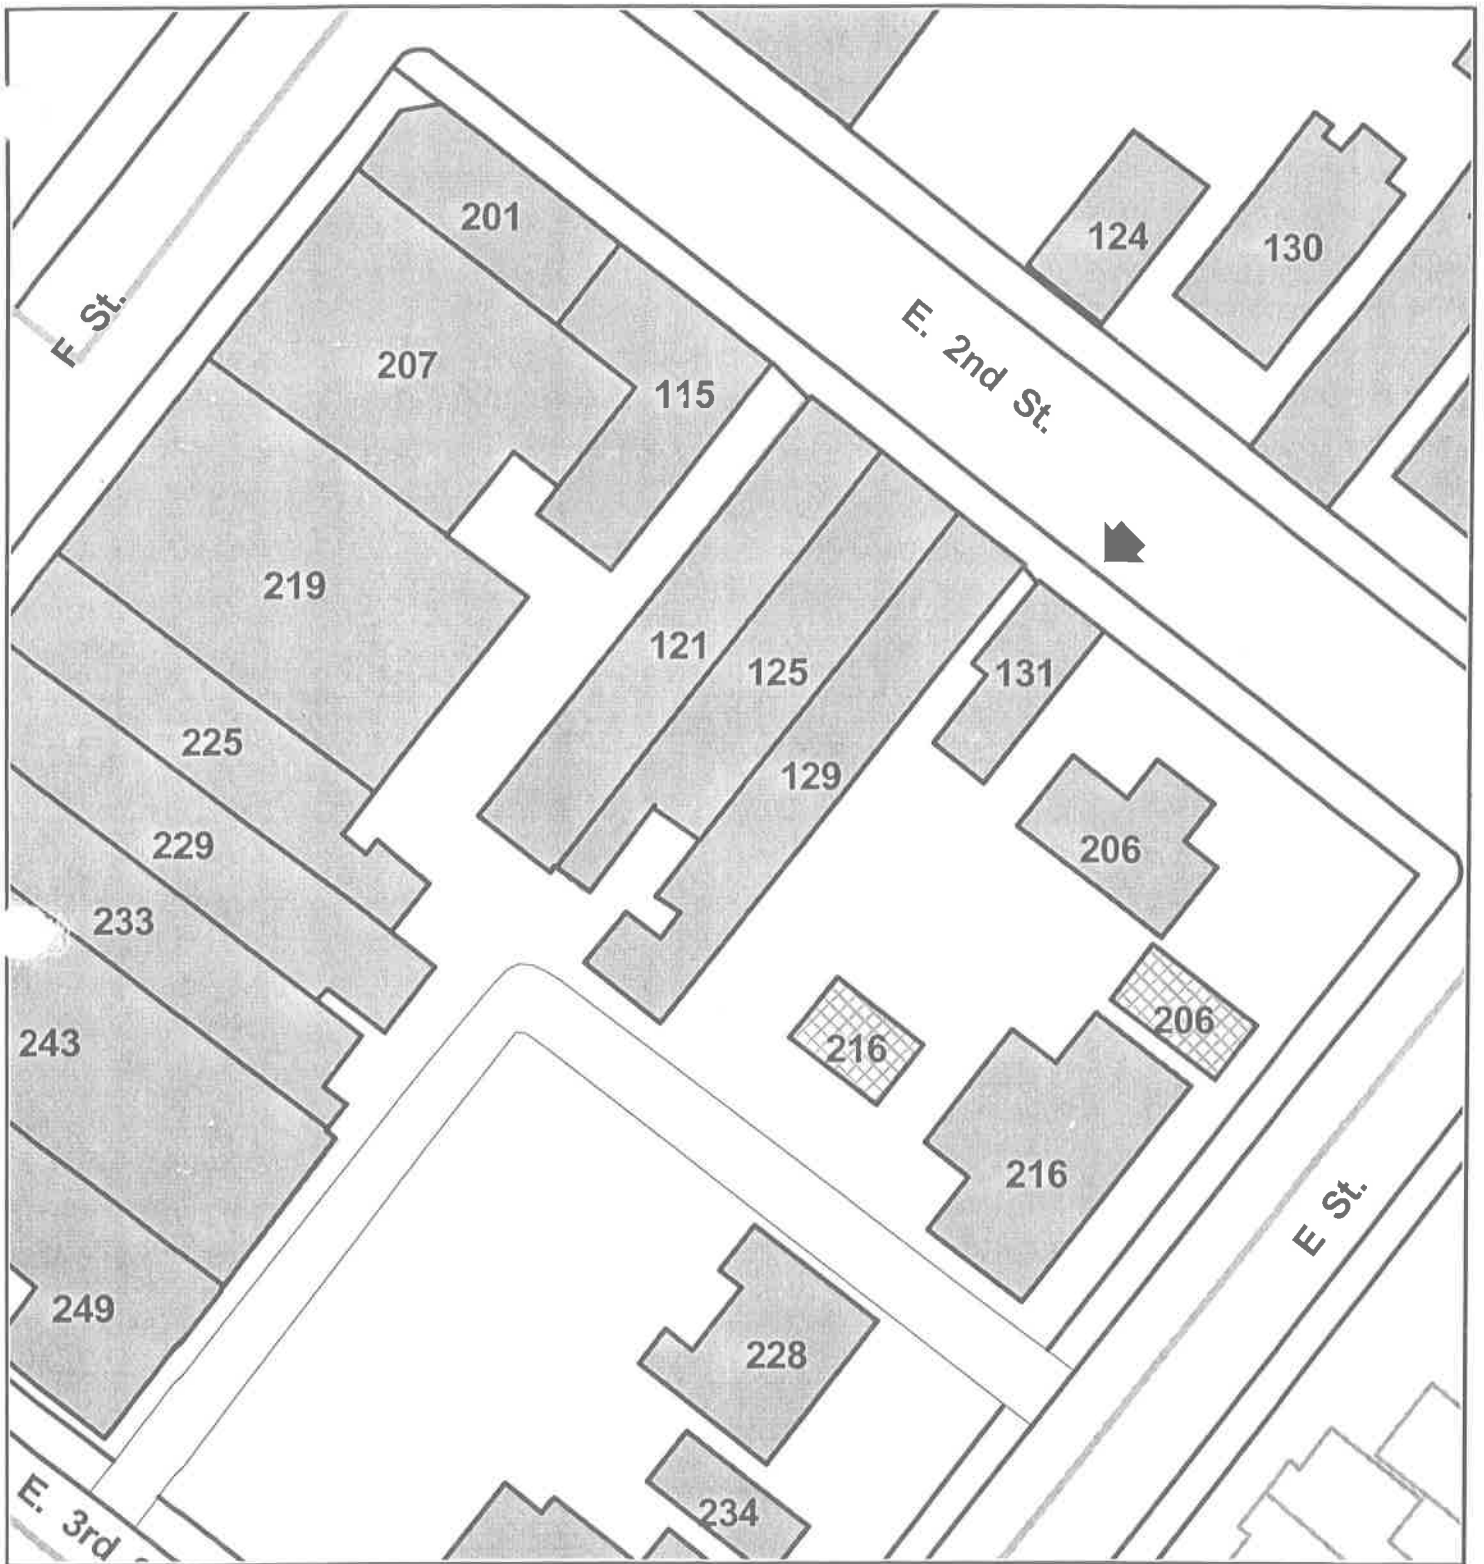
131 E. 2nd Street, 5CF406.24

One-story painted brick commercial building with flat roof. Façade has corbelled brick cornice. Wood lintel above storefront with hanging sign above entrance. Short red brick chimney at center rear of front section of building. Façade has inset center entrance with paneled and glazed door and clerestory window above door. Flanking entrance are two-part plate glass display windows topped by clerestory windows. Paneled kickplates under windows. West wall has segmental arched window toward rear. East wall is stuccoed and has no openings. Rear part of building is gabled and has corrugated metal roofing.
