COLORADO CULTURAL RESOURCE SURVEY

Architectural Inventory Form

| 5. Historic Building Name: Wise/Kern/Wells House | |
| 7. Building Address: 134 D Street | |

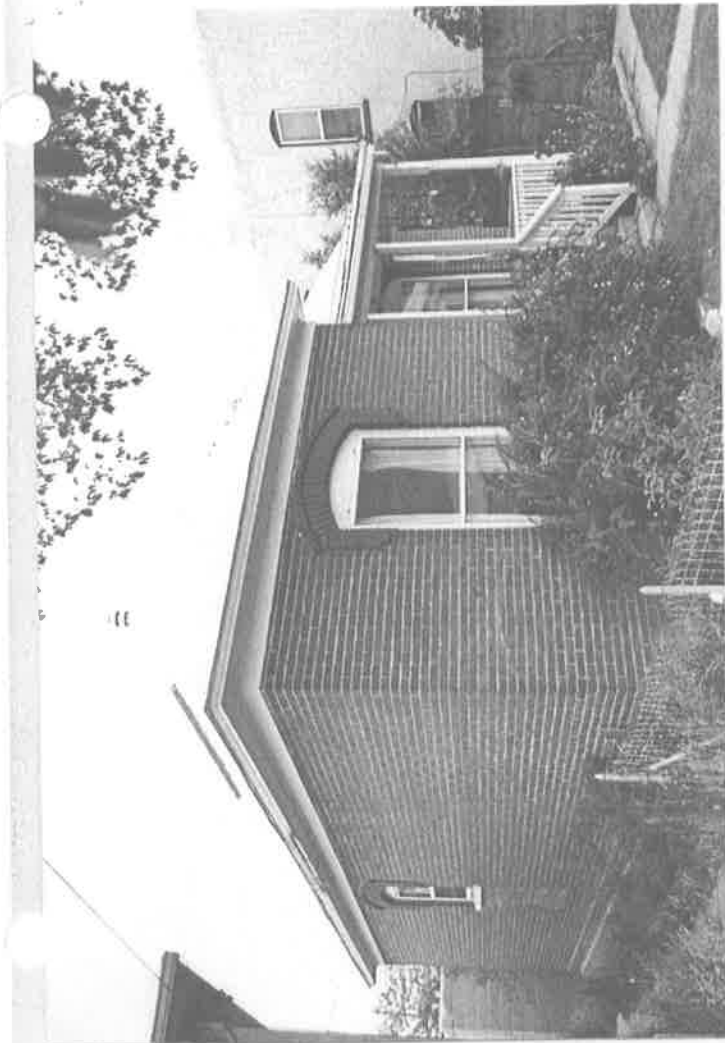
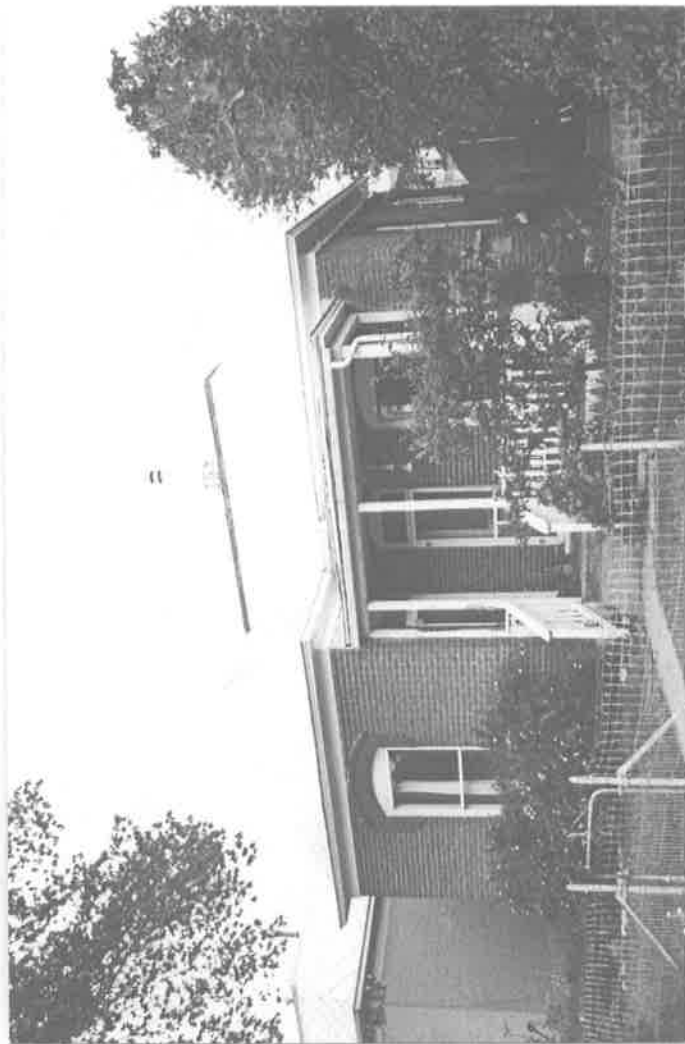
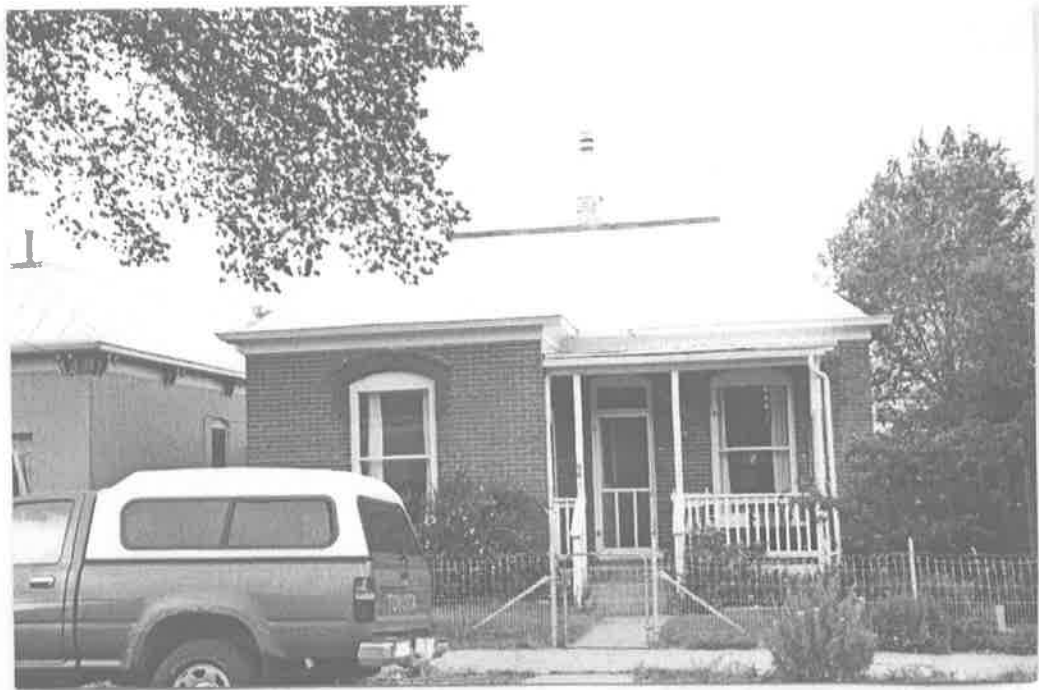
47. Photographic Reference(s): 10: 35-36; 11: 2-5

One-story red brick dwelling with hipped roof with center deck and projecting hipped roof bay on façade. Roof is covered with standing seam metal roofing and has flared eaves and a center, painted brick chimney with metal top. Plain trim boards under eaves. Projecting bay on front has large segmental arched double-hung sash window with gauged brick hood mold of darker brick. Flat roof porch in inset area at north end of façade has slender wood post supports, stick balustrade, wood railing, concrete deck, and concrete steps, as well as two original engaged spindles. There is an entrance with transom and paneled and glazed door facing east and one facing north onto the porch, as well as a double-hung sash window. South wall has one segmental arched window with hood mold that has been shortened and has a replacement window. North wall has two tall segmental arch double-hung sash

windows with hood molds. Foundation is stone covered with concrete. Attached, flat roof, 18' X 11' concrete block garage visible at southwest corner.

This house maintains historic physical integrity. The porch supports and balustrade have been replaced and a garage was added in the rear.
