COLORADO CULTURAL RESOURCE SURVEY

Architectural Inventory Form

1. Resource Number: 5CF406.49
2. Temporary Resource Number: 65
3. County: Chaffee
4. City: Salida
5. Historic Building Name: O.D. Bennett & Son Harness Shop
6. Current Building Name: All Booked Up
7. Building Address: 134 E. 1st St.
8. Owner Name and Address: Upp, Charles A.; Allison, Kristi J.; Flack, Gay L., 748 F St., Salida, CO 81201

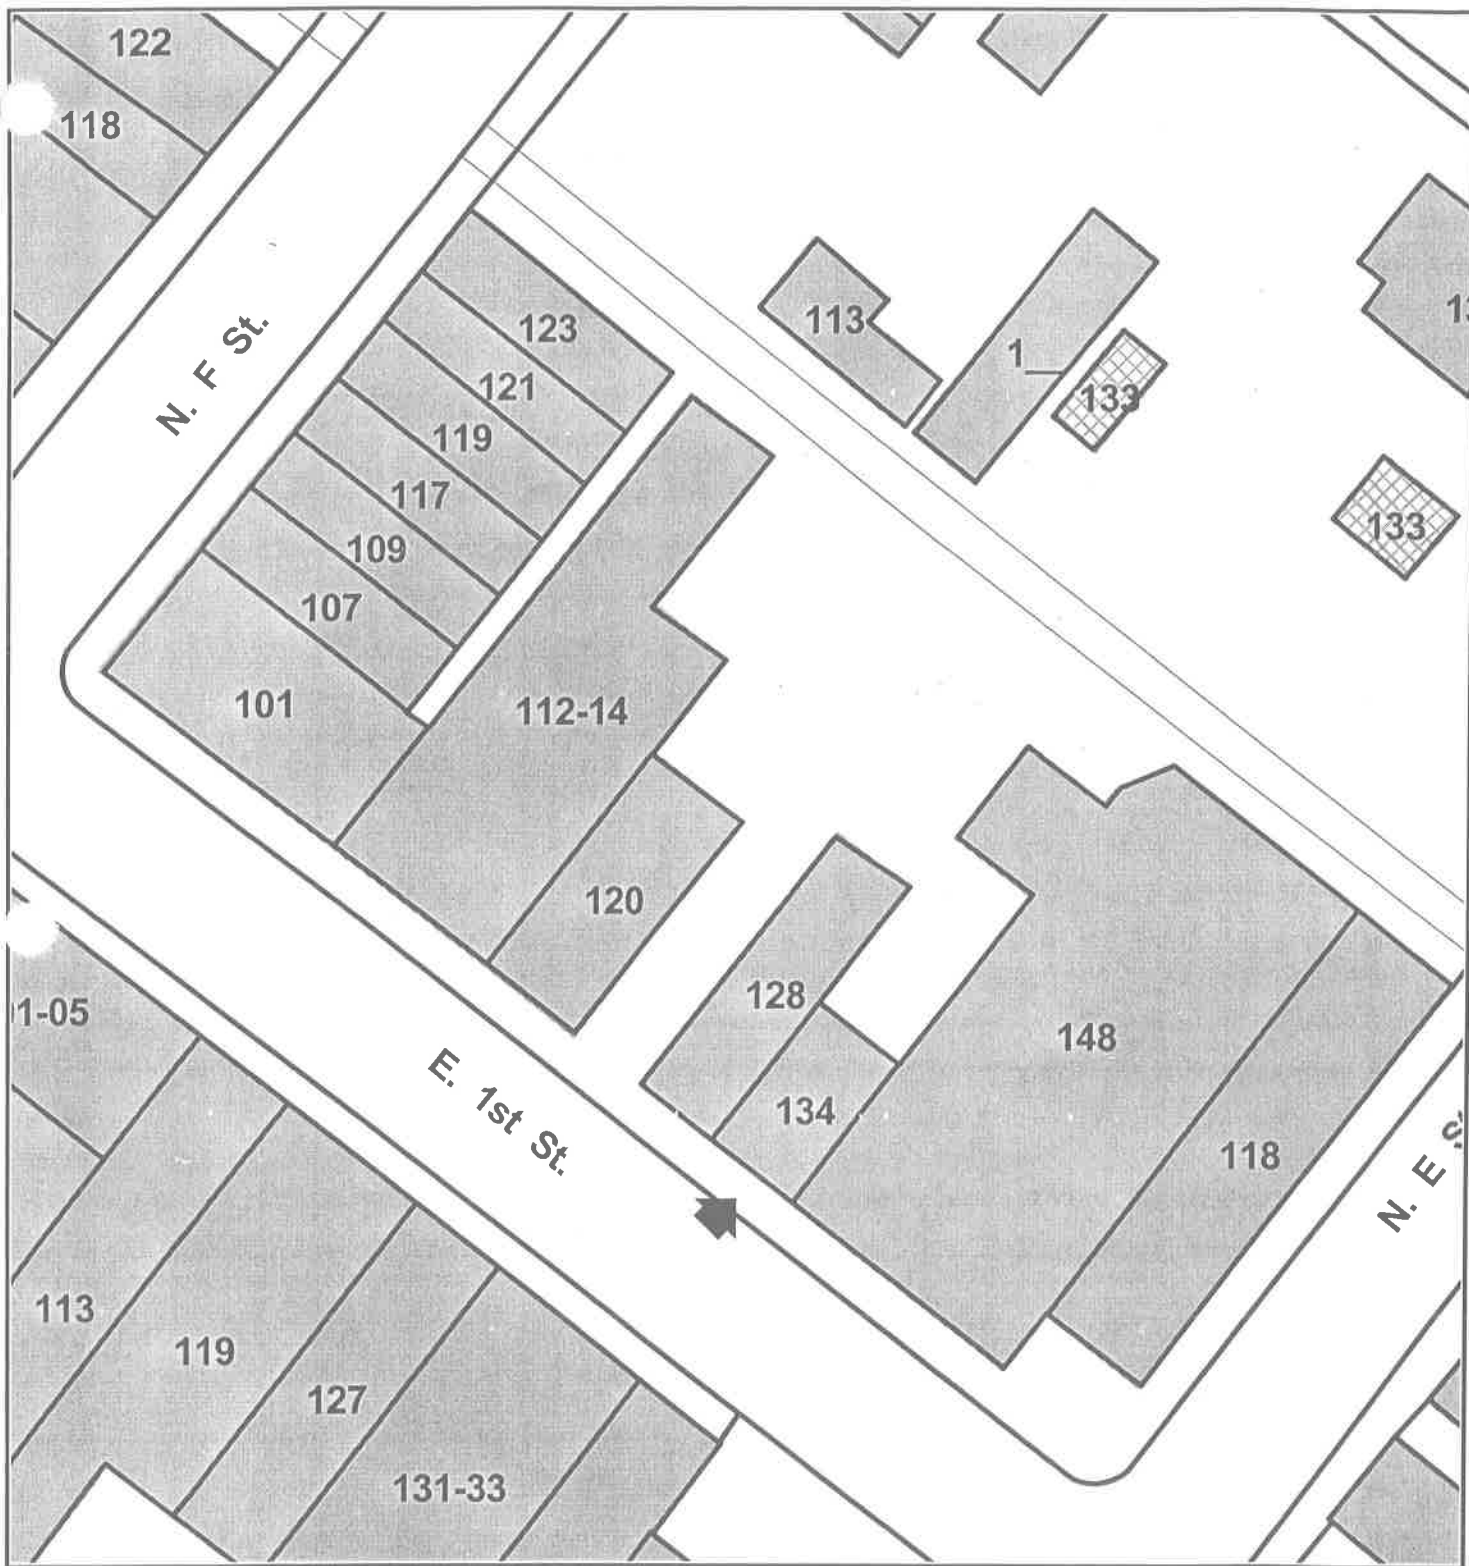
134 E. 1st Street, 5CF406.49

The façade has been altered with stucco, nonoriginal display windows, and brick kickplates. An historic photograph of the building shows that the clerestory panel is also not original, although it may be historic. The alteration of the building occurred before 1981.
