COLORADO CULTURAL RESOURCE SURVEY

Architectural Inventory Form

1. Resource Number: 5CF406.25
2. Temporary Resource Number: 113
3. County: Chaffee
4. City: Salida
5. Historic Building Name: Wenz & Son Undertakers, Stewart Mortuary
6. Current Building Name: Amica's
7. Building Address: 136 E. 2nd St.
8. Owner Name and Address: Misto Limited Company, 7626 Co. Rd. 253, Salida, CO 81201

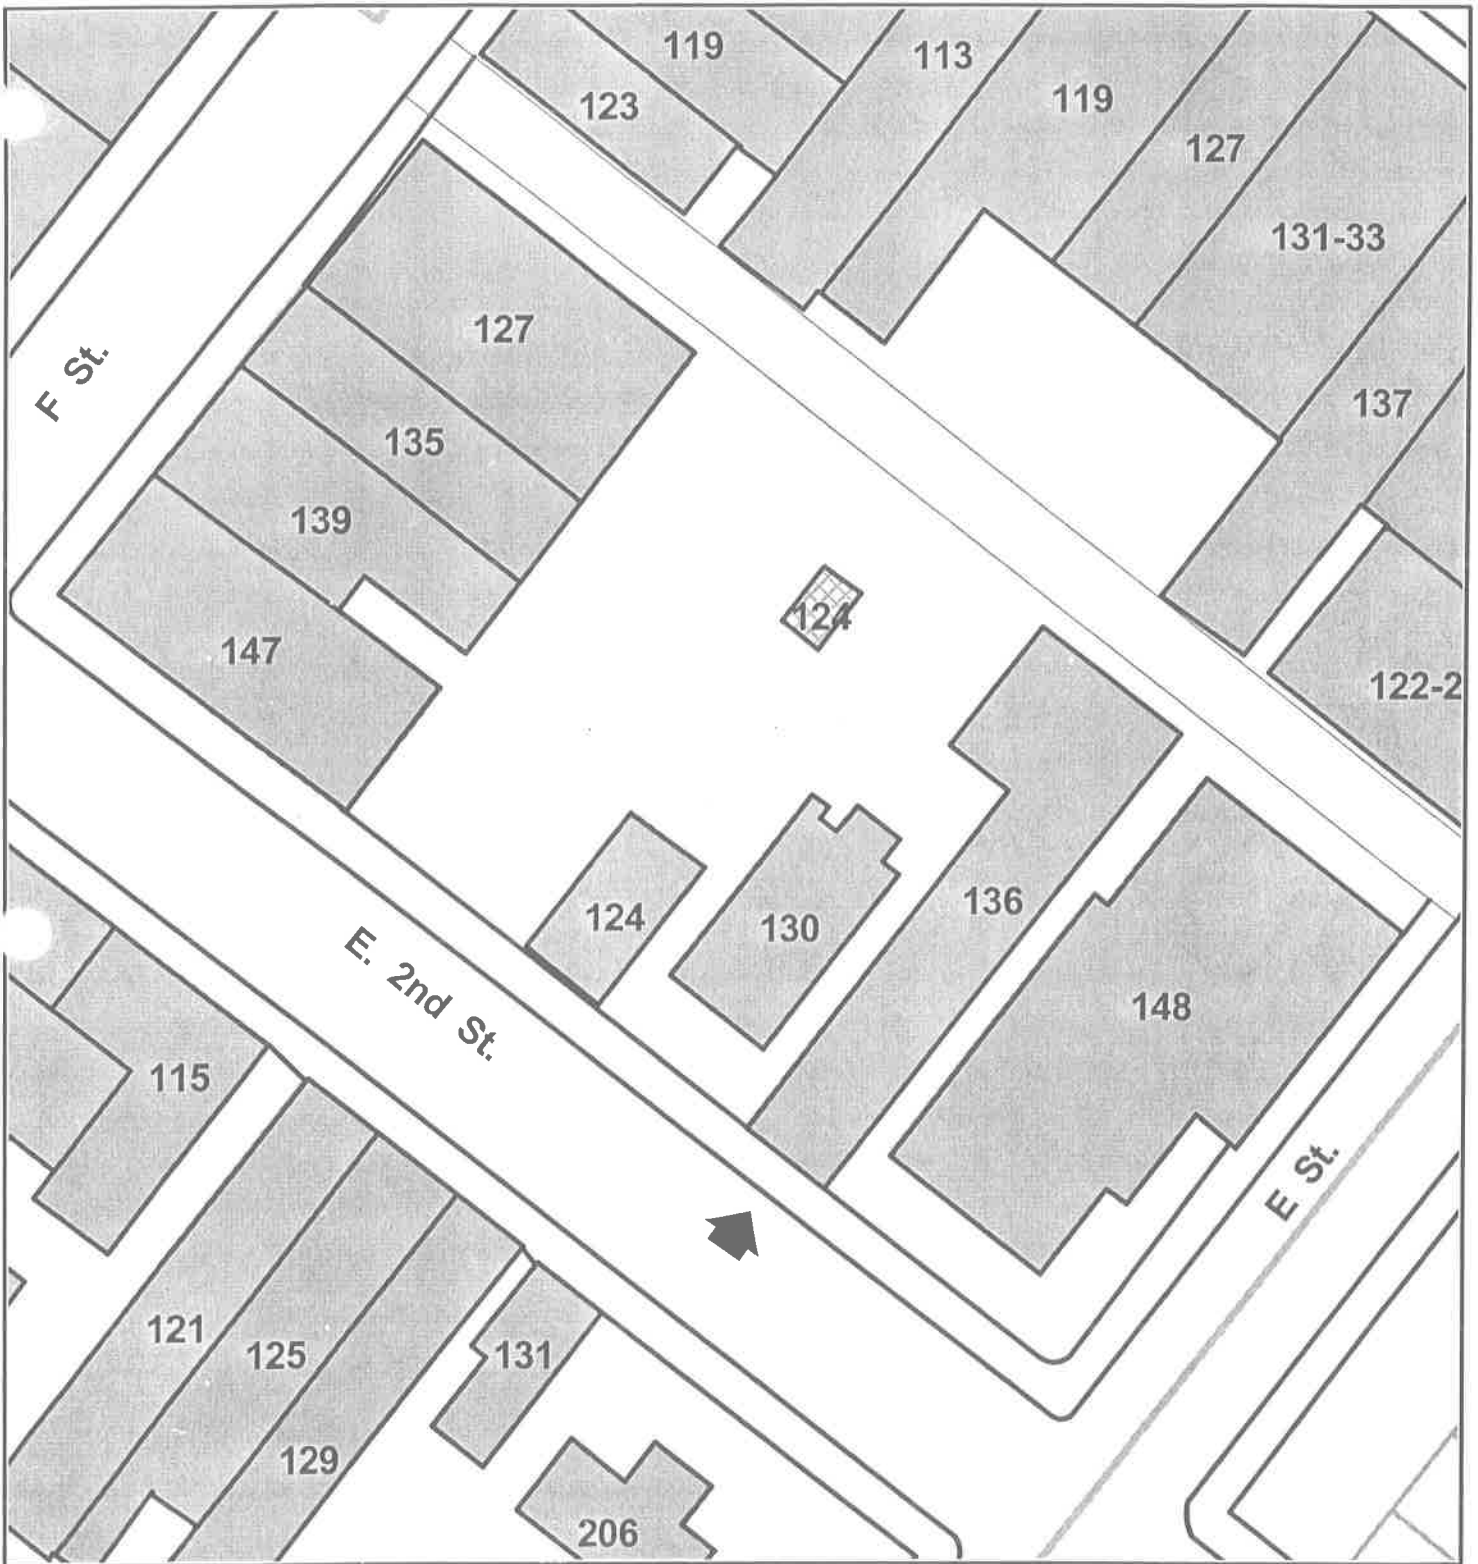
Downtown Salida Historic Buildings Survey, 2001-02
Sketch Map

136 E. 2nd Street, 5CF406.25

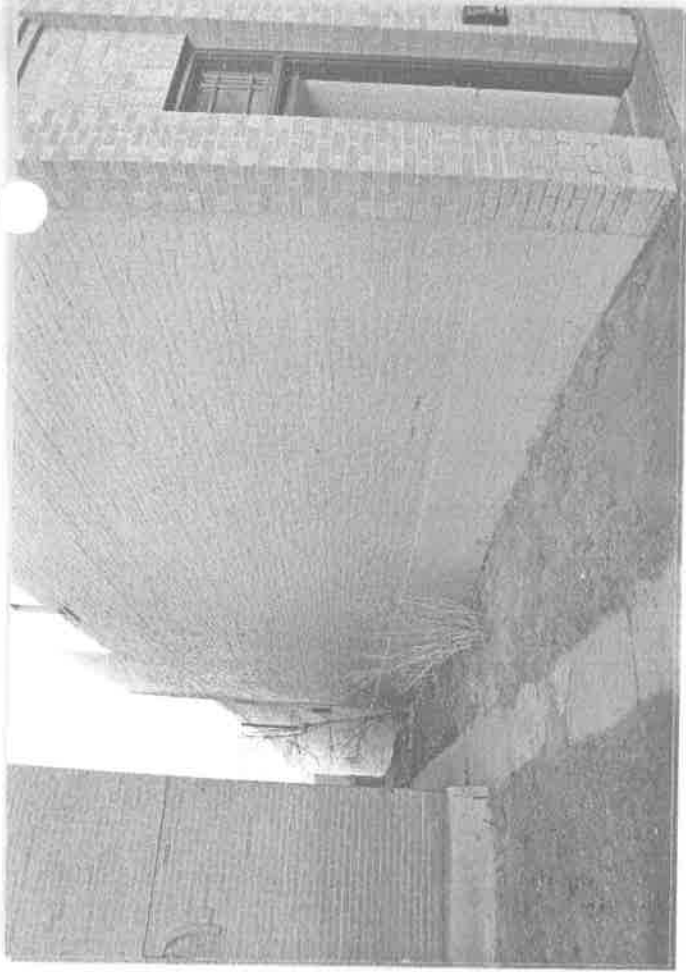
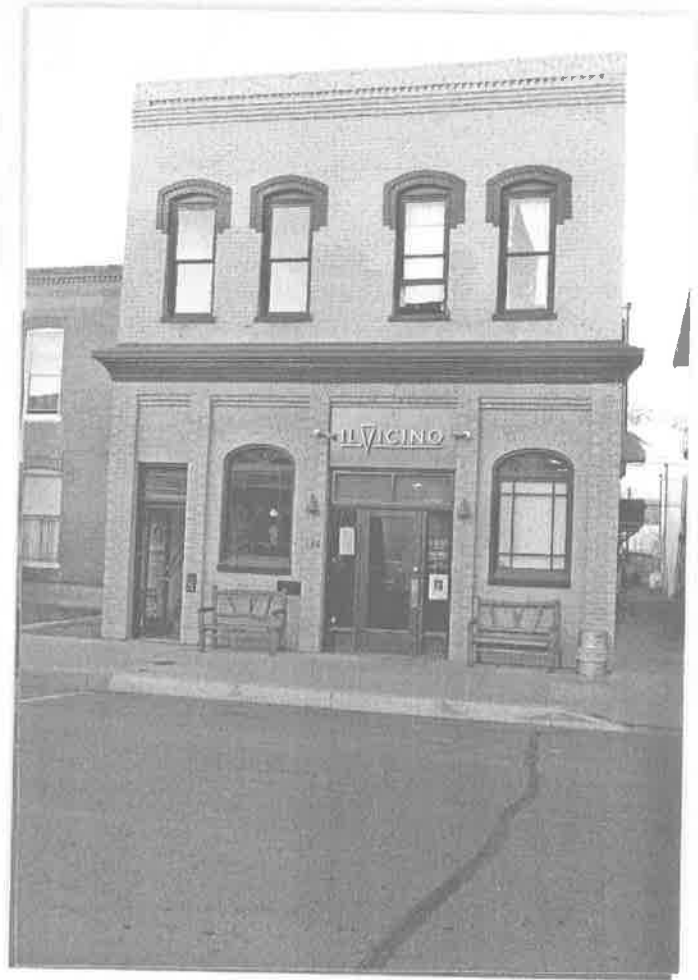
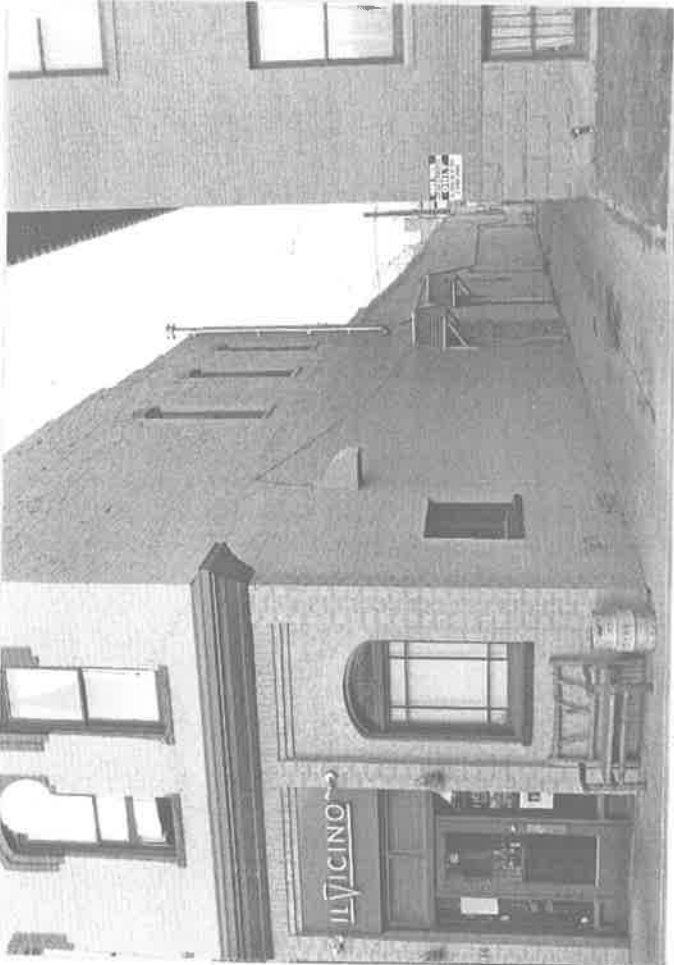
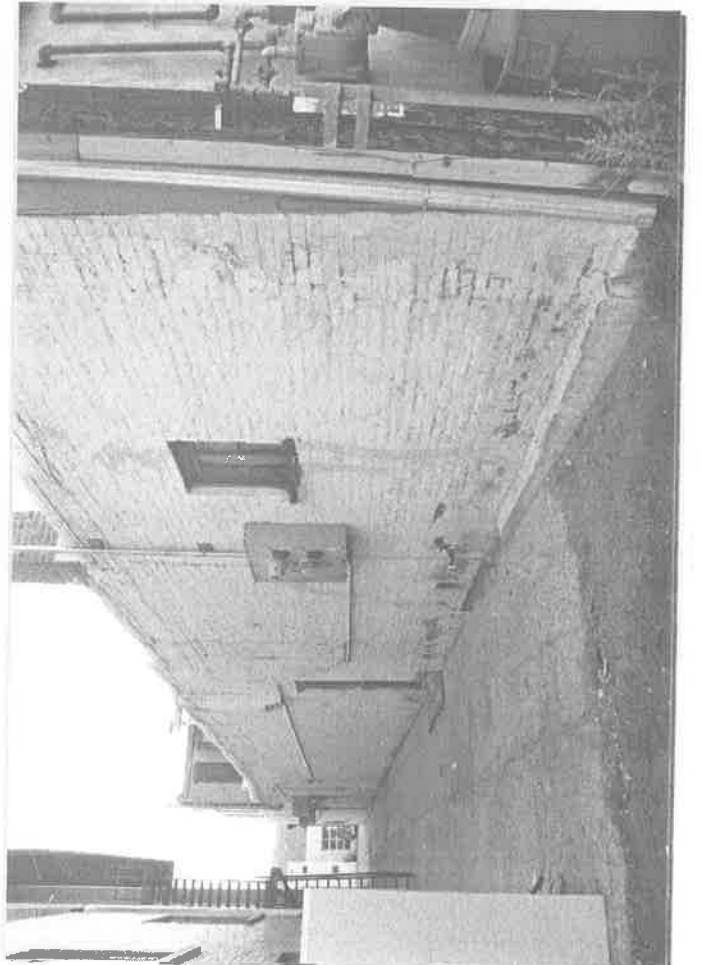
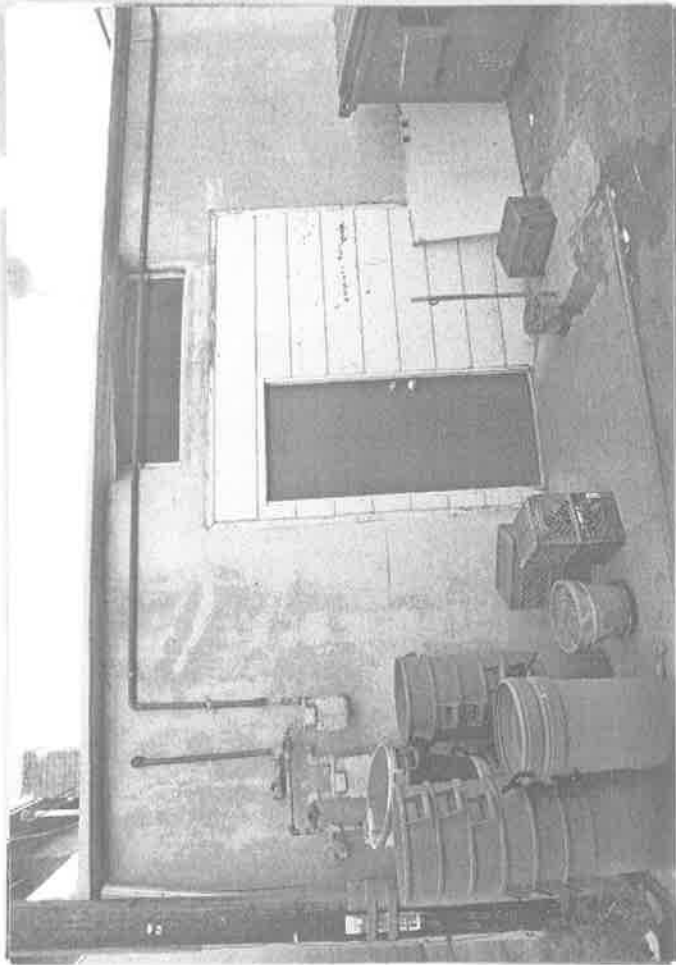
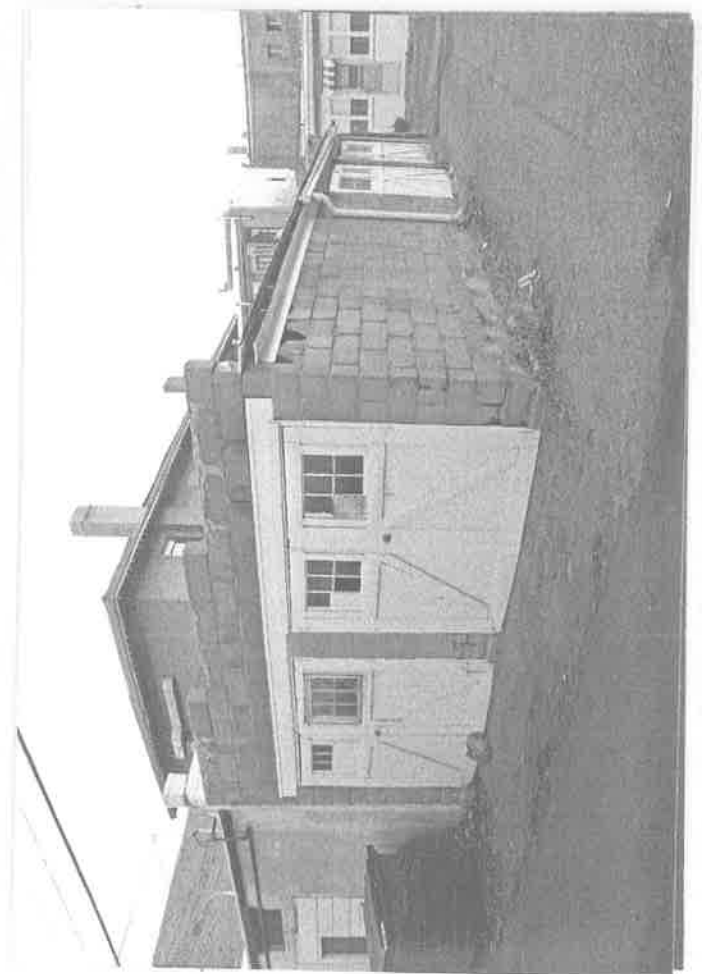
Two-story painted brick commercial building with flat roof with one-story wing at rear. Façade has plain cornice and frieze with dentils and bands of molded brick. Second story has four tall, narrow, double-hung sash windows with segmental arched brick hood molds and wood sills. Projecting molded cornice above first story. First story has remodeled storefront with painted wire-drawn brick; brick piers divide the first story into four slightly inset bays with bands of brick at top of bay. Slightly off-center entrance flanked by elliptical arched windows with geometric glazing and brick sills. Entrance has door with large rectangular light, sidelights, and transom. Entrance at west end of

façade has door with large rectangular light and geometrically glazed transom. East wall of second story has three segmental arched windows on second story. First story has one window opening near south end and two wood shingled gabled hoods sheltering entrances at center of wall. Metal chimney on east.

This building retains moderate historic physical integrity. The first story of the façade has been totally remodeled, while the upper story retains its original windows and ornamental frieze.
