COLORADO CULTURAL RESOURCE SURVEY

# Architectural Inventory Form

- 1. Resource Number: 5CF2059
- 2. Temporary Resource Number: 30
- 3. County: Chaffee
- 4. City: Salida
- 5. Historic Building Name: Easy Laundry
- 6. Current Building Name: Colorado Workforce
- 7. Building Address: 141 E. Third St.
- 8. Owner Name and Address: UPPER ARKANSAS AREA COUNCIL OF GOVERNMENTS, PO BOX 510, CANON CITY, CO 81215

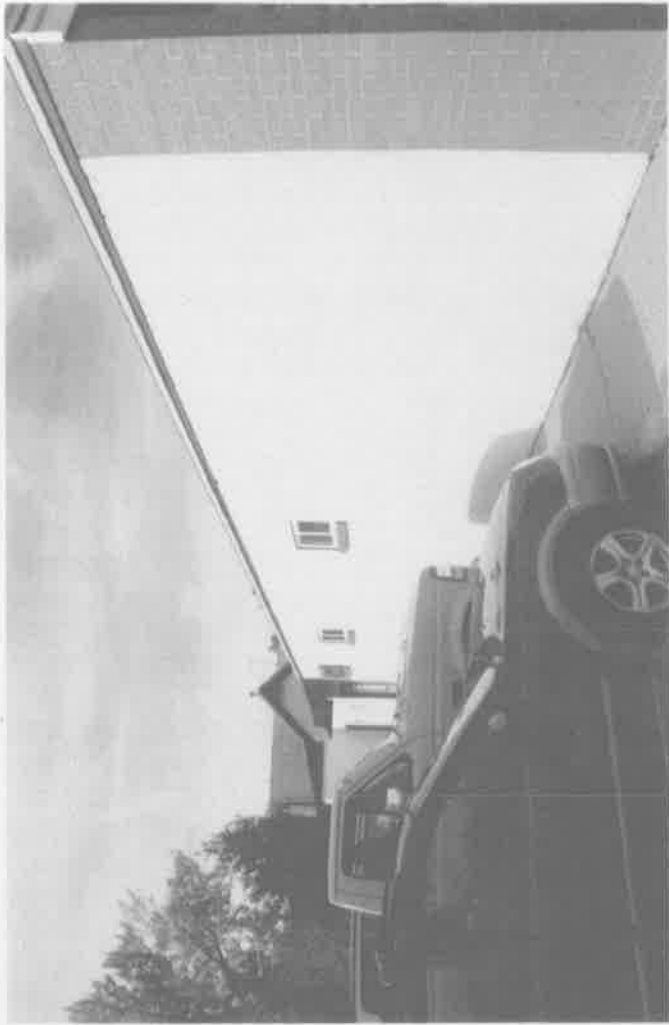
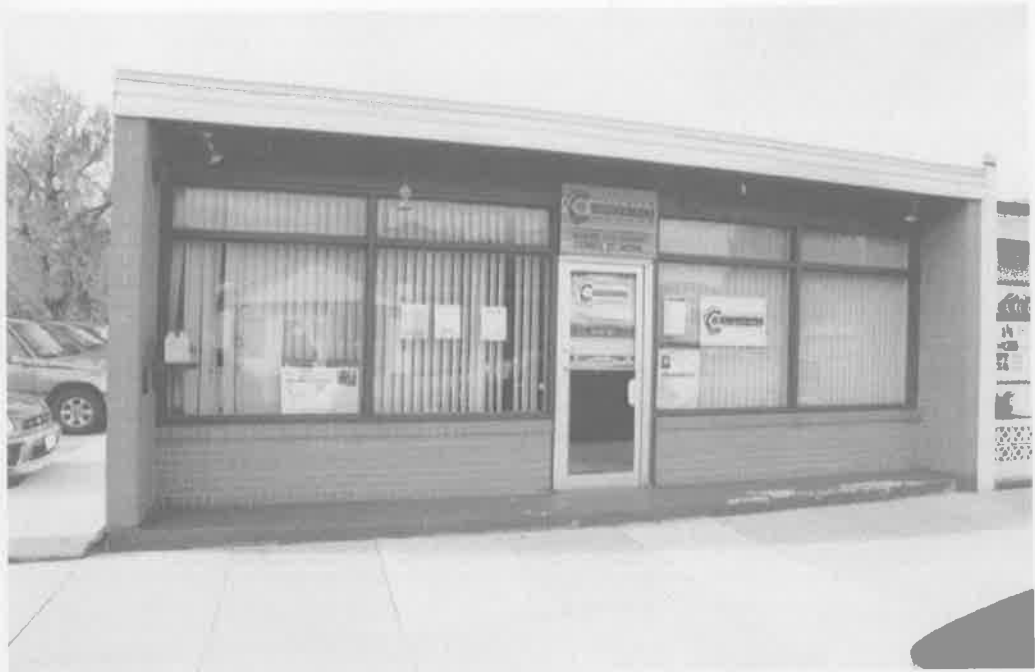
One-story, rectangular, flat roof brick office building. Front (north) has molded metal cornice. Red brick end walls project forward creating partial enclosure. Center entrance with metal frame glazed door flanked on each end by two metal frame display windows with transoms above large plate glass windows. Below windows is red brick projecting sill course and wall below is red brick. Between the projecting end walls is a raised concrete pad along the front of the building.

The east wall is painted concrete block and has two small horizontal sliding windows with brick sills toward the north

end. There are double paneled and glazed wood doors under a fabric awning toward the rear, followed by a single door. The west wall is shared with the adjacent building.
