COLORADO CULTURAL RESOURCE SURVEY
Architectural Inventory Form

1. Resource Number: 5CF406.118
2. Temporary Resource Number: 48
3. County: Chaffee
4. City: Salida
5. Historic Building Name: Windsor Café
6. Current Building Name: Arrangement of Motion Dance Studio
7. Building Address: 202 N. F St.
8. Owner Name and Address: Spencer, Robert L., Jr., & Elizabeth A., 422 W. 2nd St., Salida, CO 81201

47. **Photographic Reference(s):** 1: 3; 2: 12A, 14A.
Negatives Filed At: City of Salida
Photographer: Roger Whitacre
48. **Report Title:** Downtown Salida Historic Buildings Survey, 2001-02
49. **Date(s):** September 2002 50. **Recorder(s):** R.L. Simmons/T.H. Simmons
51. **Organization:** Front Range Research Associates, Inc.
52. **Address:** 3635 W. 46th Ave. 53. **Phone Number(s):** (303) 477-7597

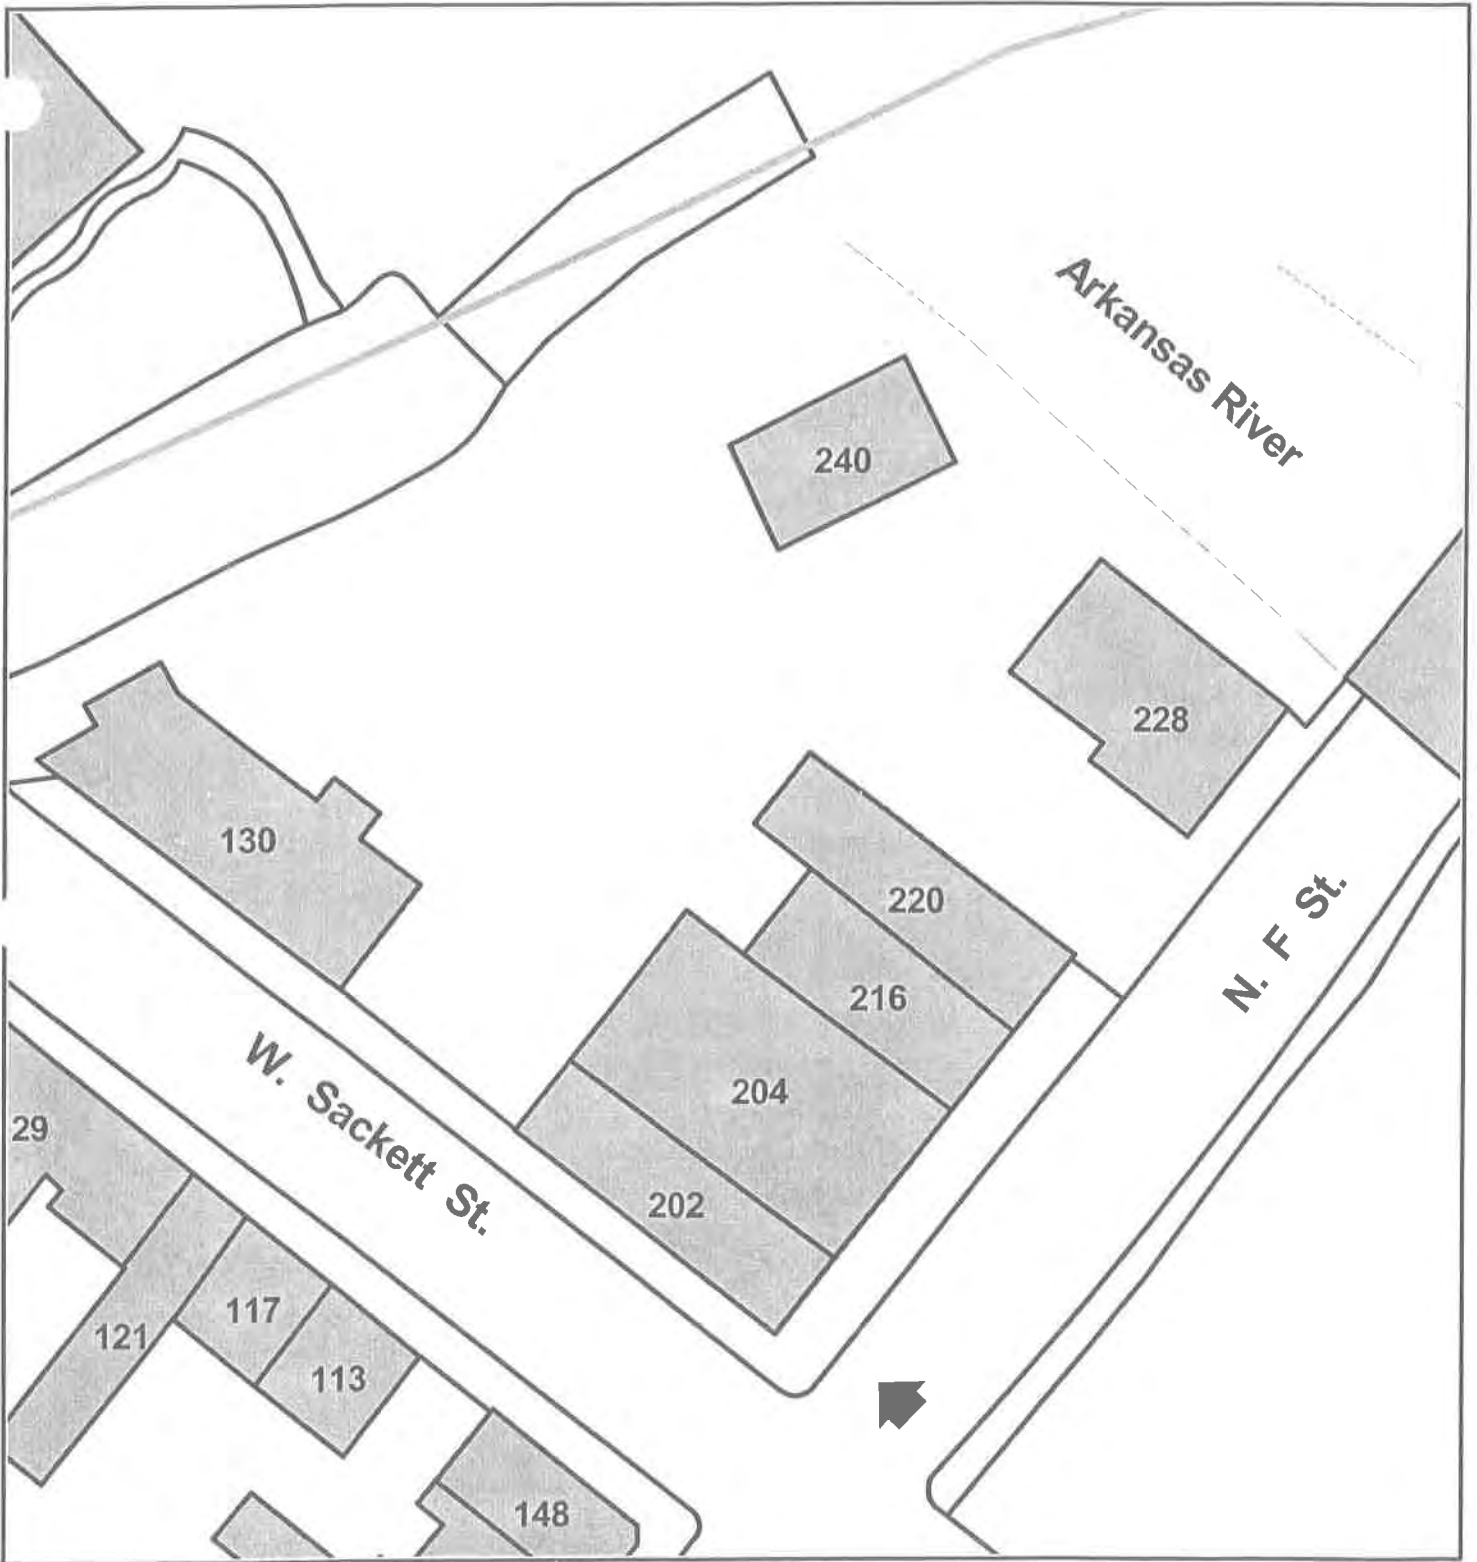
202 N. F Street, 5CF406.118

Two-story rectangular orange brick commercial building with beveled corner on southeast and one -story wing on rear. Cornice and frieze with projecting rows of molded brick and panels; coping of angled stucco or concrete. Brick chimneys, one with molded brick top. East wall, second story, has three, tall, double-hung sash windows with very low (almost flat) segmental arched lintels with brick hood molds and rock-faced stone sills. Stone and brick sill course. Two windows at south end have interlocking hood molds. First story has metal lintel with rosettes, fabric awning above display windows, which are large plate glass, with column supports. Nonoriginal variegated brick

Beveled corner has continuation of cornice and one double-hung sash window with brick hood mold and stone sill on second story. Paneled and glazed door facing steps on first story with flanking columns.

South wall has continued cornice and second story sill course. Four tall double-hung sash windows with low arched brick hood molds and rock-faced stone sills on second story. Storefront extended to south wall for one bay has metal lintel, fabric awning, display window, and variegated brick under window. Two entrances with transoms with low arched hood molds near central part of south wall. West of these are two double-hung sash windows with hood molds and stone sills.
