COLORADO CULTURAL RESOURCE SURVEY

Architectural Inventory Form

1. Resource Number: 5CF2277 Parcel Number: 380705130106
2. Temporary Resource Number: 120 SHF/CLG Grant Number: CO-06-017
3. County: Chaffee
4. City: Salida
5. Historic Building Name: McKenzie Terrace
6. Current Building Name: N/A
7. Building Address: 225-45 E. Second Street
8. Owner Name and Address: Perschbacher, Raymond J., P.O. Box 965, Salida, CO 81201

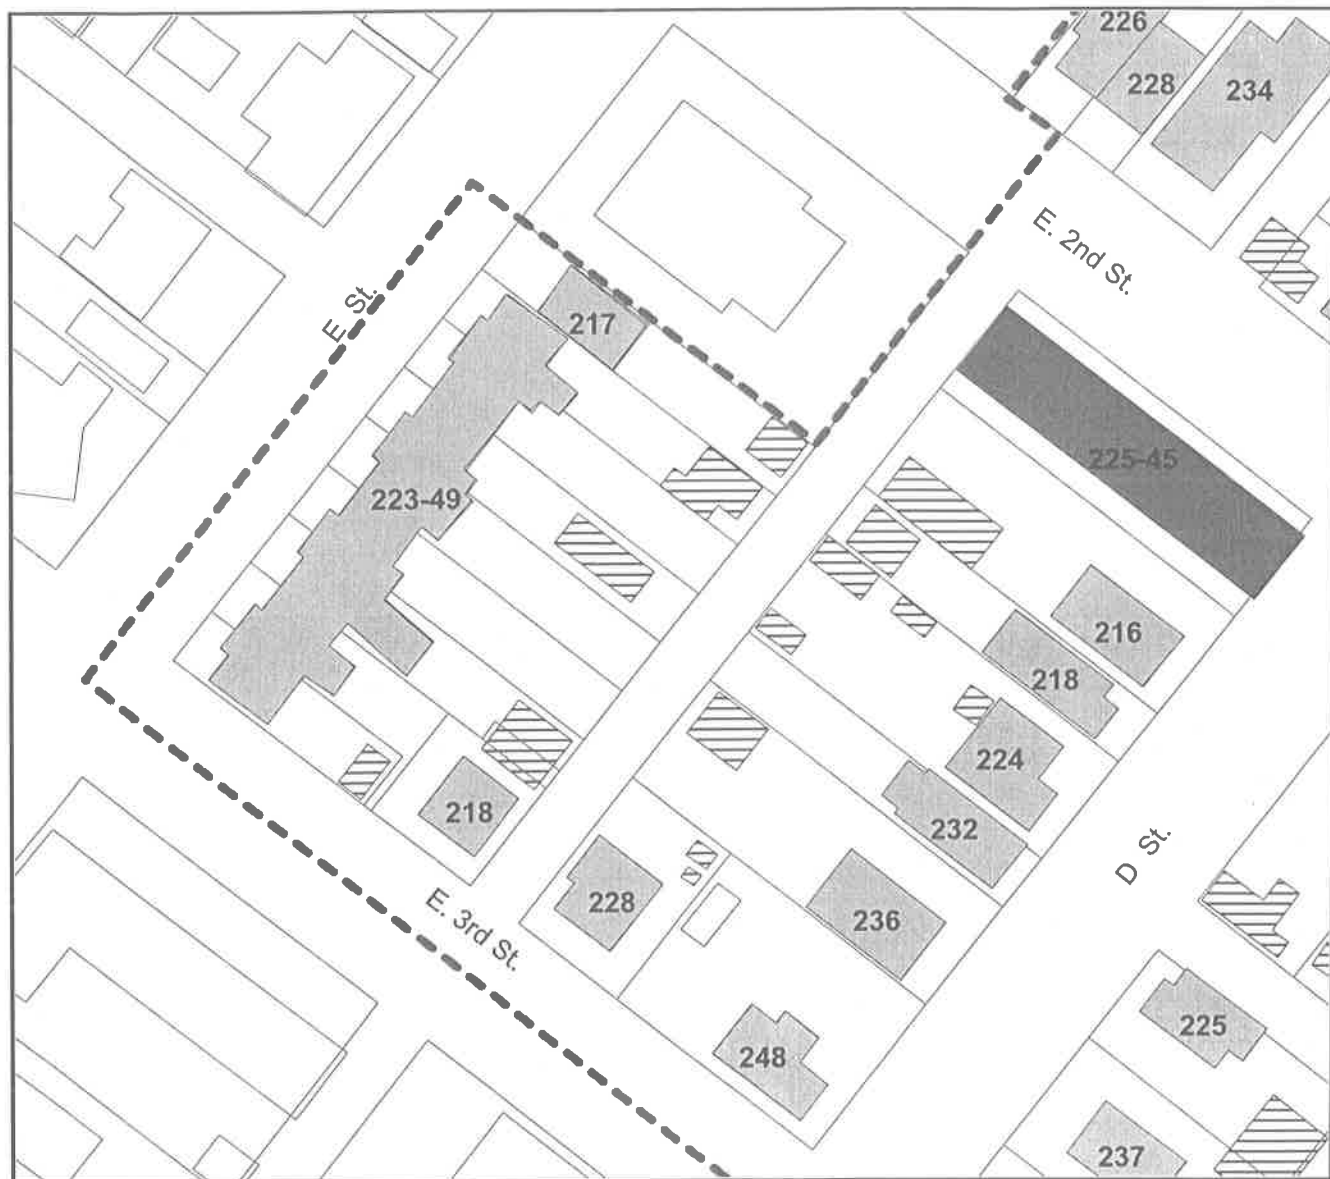
225-45 E. Second Street

SOURCE: Building outlines from CAD file provided by City of Salida (and supplemented by fieldwork) and overlaid on parcels produced by Chaffee County. The resource described by this survey form is darkly shaded.
