COLORADO CULTURAL RESOURCE SURVEY

Architectural Inventory Form

1. Resource Number: 5CF2248
2. Temporary Resource Number: 36
3. County: Chaffee
4. City: Salida
5. Historic Building Name: Hull House
6. Current Building Name: N/A
7. Building Address: 227 E. First Street
8. Owner Name and Address: Mack, Gerald Scott, P.O. Box 148, Mexia, TX 76667

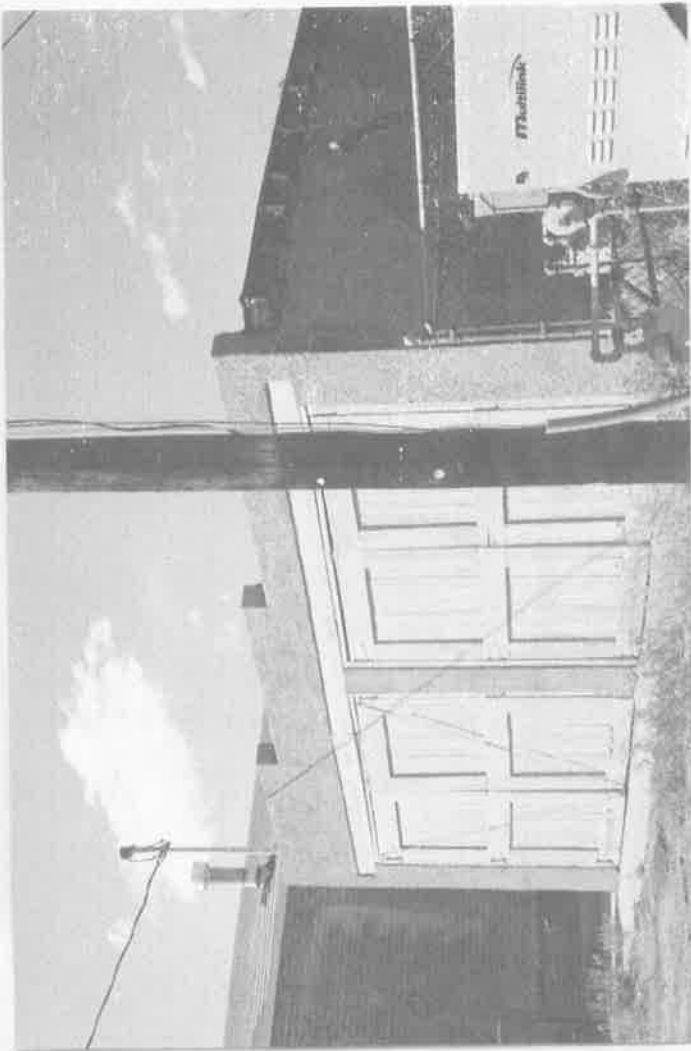
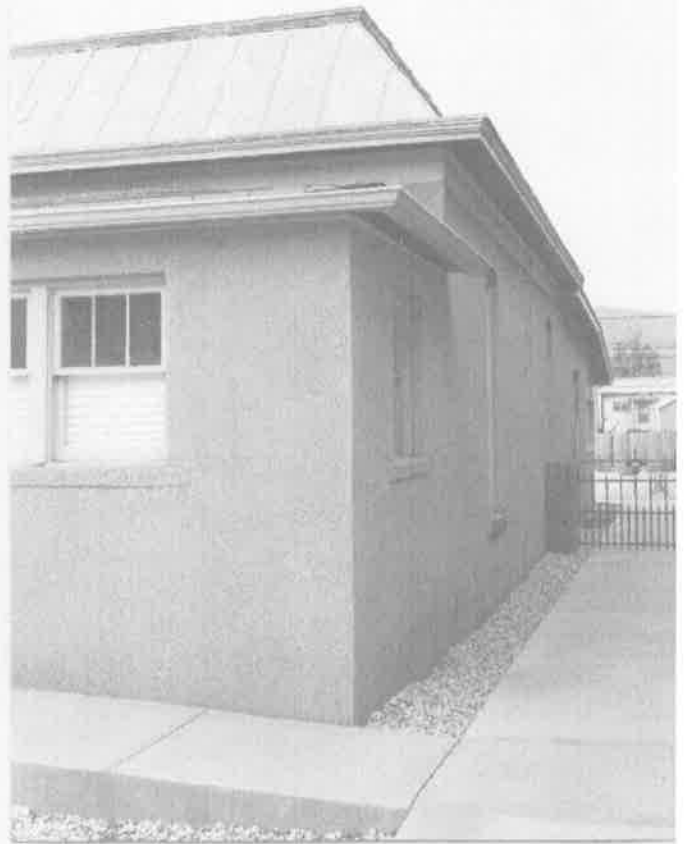
One-story garage with flat roof with stepped parapet on façade (south). Two sets of hinged paneled wood garage door on south. Sanborn maps through 1945 show only a rectangular shed at the rear of the lot.

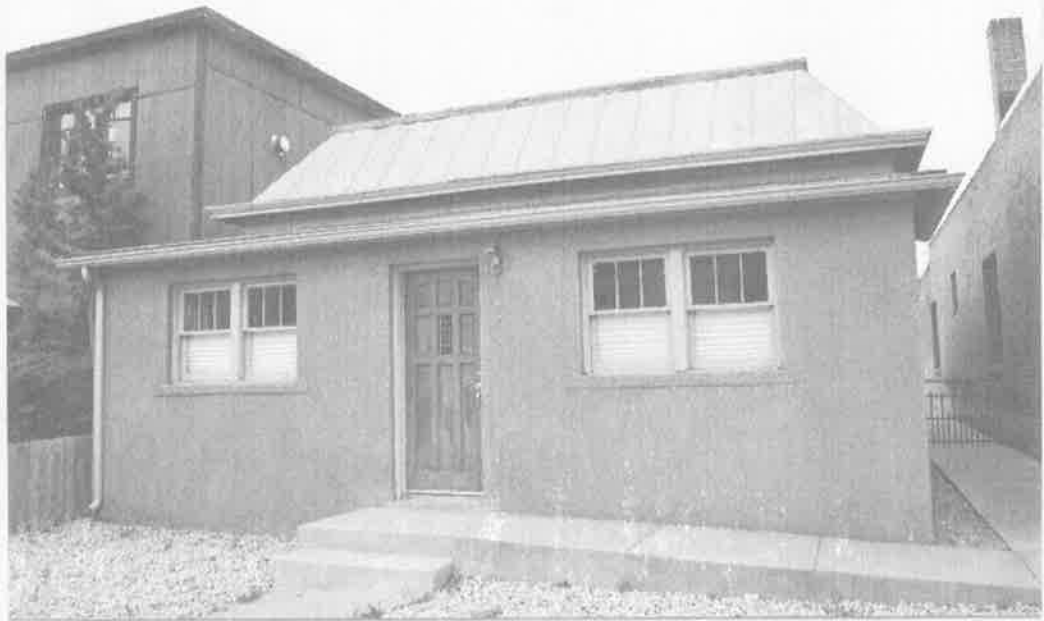
21. General Architectural Description:
One-story mansard roof dwelling with standing seam metal roofing, center brick chimney and stucco chimney, and flared overhanging eaves. Plain wood cornice. Walls clad with stucco. Full-width, projecting, hipped roof, enclosed porch with center paneled wood door flanked by paired 3/1-light windows with stucco sills. Raised concrete stoop with concrete steps and ramp.
