COLORADO CULTURAL RESOURCE SURVEY

Architectural Inventory Form

1. Resource Number: 5CF406.104
2. Temporary Resource Number: 106
3. County: Chaffee
4. City: Salida
5. Historic Building Name: Randol Residence and Furnished Rooms
6. Current Building Name: Balance Point
7. Building Address: 228 E St.
8. Owner Name and Address: Landau, Martin H. & Goodman, Brenda G., 228 E St., Apt. B, Salida, CO 81201

48. Report Title: Downtown Salida Historic Buildings Survey, 2001-02

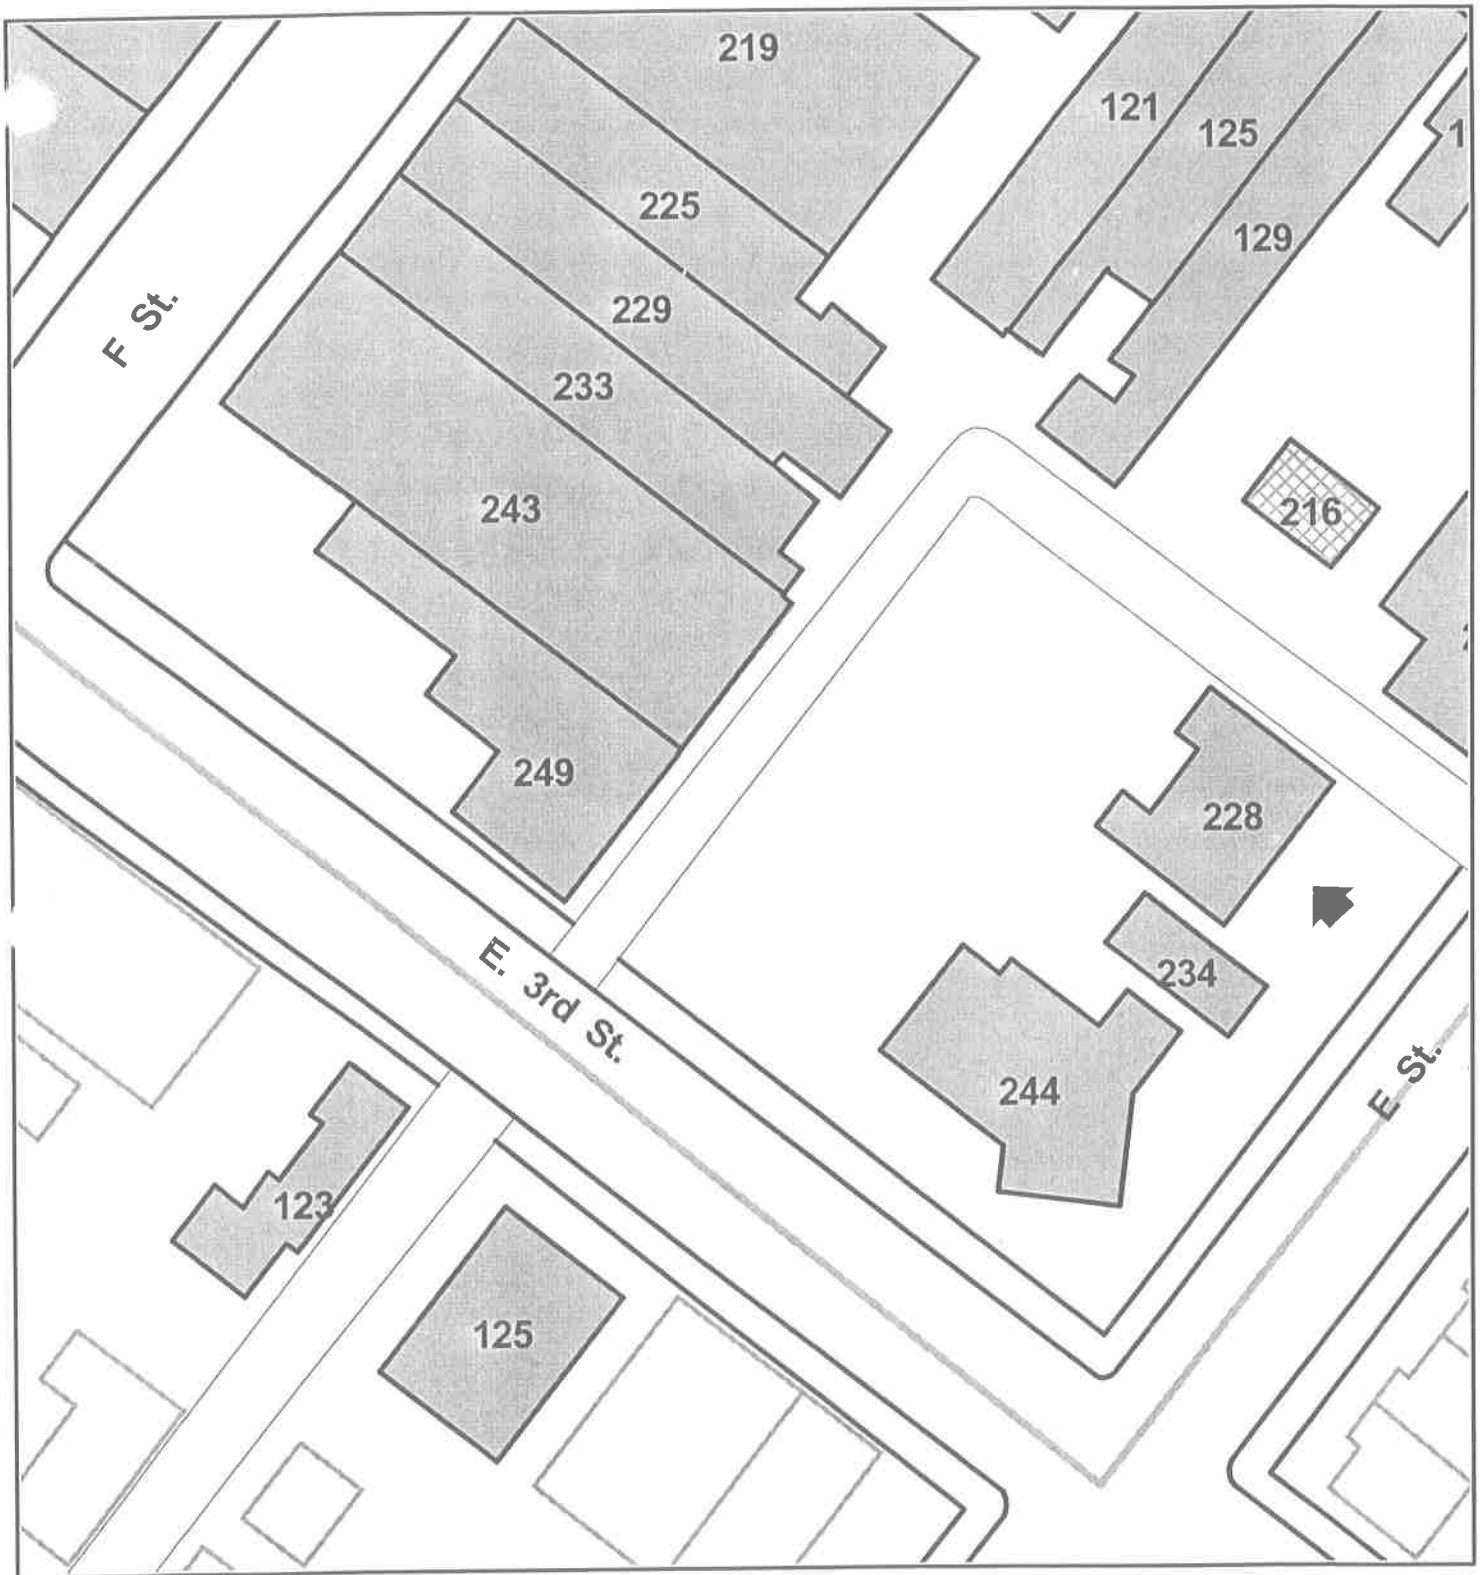
228 E Street, 5CF406.104

Downtown Salida Historic Buildings Survey, 2001-02
Sketch Map

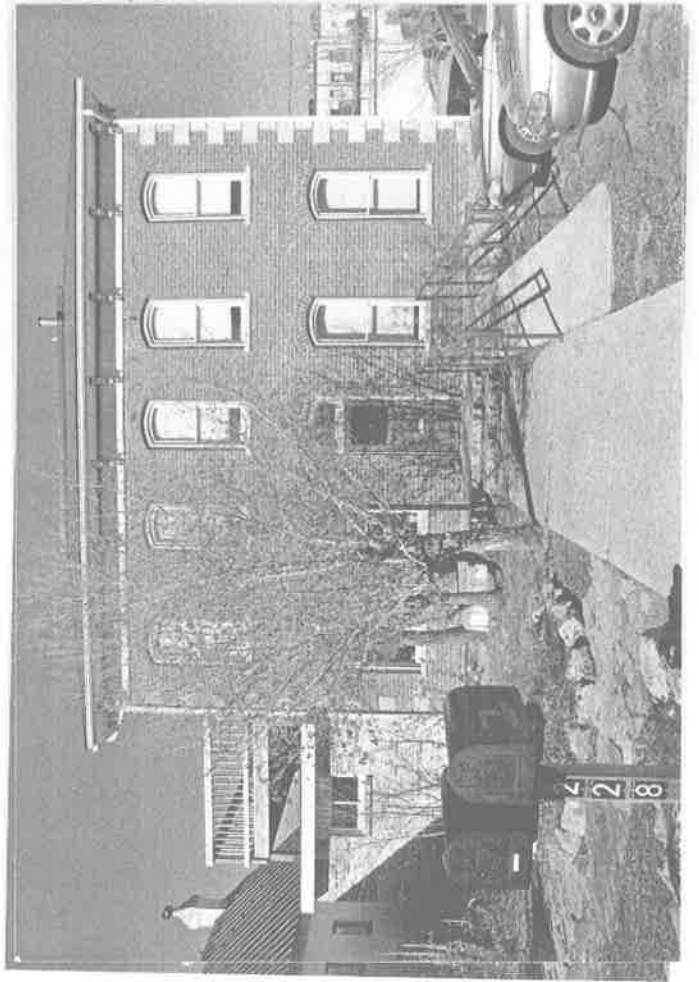
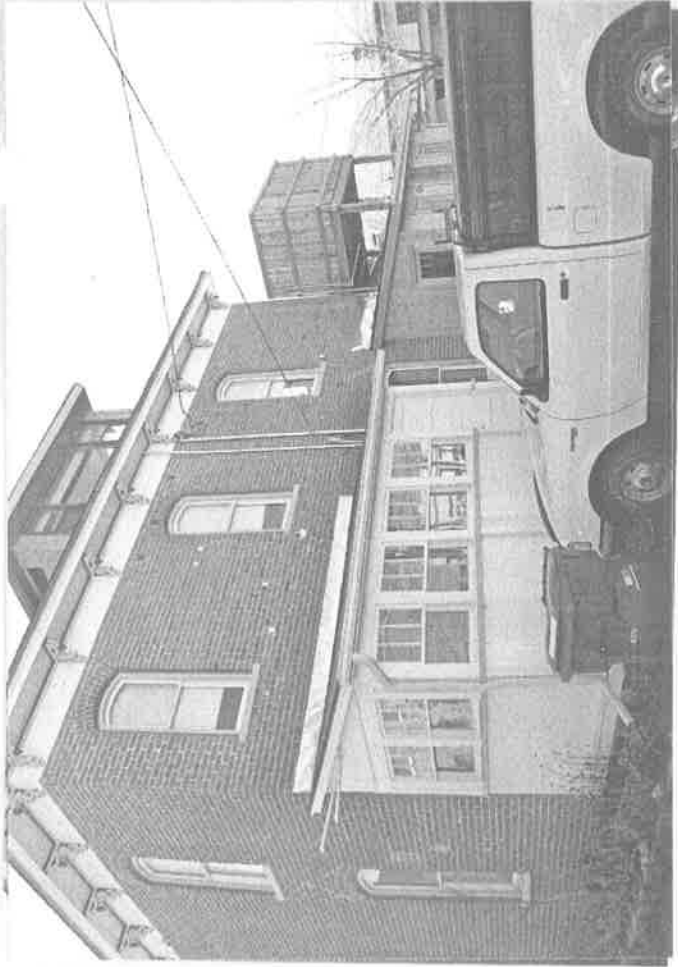
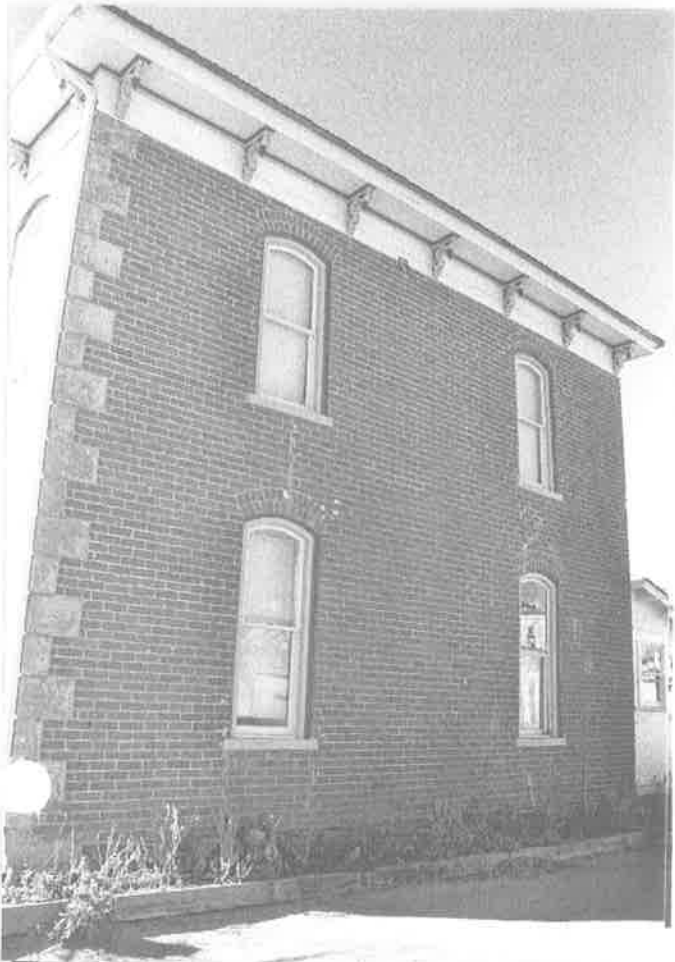
47. Photographic Reference(s): 20: 15, 17, 19.

Two-story rectangular brick dwelling with low hipped roof with metal roofing and overhanging eaves with wide frieze board and brackets. Red brick walls with stone quoins. Foundation is covered with concrete. Façade is symmetrical, with center entrance with segmental arched transom and paneled and glazed door facing concrete stoop. Tall, narrow, double-hung sash windows with brick lintels and stone sills on first and second stories. On south is one-story painted brick projection with flat roof topped by wood deck. Hipped roof dormer at rear, as well as two shed roof frame entrance projections, one old and one newer.

The original porch is missing, and the one-story projection of the south appears rebuilt and is topped by a wood deck. A newer one-story projection is at the rear.
