COLORADO CULTURAL RESOURCE SURVEY

# Architectural Inventory Form

1. Resource Number: 5CF2266 Parcel Number: 368132403057  
 2. Temporary Resource Number: 25 SHF/CLG Grant Number: CO-06-017  
 3. County: Chaffee  
 4. City: Salida  
 5. Historic Building Name: Newell House  
 6. Current Building Name: N/A  
 7. Building Address: 235 E. Sackett Avenue  
 8. Owner Name and Address: Montoya, David, c/o Liddington, Jeff, P.O. 536, Snowmass, CO 81654

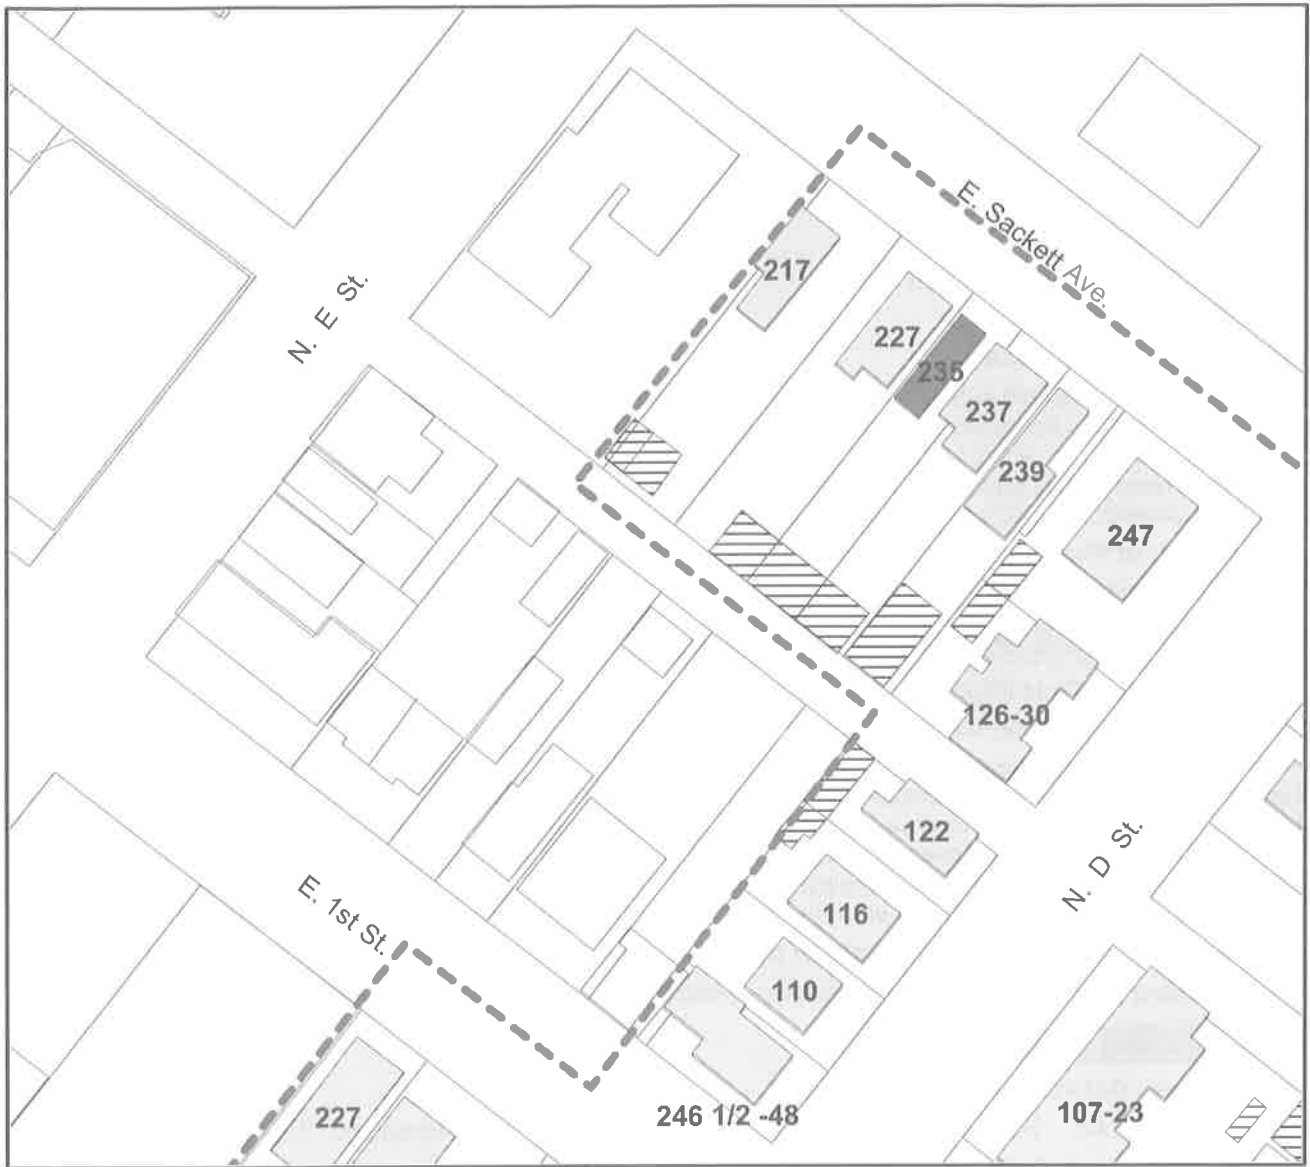
235 E. Sackett Avenue

SOURCE: Building outlines from CAD file provided by City of Salida (and supplemented by fieldwork) and overlaid on parcels produced by Chaffee County. The resource described by this survey form is darkly shaded.
