COLORADO CULTURAL RESOURCE SURVEY

Architectural Inventory Form

1. Resource Number: 5CF2267
2. Temporary Resource Number: 28
3. County: Chaffee
4. City: Salida
5. Historic Building Name: Mountford/Argys House
6. Current Building Name: N/A
7. Building Address: 237 E. Sackett Avenue
8. Owner Name and Address: Montoya, David, c/o Liddington, Jeff, P.O. 536, Snowmass, CO 81654
- Parcel Number: 368132403066
SHF/CLG Grant Number: CO-06-017

.8. Report Title: Salida, Colorado, Historic Buildings Survey, 2006-07

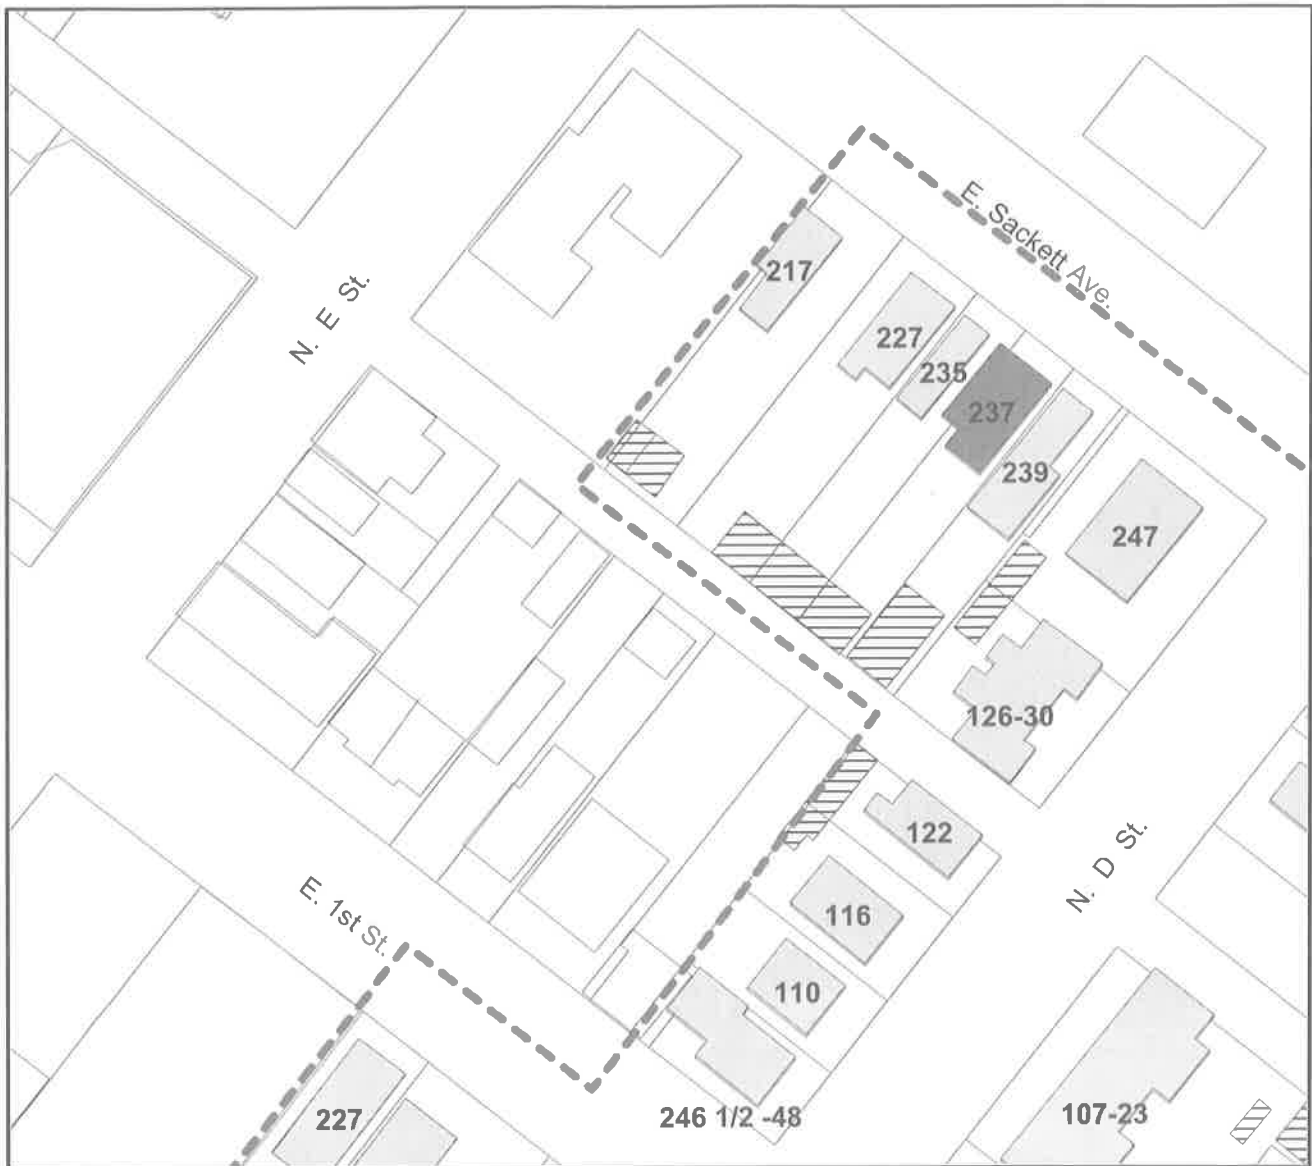
237 E. Sackett Avenue

SOURCE: Building outlines from CAD file provided by City of Salida (and supplemented by fieldwork) and overlaid on parcels produced by Chaffee County. The resource described by this survey form is darkly shaded.
