COLORADO CULTURAL RESOURCE SURVEY

Architectural Inventory Form

| 5. Historic Building Name: Huston House | |
| 7. Building Address: 239 E. Sackett Avenue | |

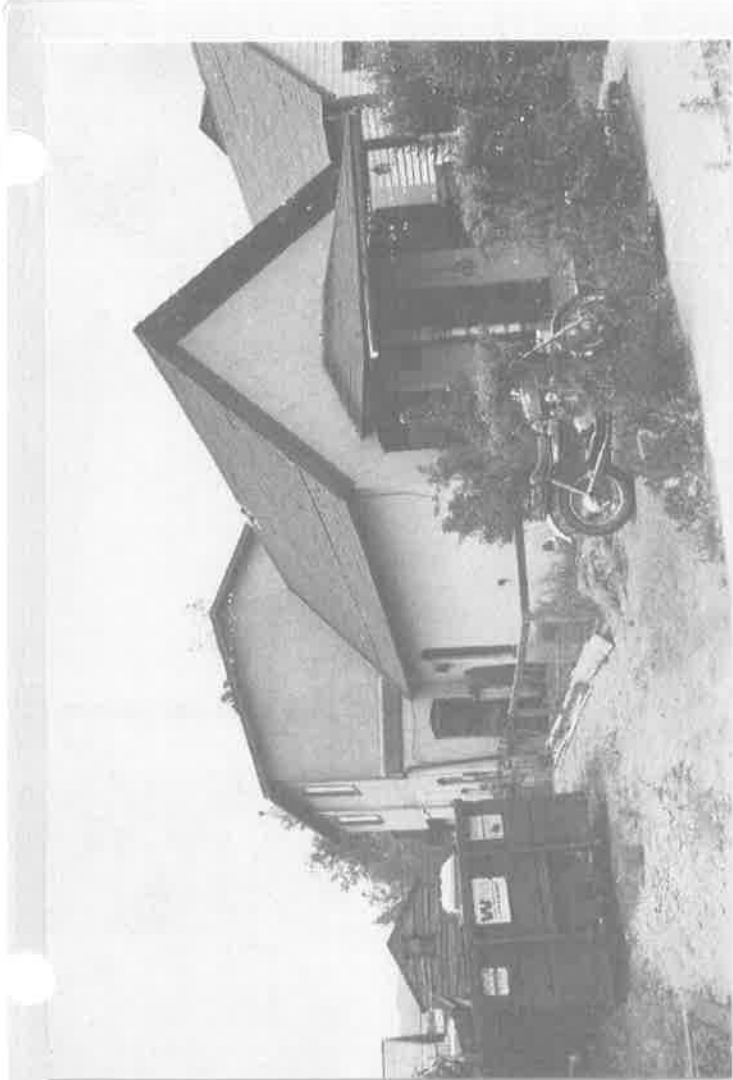
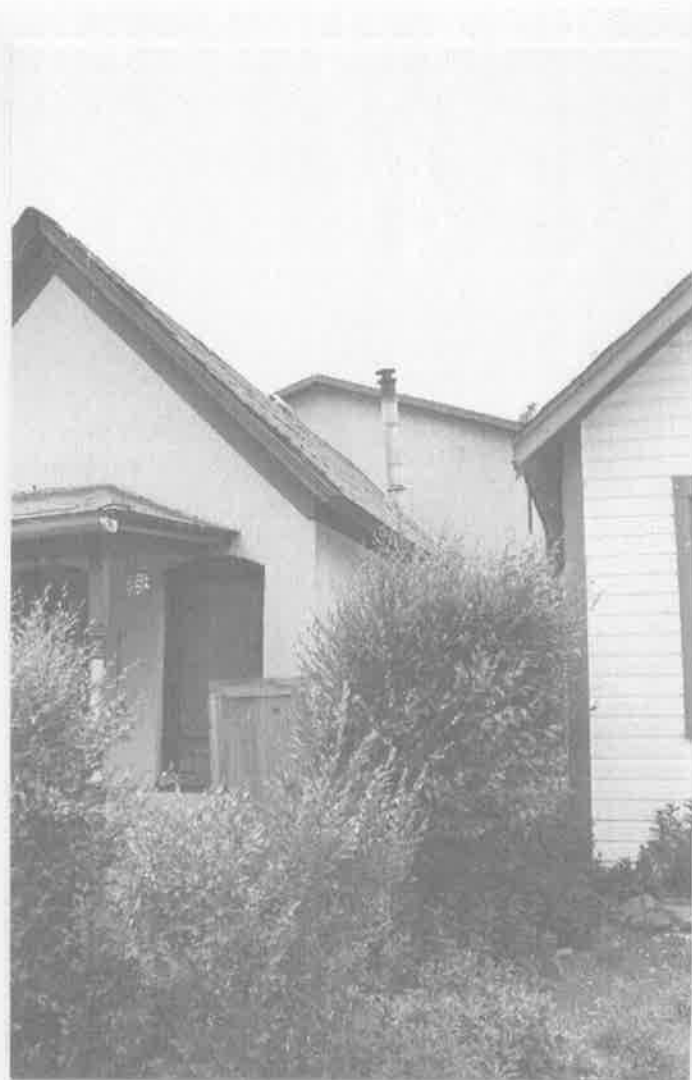
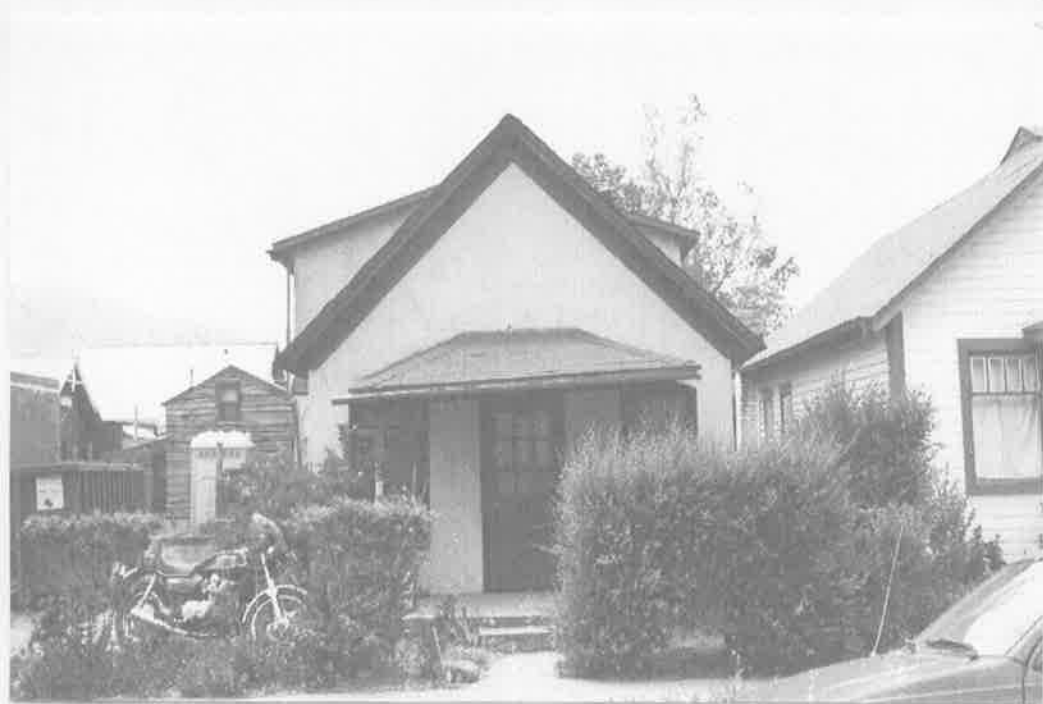
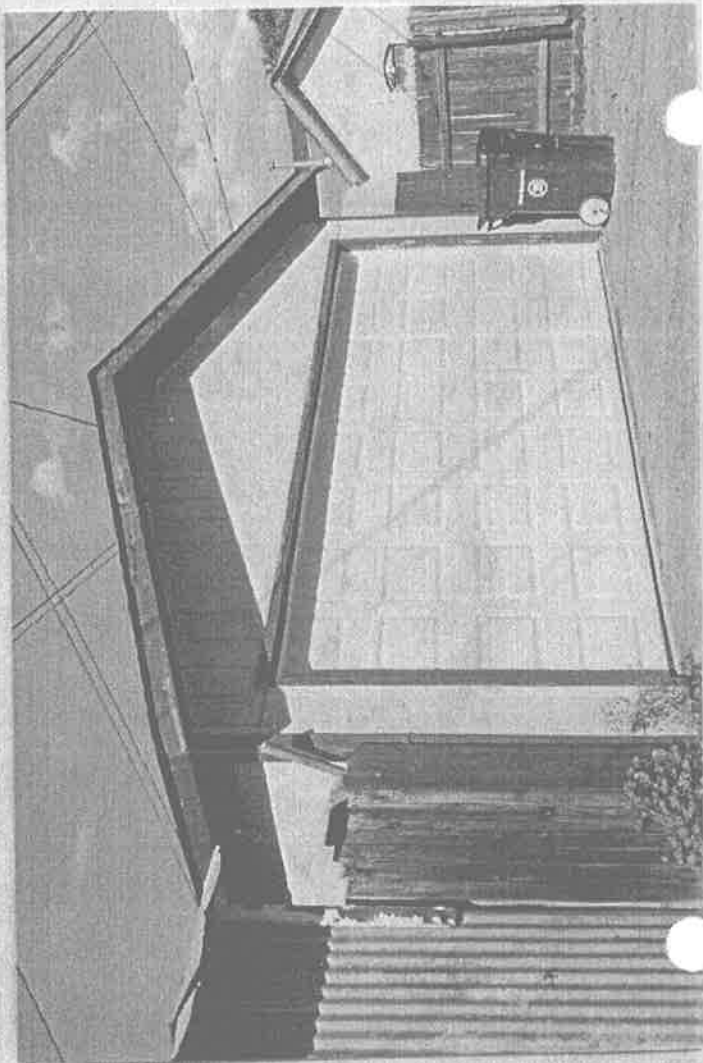
47. Photographic Reference(s): 1: 26-31; 21: 12

Front gable roof dwelling with one-story component at front and two-story component at rear (historically it was one story). Roof has overhanging eaves and composition roofing. Walls are covered with stucco. Facade (north) of front component has plain raking cornice. Center, projecting, hipped roof porch with slender turned spindle supports and concrete deck. Center entrance with door with multiple lights is flanked by segmental arch windows with plate glass lights. East wall of front component has tall segmental arch window toward south end. Rear addition is stepped out toward east and has gabled roof and stucco walls. Segmental arch entrance on first story of north wall of rear component. No windows on upper story of north wall of rear component. At least one segmental arch window on first story of rear component. Two flat arch windows on each wall of second story of rear component.

Assessment of Integrity: This house no longer displays historic physical integrity due to alterations, which include stucco on the walls, replacement of windows, and addition of a second story to the rear projecting component.
