COLORADO CULTURAL RESOURCE SURVEY

# Architectural Inventory Form

1. Resource Number: 5CF2236  
 2. Temporary Resource Number: 89  
 3. County: Chaffee  
 4. City: Salida  
 5. Historic Building Name: Adams/Bergman House  
 6. Current Building Name: N/A  
 7. Building Address: 247 D Street  
 8. Owner Name and Address: Perschbacher, Nicholas P., 8970 County Road 126, Salida, CO 81201
- Parcel Number: 380705129069  
 SHF/CLG Grant Number: CO-06-017

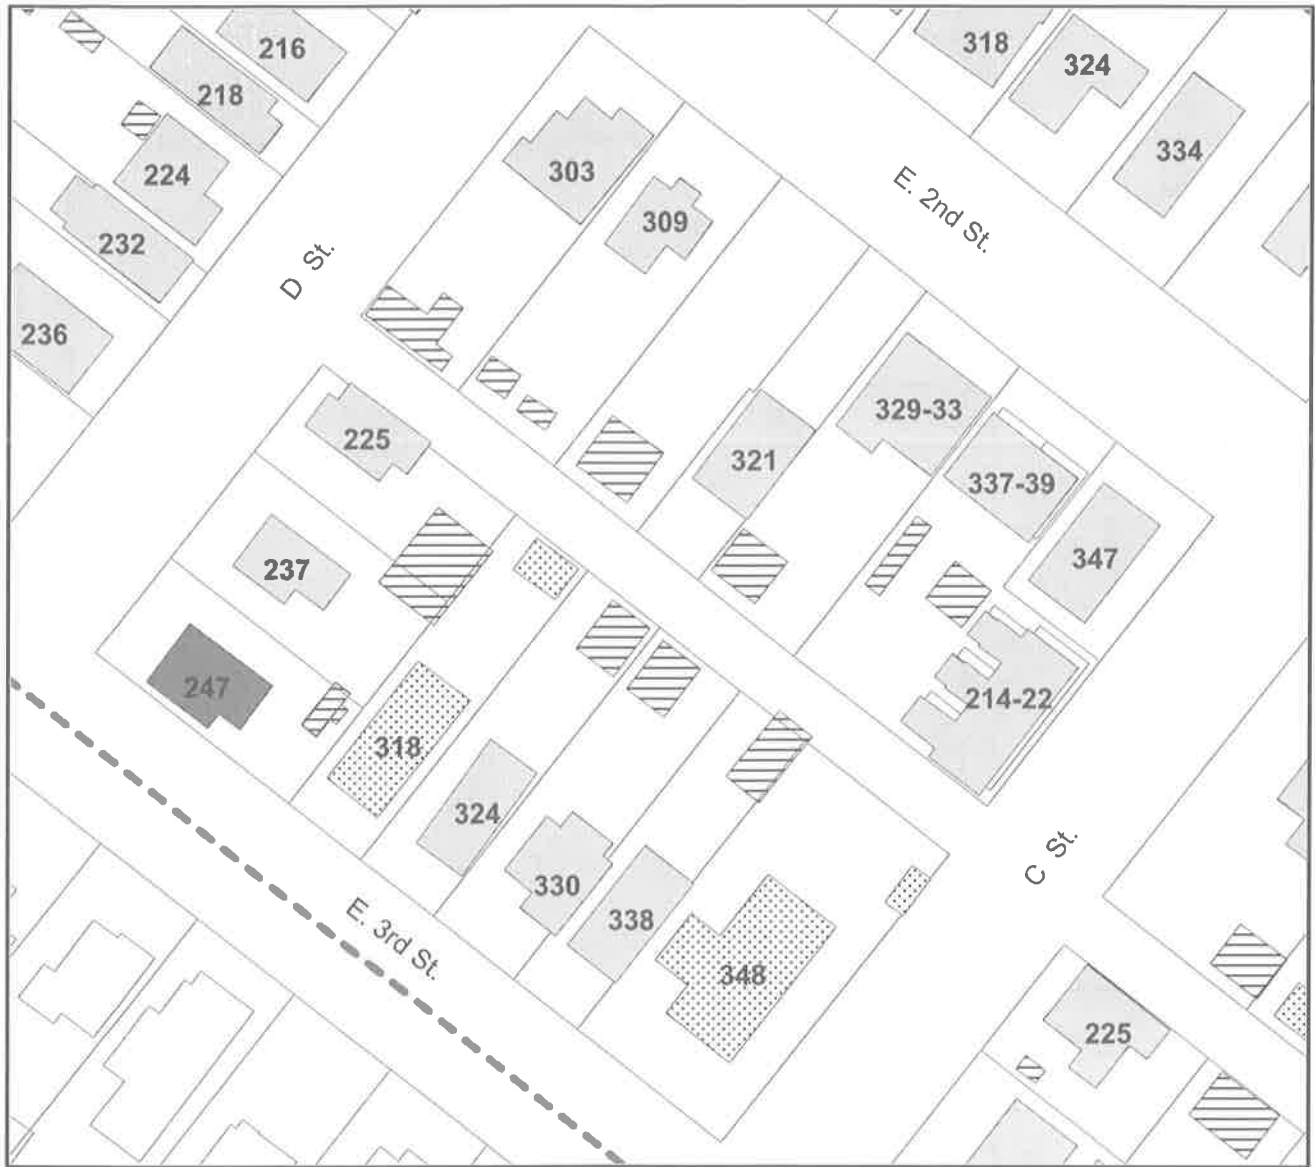
247 D Street

SOURCE: Building outlines from CAD file provided by City of Salida (and supplemented by fieldwork) and overlaid on parcels produced by Chaffee County. The resource described by this survey form is darkly shaded.
