COLORADO CULTURAL RESOURCE SURVEY

Architectural Inventory Form

1. Resource Number: 5CF2270
2. Temporary Resource Number: 11
3. County: Chaffee
4. City: Salida
5. Historic Building Name: Johnson House
6. Current Building Name: N/A
7. Building Address: 307 E. Sackett Avenue
8. Owner Name and Address: Salazar, James and Connie R., 522 W. 2nd St., Salida, CO 81201

48. Report Title: Salida, Colorado, Historic Buildings Survey, 2006-07

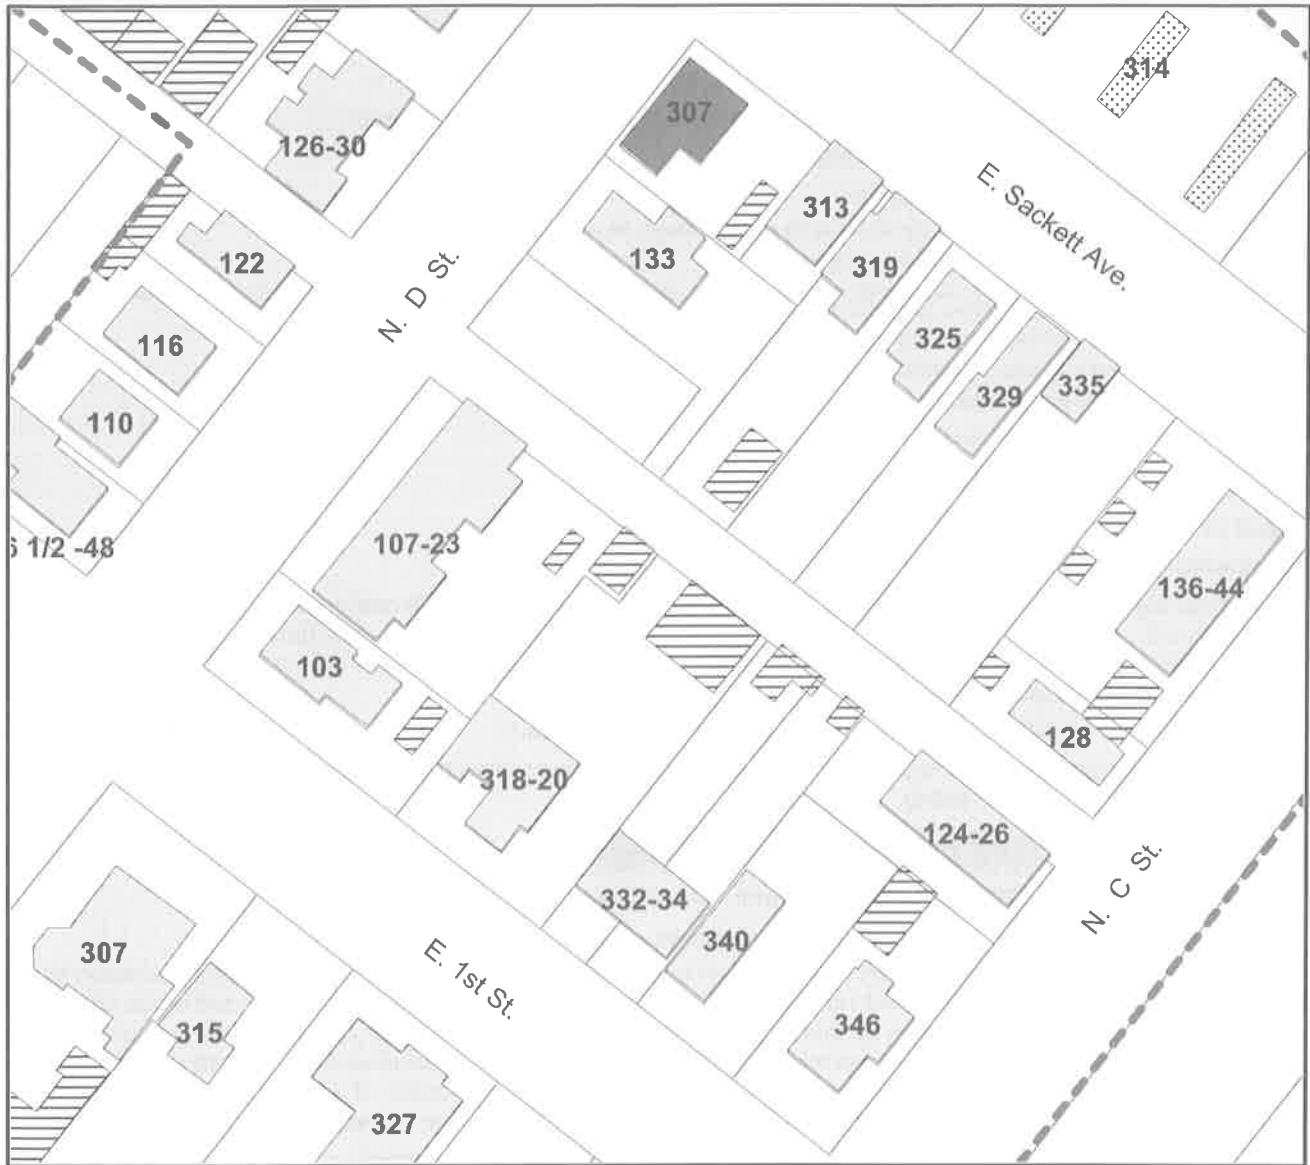
307 E. Sackett Avenue

SOURCE: Building outlines from CAD file provided by City of Salida (and supplemented by fieldwork) and overlaid on parcels produced by Chaffee County. The resource described by this survey form is darkly shaded.
