COLORADO CULTURAL RESOURCE SURVEY

Architectural Inventory Form

| 5. Historic Building Name: Keeton/Blunkall House | |
| 7. Building Address: 309 E. Second Street | |

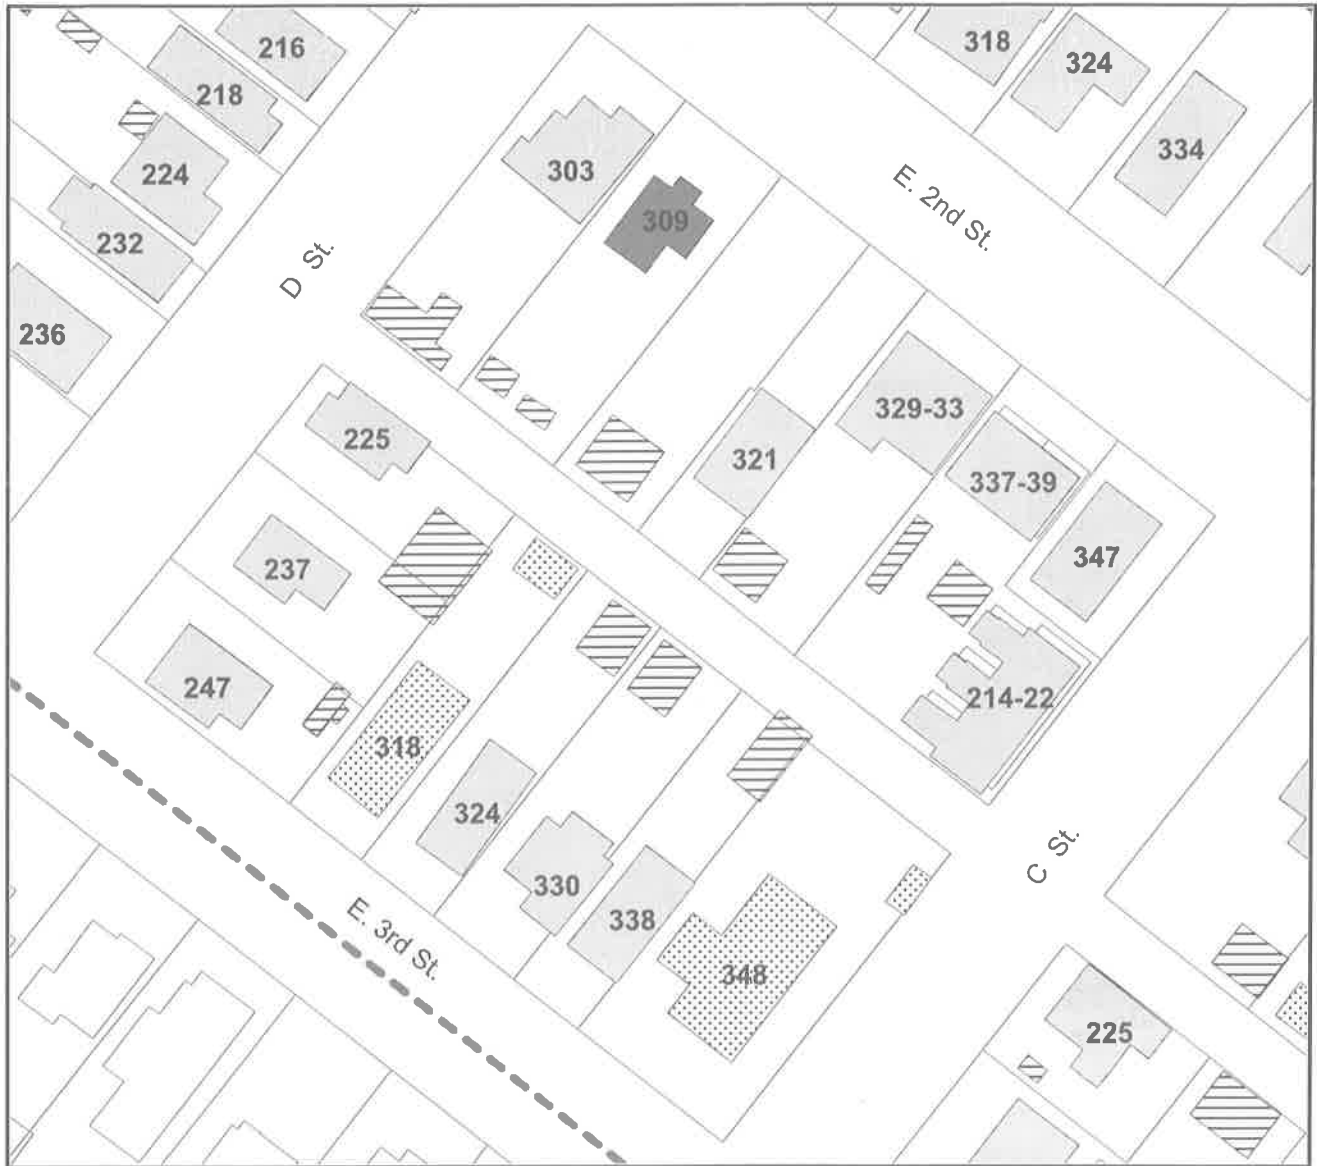
309 E. Second Street

SOURCE: Building outlines from CAD file provided by City of Salida (and supplemented by fieldwork) and overlaid on parcels produced by Chaffee County. The resource described by this survey form is darkly shaded.
