COLORADO CULTURAL RESOURCE SURVEY

# Architectural Inventory Form

- 1. Resource Number: 5CF2273
  - 2. Temporary Resource Number: 8
  - 3. County: Chaffee
  - 4. City: Salida
  - 5. Historic Building Name: Hartbaner/Luna House
  - 6. Current Building Name: N/A
  - 7. Building Address: 325 E. Sackett Avenue
  - 8. Owner Name and Address: Archuleta, Jose B. and Gloria M., P.O. Box 582, Poncha Springs, CO 81242
- Parcel Number: 368132402043  
SHF/CLG Grant Number: CO-06-017

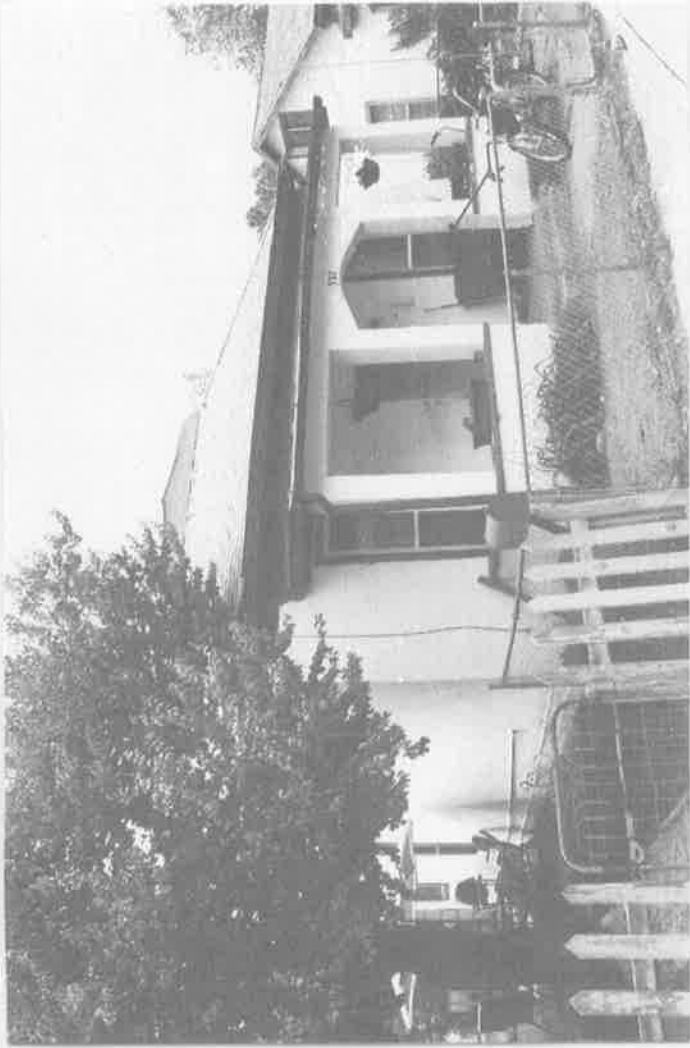
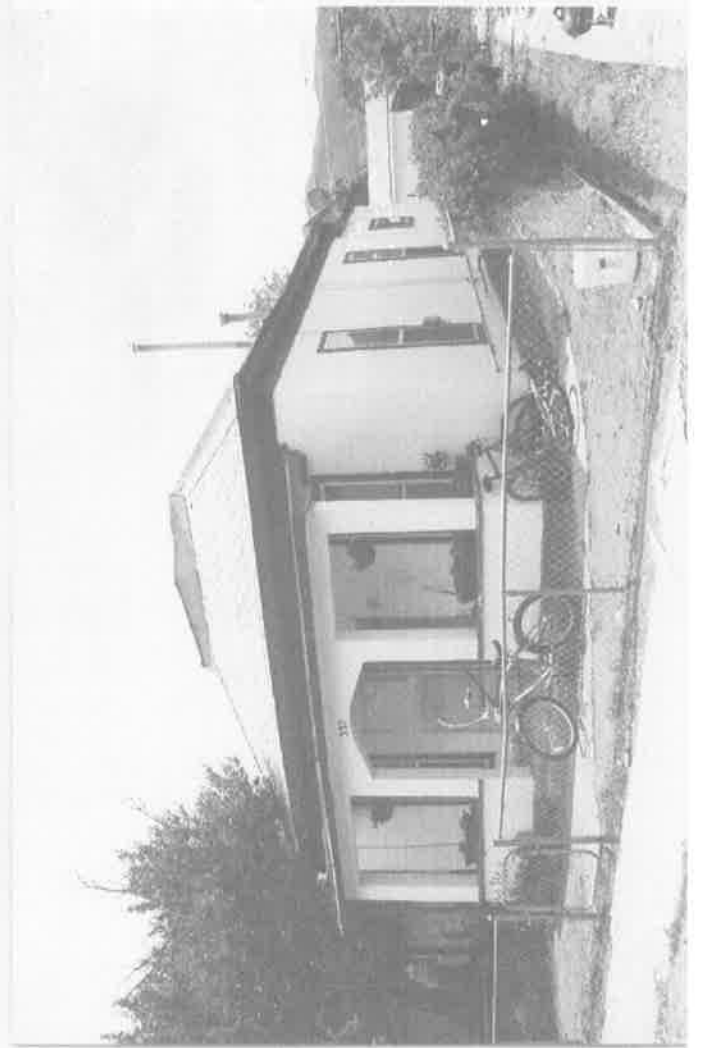
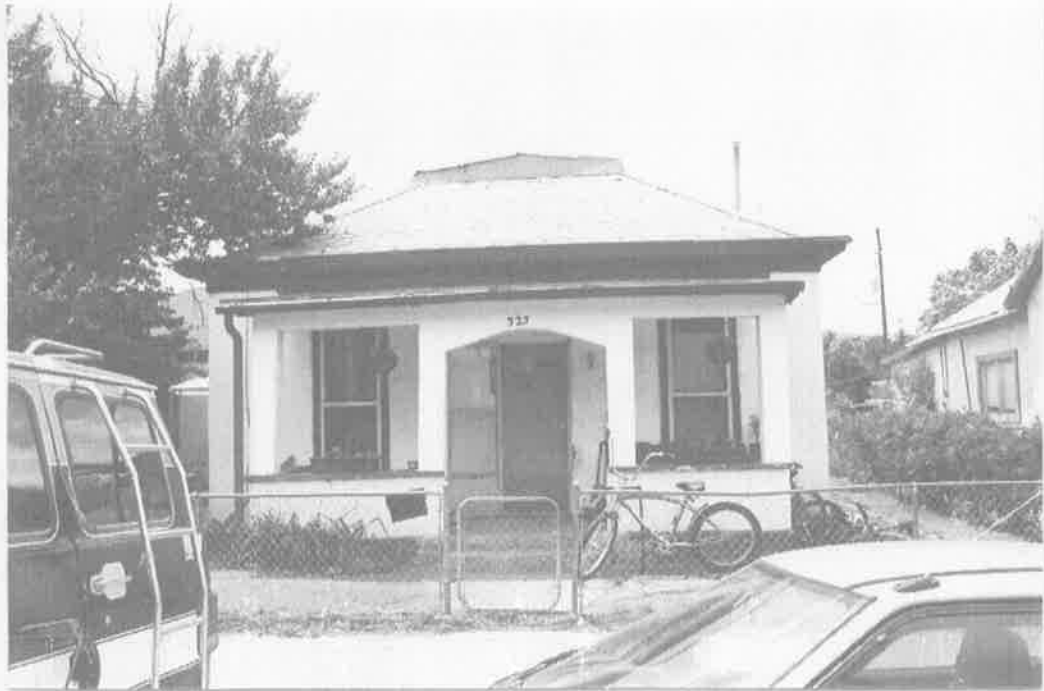
**47. Photographic Reference(s):** 3: 27-32

One-story hipped roof house with center deck, flared overhanging eaves, and composition roofing. Metal pipe chimney on west roof slope. Walls clad with smooth stucco. Façade (north) has projecting shed roof porch with stucco piers atop solid stucco balustrade. Central entrance of porch is arched. Center door is wood with three stepped lights. Flanking entrance are double-hung sash windows. West wall has two tall double-hung sash windows. One-story shed roof projection on rear has sliding window. East wall has double-hung sash and sliding window toward rear. One-story shed roof section at rear on southeast is covered with rolled asphalt.

This house no longer retains historic physical integrity due to alterations, which include stucco on the walls, window alterations, a rebuilt porch, and a missing brick chimney.
