COLORADO CULTURAL RESOURCE SURVEY

Architectural Inventory Form

| 5. Historic Building Name: Carman House | |
| 7. Building Address: 333 F St. | |

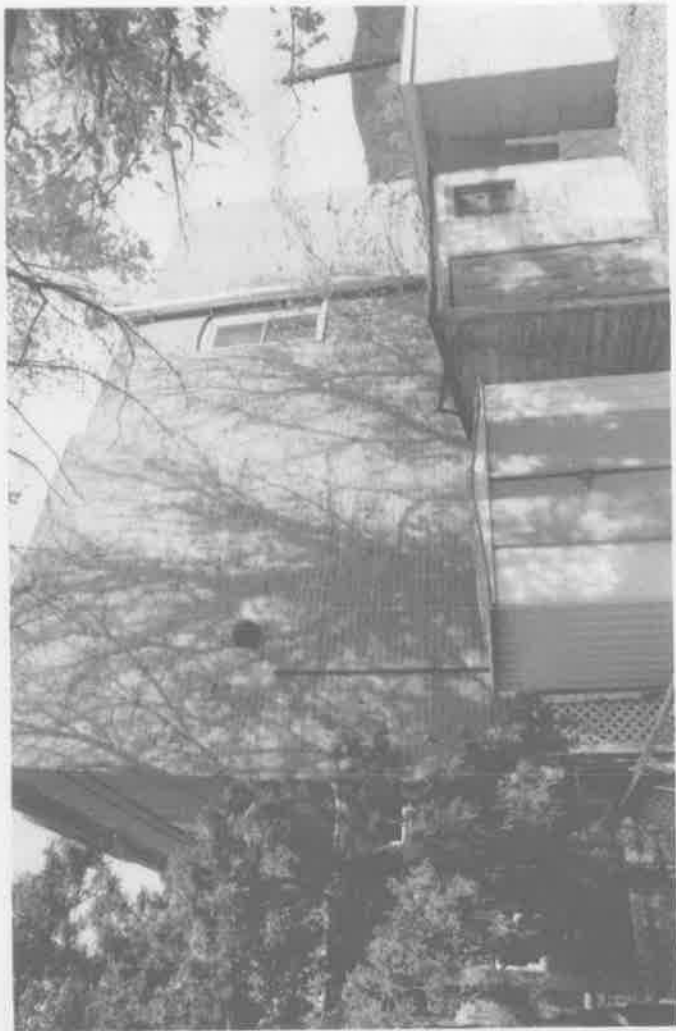
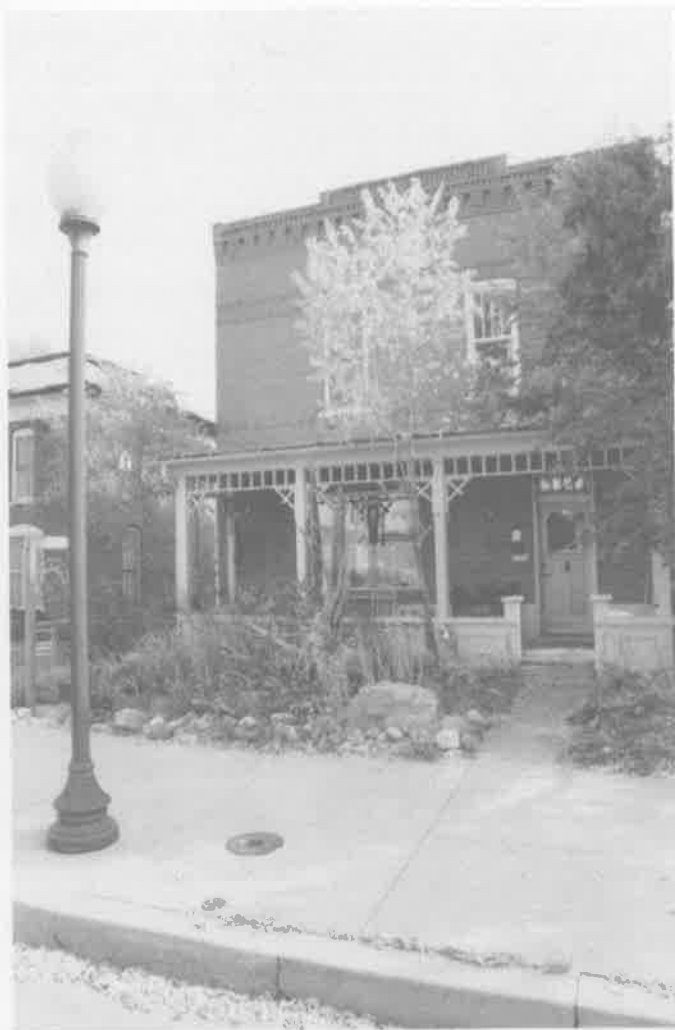
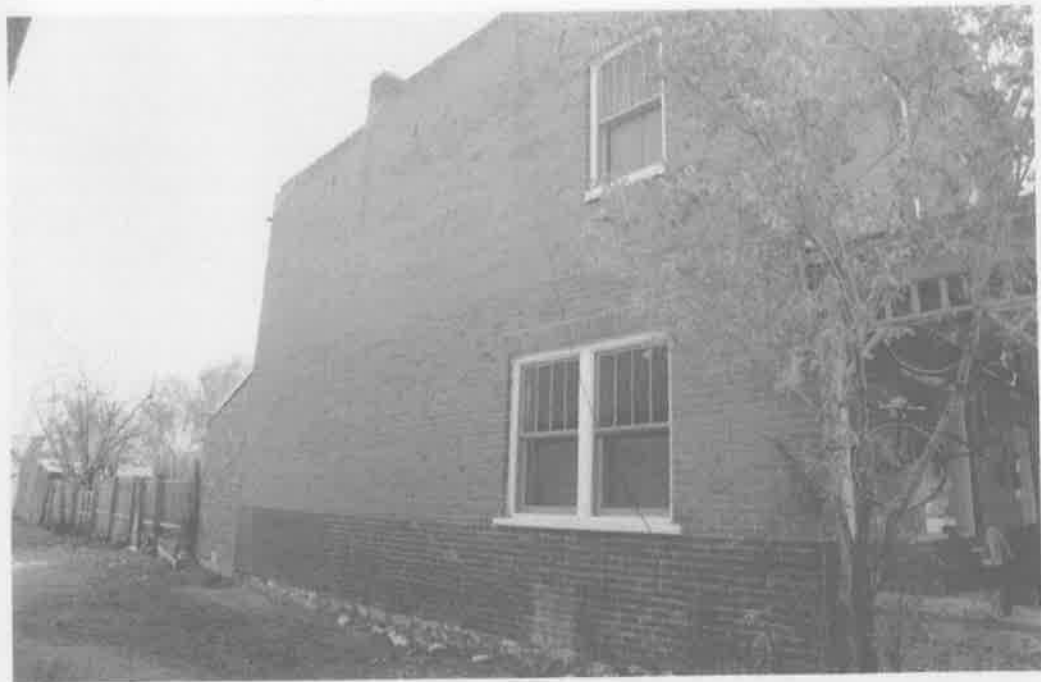
47. Photographic Reference(s): 5: 37; 6: 3, 5

21. General Architectural Description:
 Two-story red brick dwelling with flat roof that is stepped down toward the rear. Front has corbelled brick cornice with band of dentils and a center parapet with decorative brickwork. Second story has two segmental arch 4/1-light double-hung sash windows with wood sills. Decorative lintel course and sill course on second story. First story has full-width, projecting, hipped roof porch with stickwork frieze and slender wood supports with brackets atop low paneled concrete balustrade. Off-center paneled and glazed door with transom. Flat arch picture window north of entrance.

North. North wall has two short chimneys on roof. Second story has 4/1-light double-hung sash flat arch window toward west end, below which are paired 4/1-light double-hung sash windows with a painted, shared sill. The lower wall has a wide section of brick painted dark red. A one-story shed roof brick projection is visible at the rear.

South. South wall has a segmental arch 1/1-light double-hung sash window toward the rear of the second story. There is a tall metal chimney pipe on the wall adjacent the window.
