COLORADO CULTURAL RESOURCE SURVEY

Architectural Inventory Form

1. **Resource Number:** 5CF2309
2. **Temporary Resource Number:** 91
3. **County:** Chaffee
4. **City:** Salida
5. **Historic Building Name:** Gloyd/Fowler/Kincaid House
6. **Current Building Name:** N/A
7. **Building Address:** 338 E. Third Street
8. **Owner Name and Address:** Folsom, Dwane L. and Violet L., 3885 S. Lake Dr., Boynton Beach, FL 33435

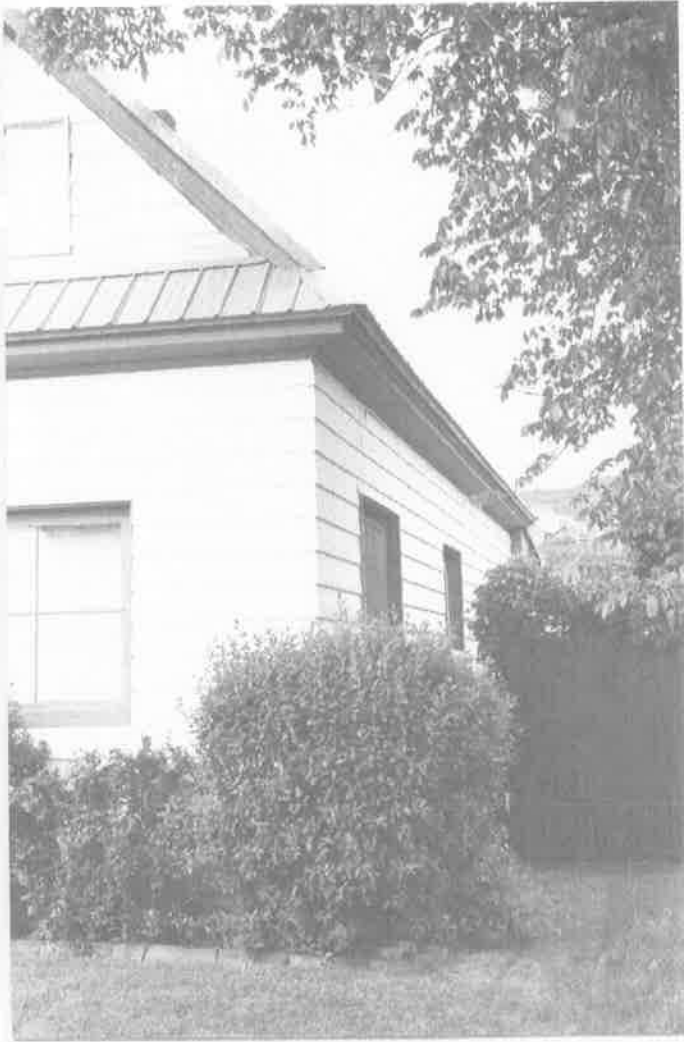
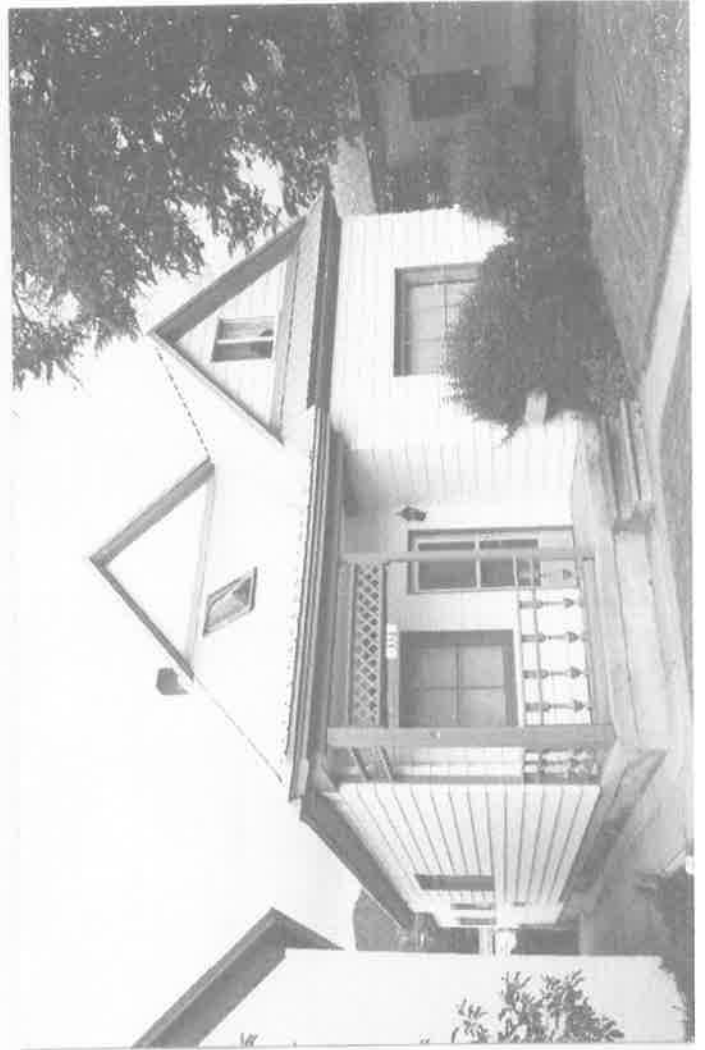
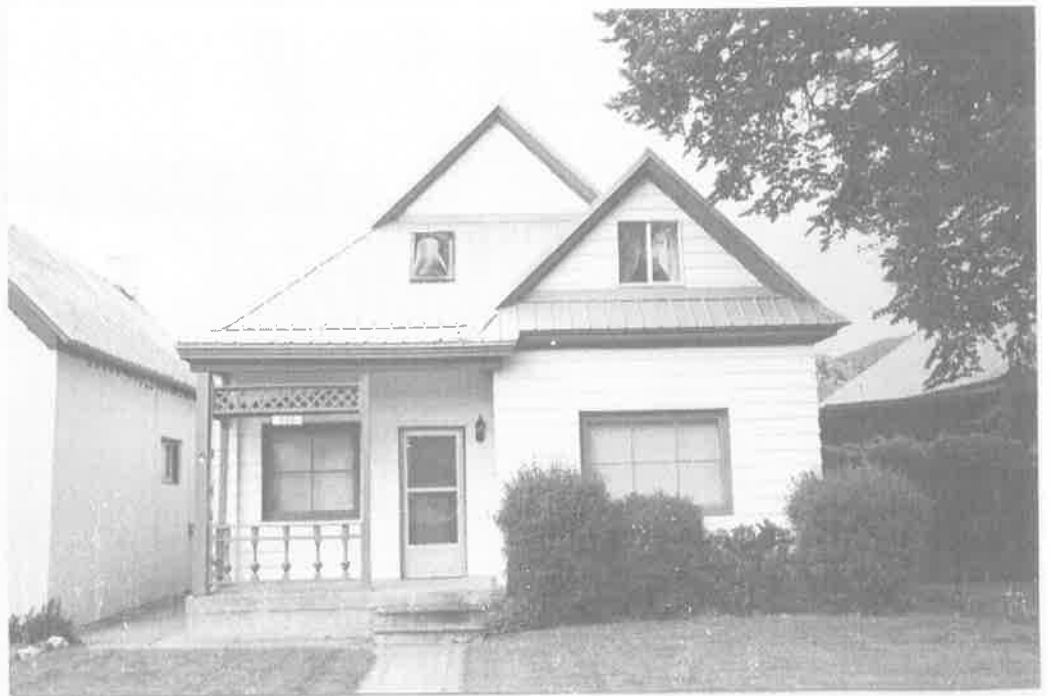
47. **Photographic Reference(s):** 16: 36-37; 17: 2-5

One-story dwelling with gable on hip roof and overlapping projecting gable on façade. Standing seam metal roofing, overhanging eaves, and brick chimney. Walls are clad with wide, nonhistoric, lap siding. Front (south) has shed roof porch at west end with decorative balustrade, lattice lintel, and shaped posts atop a concrete deck with concrete steps. Facing porch is a center paneled and glazed door with aluminum storm door. West of entrance is a large four-light window. East of the porch is a projecting gabled roof bay with lap siding and a sliding window on the gable face; gable is enclosed with a pent roof which shelters the large six-light window on the wall below. There is a skylight on the slope of the roof west of the projecting gable. The east wall has a three-light window and a sliding window. There is a lower frame projection on the rear visible on the west that has two multi-light windows. The west wall has

a casement window.

The house has experienced major alterations which have diminished its historic physical integrity. Notable alterations include: covering the brick walls with wide horizontal siding; covering the shingled gable faces with the same siding; replacing the original round arch windows on the porch and the front projecting gable; replacing the three-light horizontal window on the front gable face with a larger two-light slider; removing the brick porch pier at the southwest corner as well as the original frieze and balustrade; and replacing the roofing with standing seam metal and installing a skylight on the front roof place above the porch.
