COLORADO CULTURAL RESOURCE SURVEY  
**Architectural Inventory Form**

1. Resource Number: 5CF2035  
2. Temporary Resource Number: 5  
3. County: Chaffee  
4. City: Salida  
5. Historic Building Name: Wheeler House  
6. Current Building Name: David Wancura, Certified Public Accountant  
7. Building Address: 348 E St.  
8. Owner Name and Address: WANCURA DAVID, WANCURA MARIANNE, 932 F STREET, SALIDA, CO 81201

**48. Report Title:** Salida, Colorado, Historic Buildings Survey, 2005-06

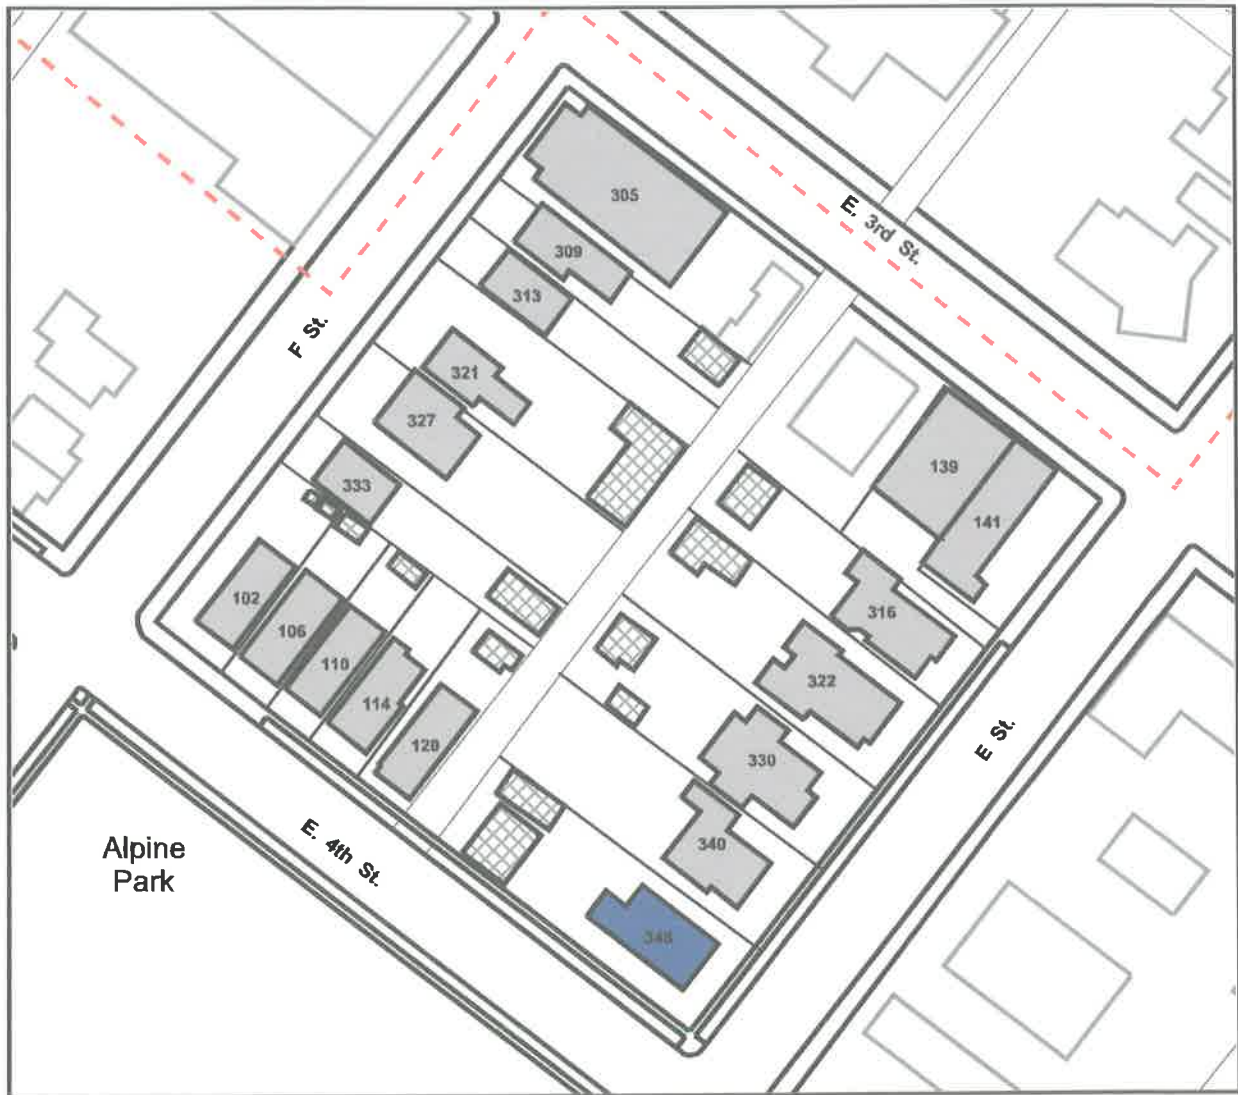
348 E Street

SOURCE/NOTE: Based on CAD file supplied by the Town of Salida. The darker-shaded resource is described by this survey form. Other resources surveyed in this project are shaded gray. Associated outbuildings (if any) are crosshatched. Resources not included in this project are not shaded. Dashed line is boundary of Salida Downtown Historic District.
