COLORADO CULTURAL RESOURCE SURVEY

# Architectural Inventory Form

1. Resource Number: 5CF2296 Parcel Number: 380705125030  
2. Temporary Resource Number: 63 SHF/CLG Grant Number: CO-06-017  
3. County: Chaffee  
4. City: Salida  
5. Historic Building Name: Wilcox Terrace  
6. Current Building Name: N/A  
7. Building Address: 410-12 E. Second Street  
8. Owner Name and Address: McCormick, Robert H., P.O. Box 478, Salida, CO 81201

48. Report Title: Salida, Colorado, Historic Buildings Survey, 2006-07

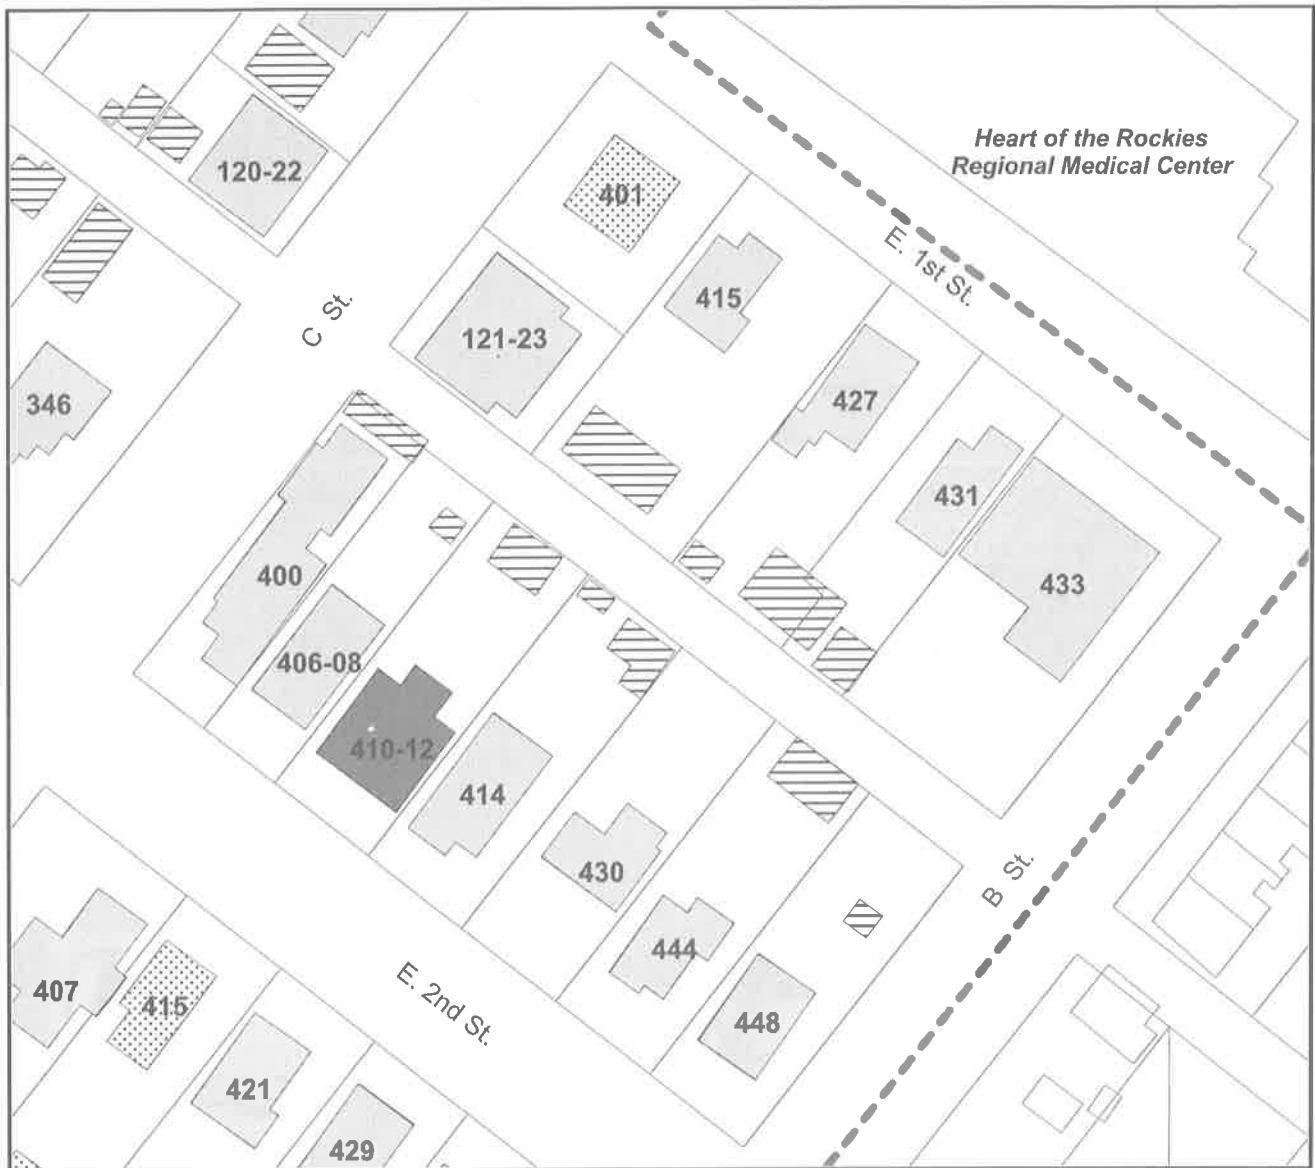
410-12 E. Second Street

SOURCE: Building outlines from CAD file provided by City of Salida (and supplemented by fieldwork) and overlaid on parcels produced by Chaffee County. The resource described by this survey form is darkly shaded.
