COLORADO CULTURAL RESOURCE SURVEY

Architectural Inventory Form

1. Resource Number: 5CF2043 Parcel Number: 380705160531
 2. Temporary Resource Number: 12 SHF/CLG Grant Number: CO-05-018
 3. County: Chaffee
 4. City: Salida
 5. Historic Building Name: Ryan/Ahern House
 6. Current Building Name: Jacobson House
 7. Building Address: 420 F St.
 8. Owner Name and Address: JACOBSON THOMAS A, , 420 F ST, SALIDA, CO 81201

48. Report Title: Salida, Colorado, Historic Buildings Survey, 2005-06

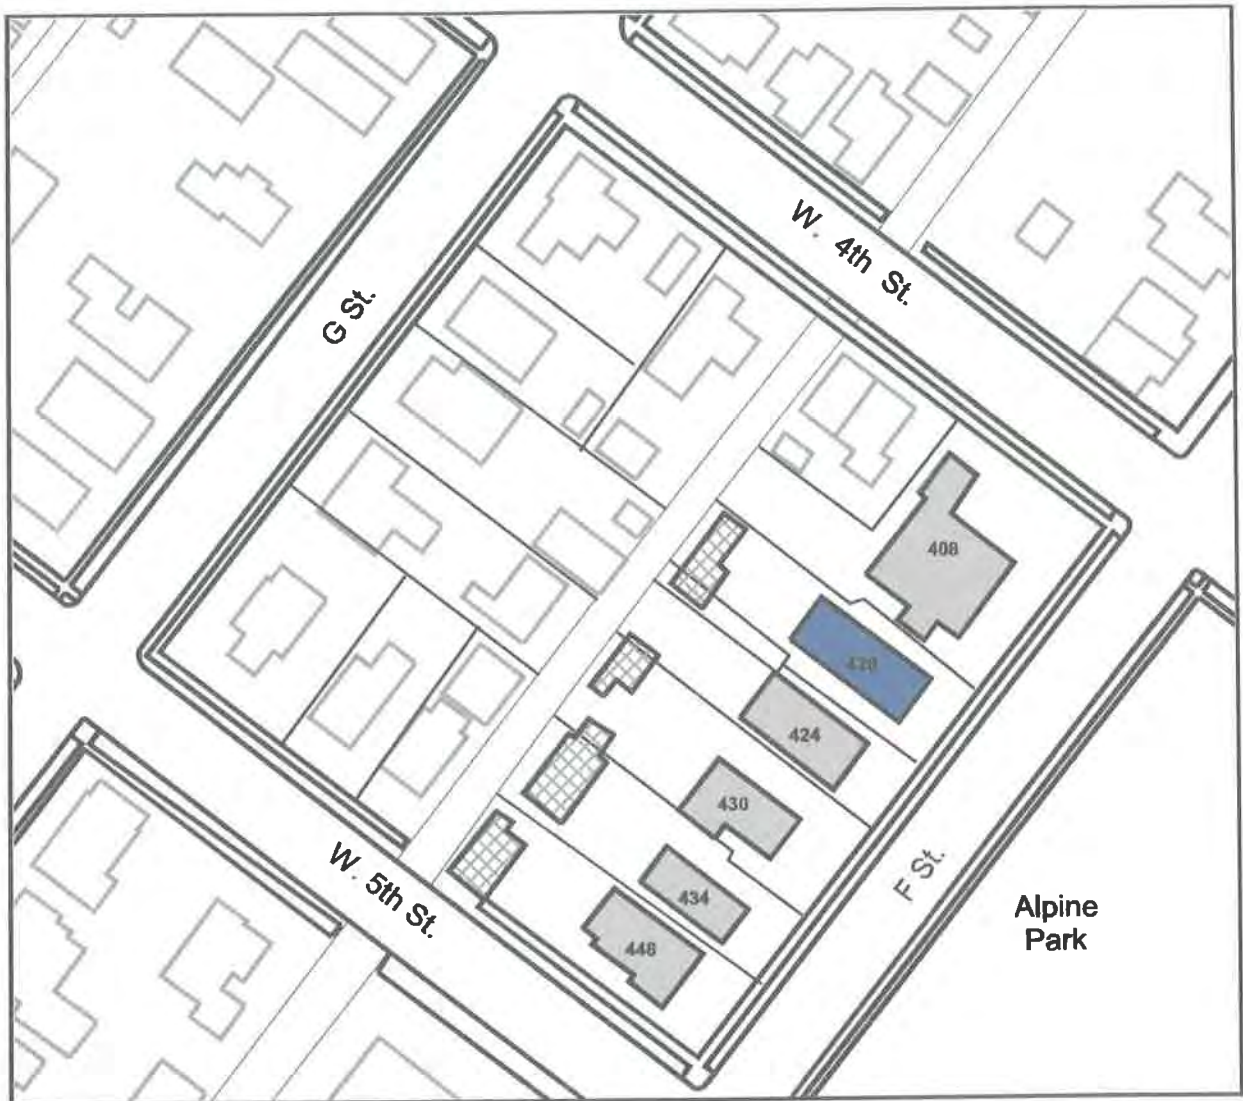
420 F Street

SOURCE/NOTE: Based on CAD file supplied by the Town of Salida. The darker-shaded resource is described by this survey form. Other resources surveyed in this project are shaded gray. Associated outbuildings (if any) are crosshatched. Resources not included in this project are not shaded. Dashed line is boundary of Salida Downtown Historic District.
