COLORADO CULTURAL RESOURCE SURVEY

Architectural Inventory Form

| 5. Historic Building Name: Hartman/Stewart/Glenn House | |
| 7. Building Address: 421 E. Second Street | |

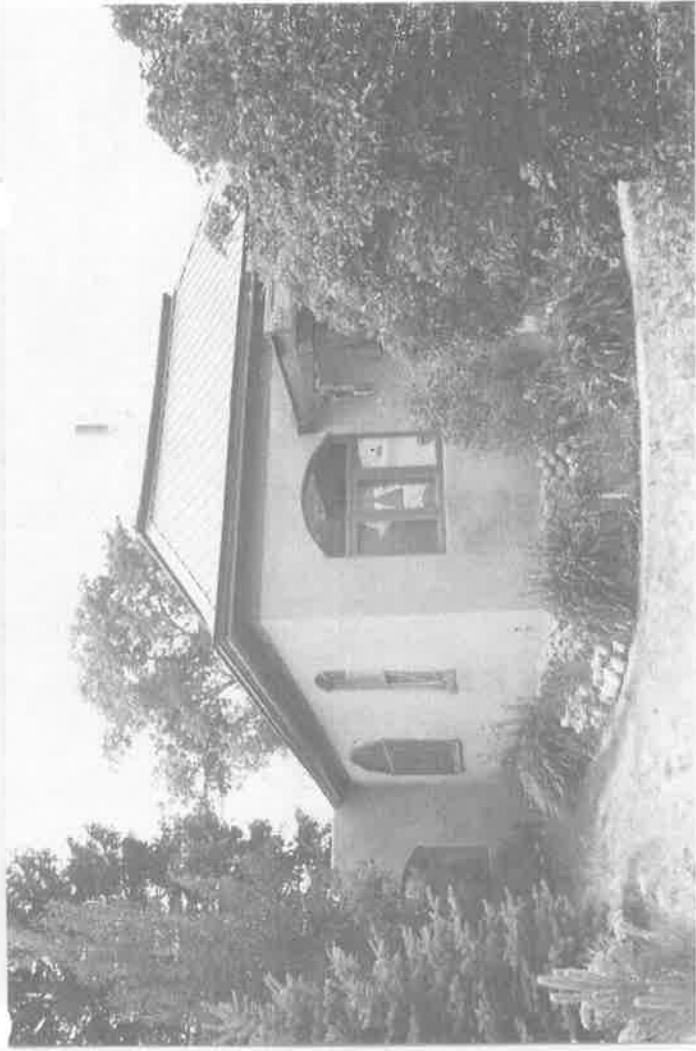
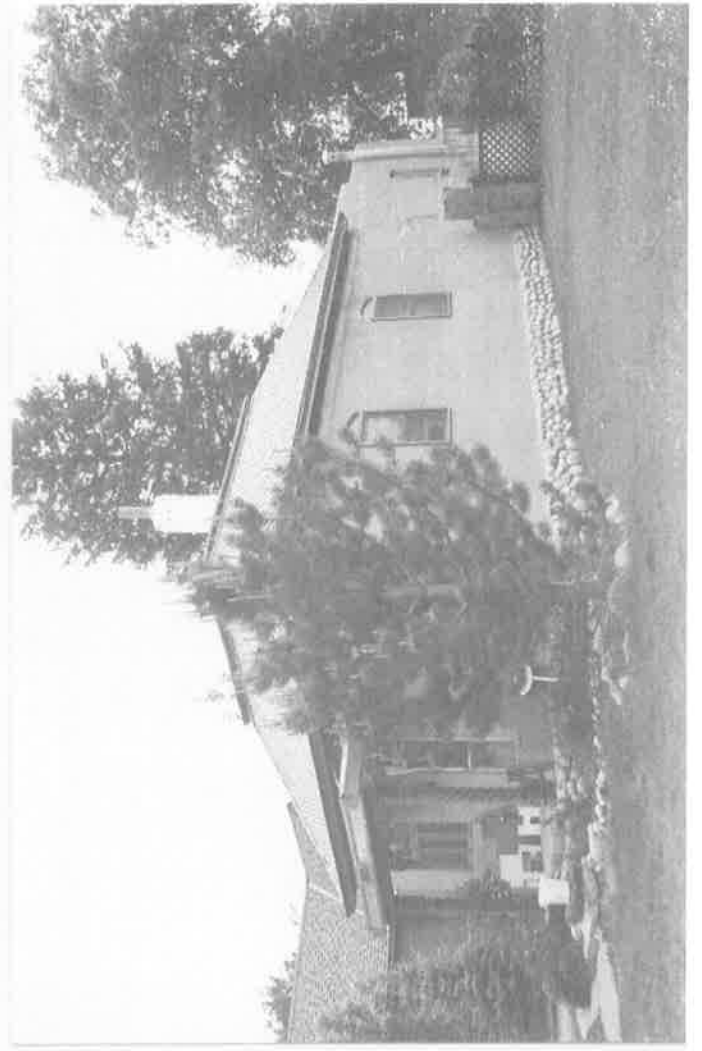
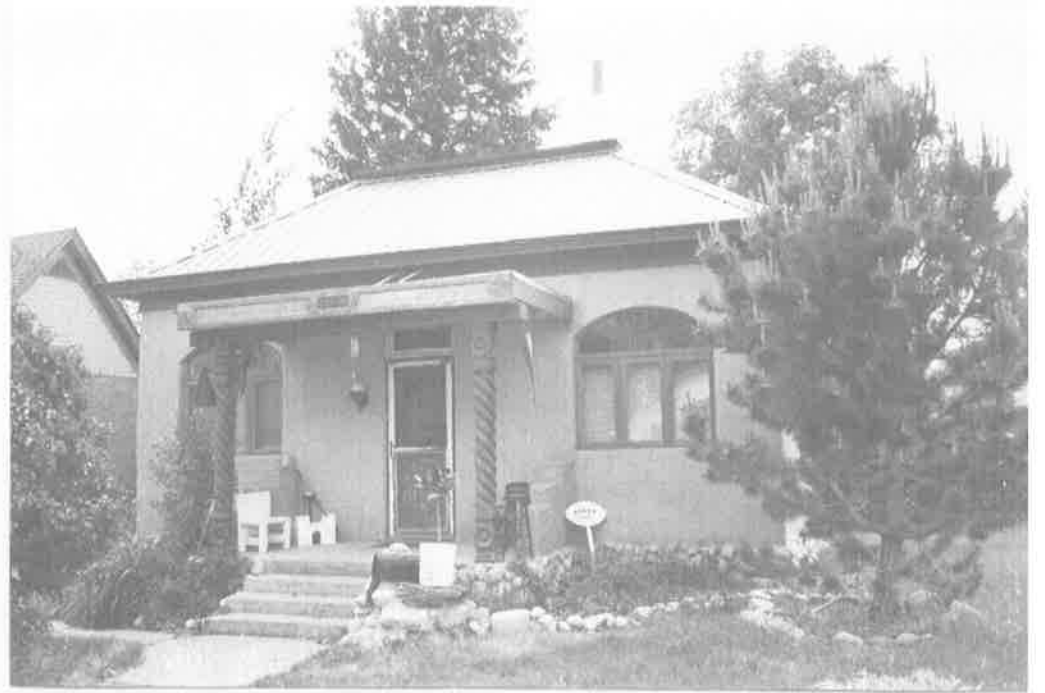
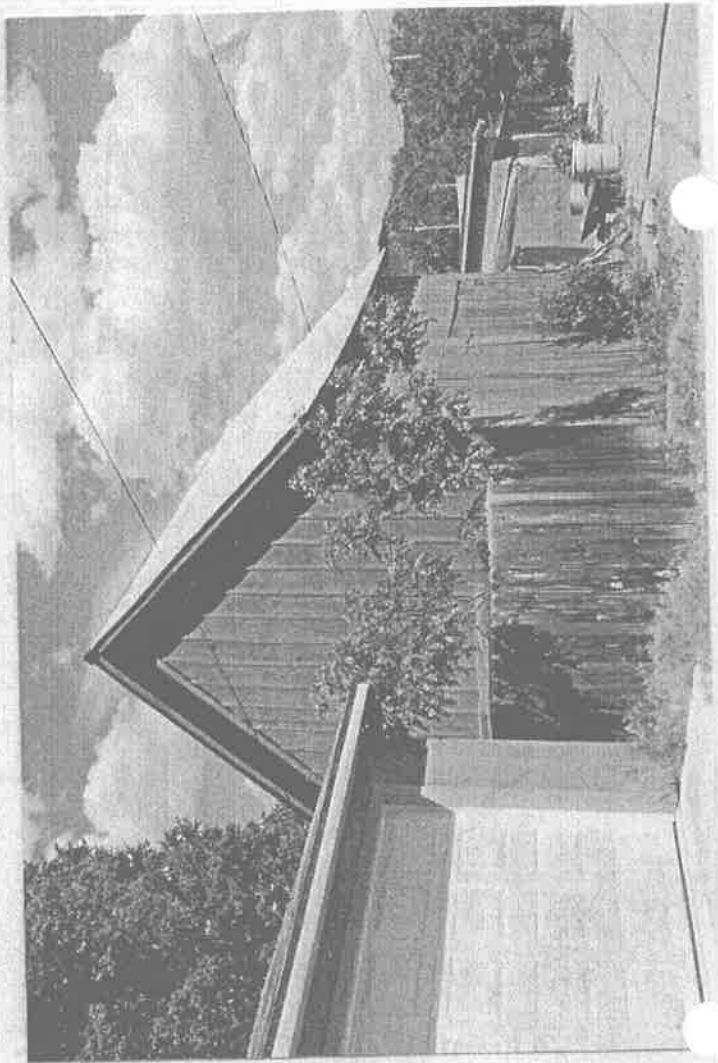
47. Photographic Reference(s): 12: 10-15; 19: 3

One-story dwelling with hipped roof with center deck, overhanging eaves, standing seam metal roofing, and center painted brick chimney. Walls are clad with stucco; wide, plain, wood cornice at top of walls. Façade (north) has center, projecting porch with spiral column supports, flat roof, and concrete deck and steps. River rock placed along sides of porch deck, steps, and foundation. Center entrance with paneled and glazed door and rectangular transom. Flanking porch are wide arched apertures with transoms above triple casement windows. East wall has segmental arch 1/1-light double-hung sash window toward front and wide, arched, tripartite window toward rear. At rear is one-story, flat roof, stucco projection with arched window (like those on front) facing north. West wall has two short double-hung sash windows. Inset from west wall at rear one-story flat roof projection is visible, with glass block

window, segmental arch window, and metal pipe chimney.

Alterations have diminished the historic physical integrity of this house. Changes include stuccoing of the walls, removal and replacement of the original front porch, replacement of windows, installation of cobblestone facing on the foundation, and metal standing seam roofing.
