COLORADO CULTURAL RESOURCE SURVEY

Architectural Inventory Form

1. **Resource Number:** 5CF2262
2. **Temporary Resource Number:** 69
3. **County:** Chaffee
4. **City:** Salida
5. **Historic Building Name:** Hamm House
6. **Current Building Name:** Winters House
7. **Building Address:** 431 E. First Street
8. **Owner Name and Address:** Sterrett, Linda L. and Dickey, Robert Alexander, c/o Mary L. Winters, 431 E. 1st St.,
Salida, CO 81201

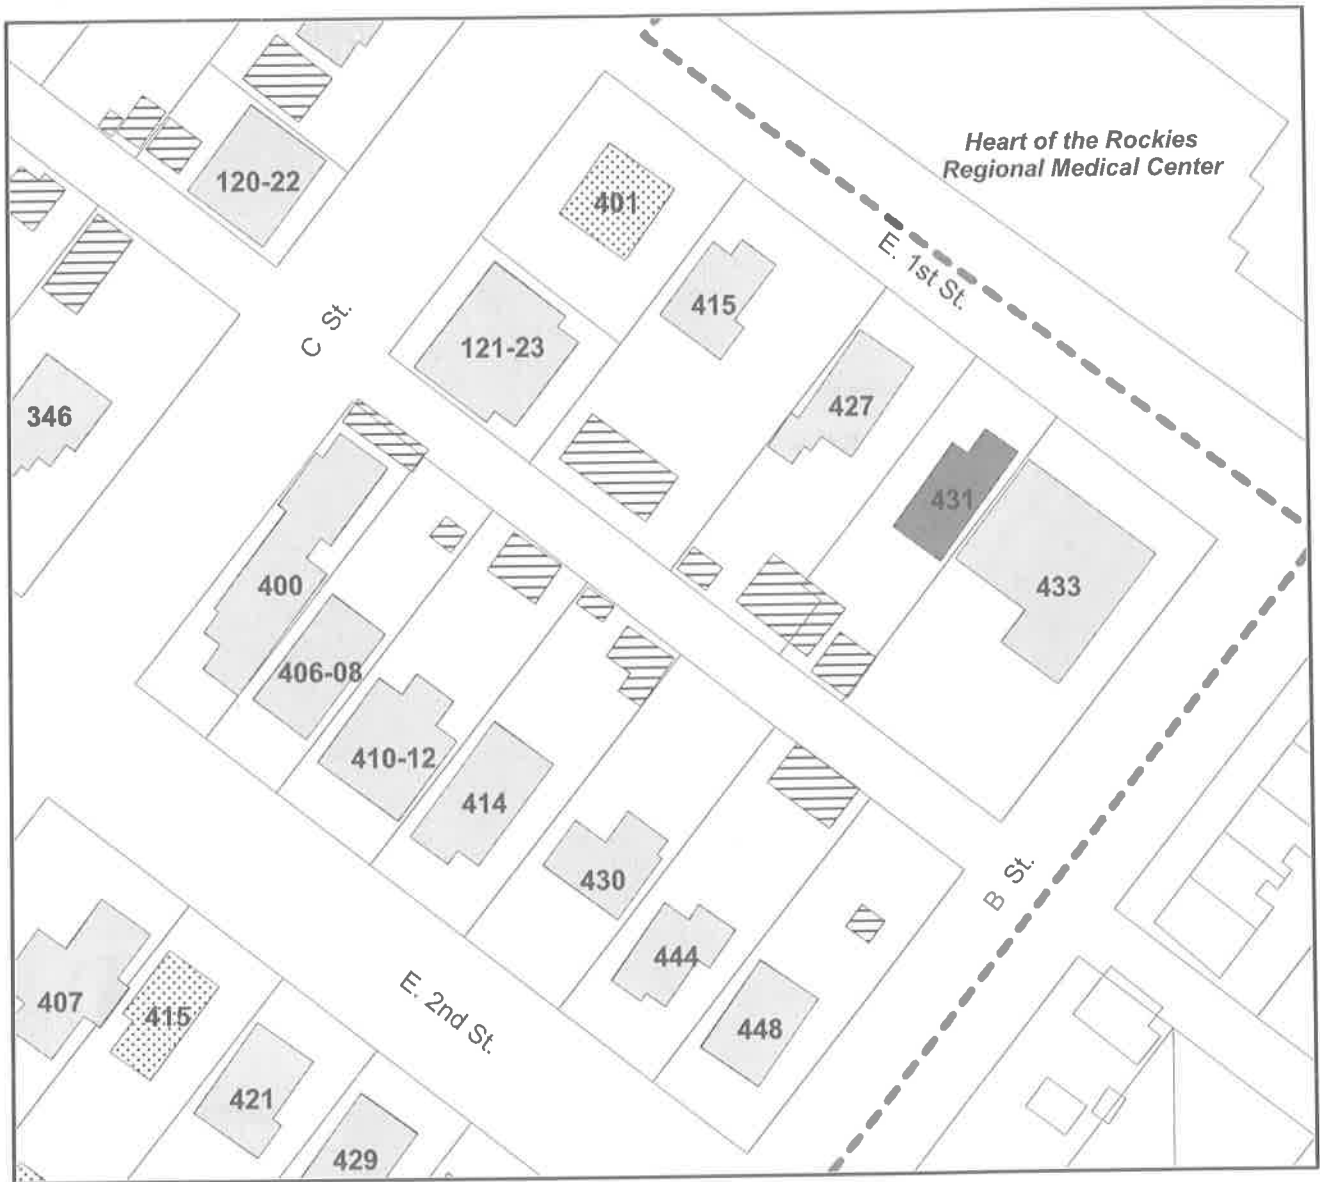
431 E. First Street

SOURCE: Building outlines from CAD file provided by City of Salida (and supplemented by fieldwork) and overlaid on parcels produced by Chaffee County. The resource described by this survey form is darkly shaded.
