ARCHITECTURAL/HISTORICAL COMPONENT FORM

- 1) Resource No. 5CF274 2) Temp No. 63 3) Name Commercial Building
(apartments upstairs)
4) Address 100 blk. E. Sackett St 5) District Name Salida Commercial District
south side
I. INTEGRITY: 6) Condition: Good Fair Deteriorated
7) Original Use commercial property 8) Present Use commercial property
9) Original Site Moved Date(s) of Move: _____
10) Unaltered Altered Explain: _____

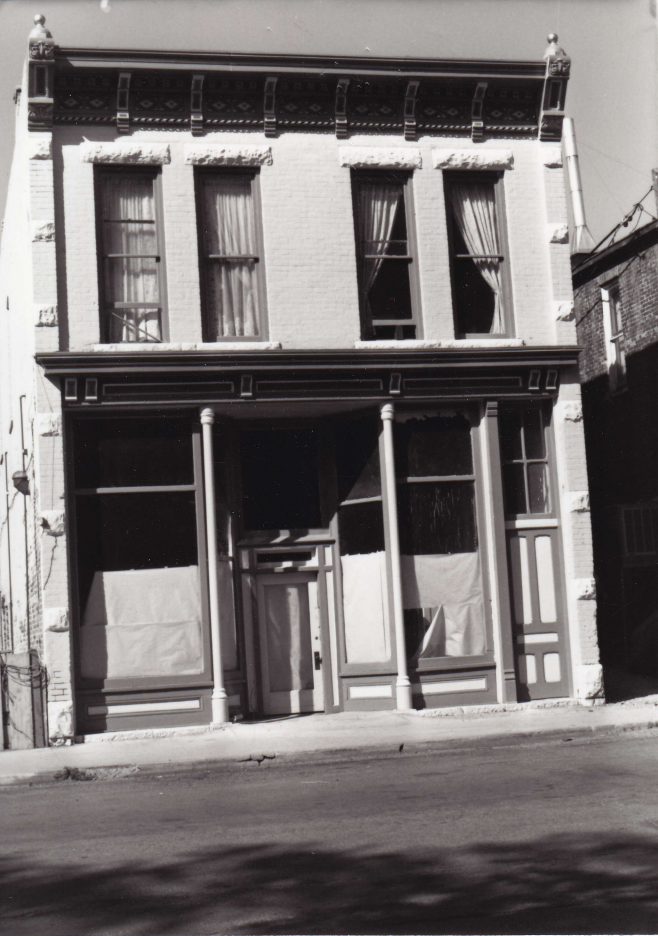
Frame Number 13
Roll Number CF4
Facade Orientation N

Within Salida, this two story brick structure is a fine intact example of late nineteenth century commercial architecture. The building is distinguished by a richly decorated bracketed cornice, four window openings on the second floor accented by rough cut stone lintels and sills, and a continuous lintel separating the upper floor from the storefront area. The storefront area displays the features common to nineteenth century commercial structures - a recessed entrance, flanking display windows, kickplates (panels beneath the display windows), and iron support columns. On this particular structure, a side entrance is also evident.
