ARCHITECTURAL/HISTORICAL COMPONENT FORM

1) Resource No. 5CF260 2) Temp No. 49 3) Name former Salida Drugs/The Closet
 4) Address 100 blk. F Street, east side 5) District Name Salida Commercial District

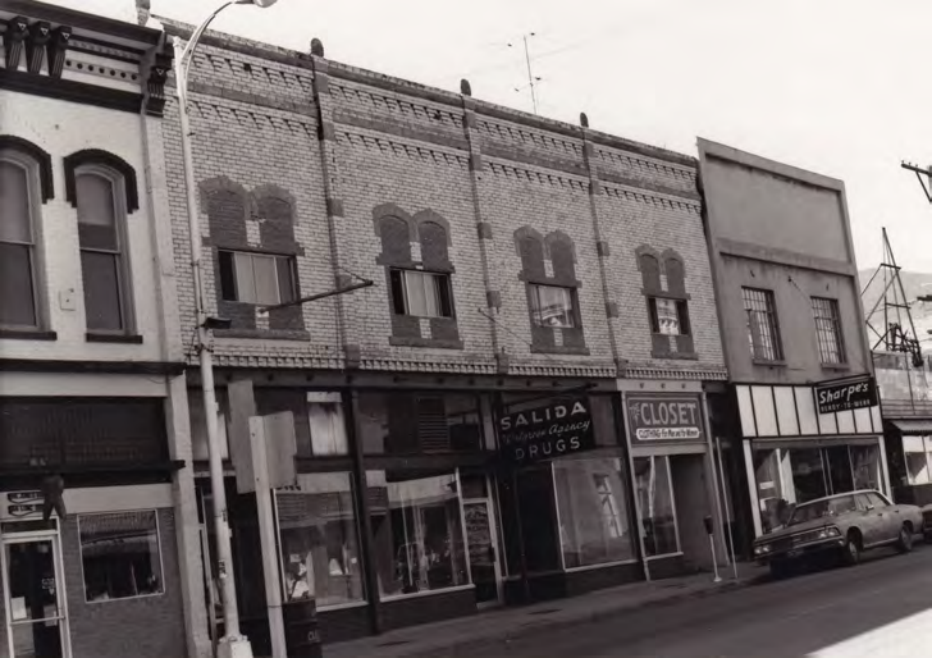
Frame Number	<u>18</u>
Roll Number	<u>CF3</u>
Facade Orientation	<u>W</u>

10) Unaltered Altered Explain: Second floor windows modified; brick and wood siding over portions of lower facade; The building is currently being rehabilitated after a fire.

A two story brick commercial building which features a four part facade. On the second floor the paired segmental openings (these have been partially bricked in) are separated by narrow pilasters which rise to the roof line. Parallel rows of brick corbelling provide additional decorative details. At the storefront level, only minor alterations obscure the original features.
