ARCHITECTURAL/HISTORICAL COMPONENT FORM

1) Resource No. 5CF241 2) Temp No. 30 3) Name IOOF Lodge
4) Address 113 E. First St. 5) District Name Salida Commercial District

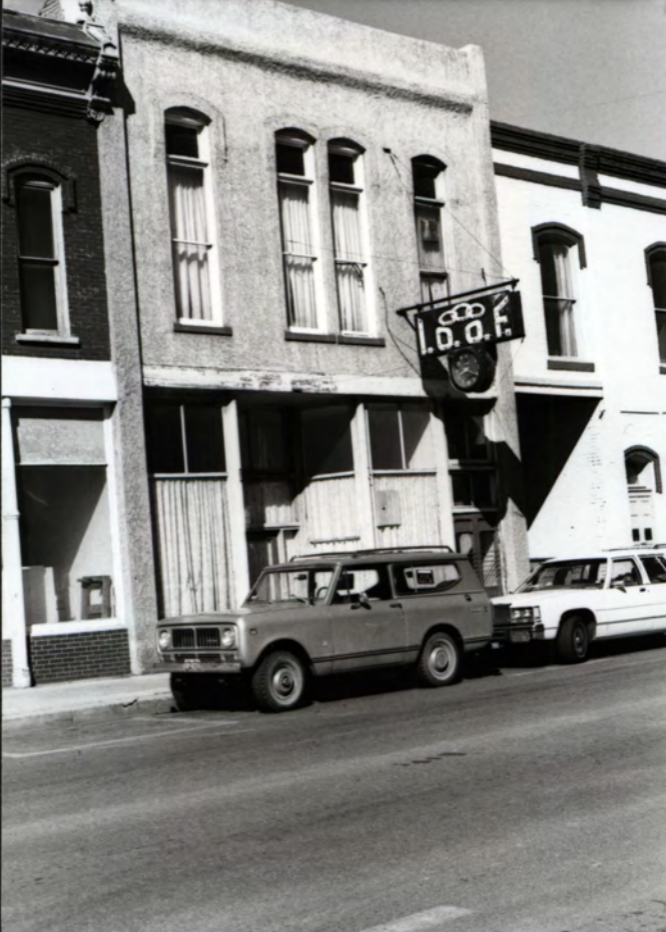
Frame Number 12
 Roll Number CF 2
 Facade Orientation N

10) Unaltered Altered Explain: Stucco over original brick facade.
Brick siding over kickplates (panels beneath display windows).

Although the IOOF Building has been stuccoed, it retains its original features and thus plays a contributing role in the district. The building is characterized by four segmental arch bays which are arranged 1-2-1. The bays are double hung with a transom. At the storefront level, a lintel separates the commercial entrance from the upper floor. The storefront features a recessed entrance flanked by large display windows. A side entrance to the second story which housed the IOOF Hall is also visible.
