ARCHITECTURAL/HISTORICAL COMPONENT FORM

1) Resource No. 5CF269 2) Temp No. 58 3) Name Master Printers/Storage
4) Address 114 E. First 5) District Name Salida Commercial District

7) Original Use commercial property 8) Present Use commercial property

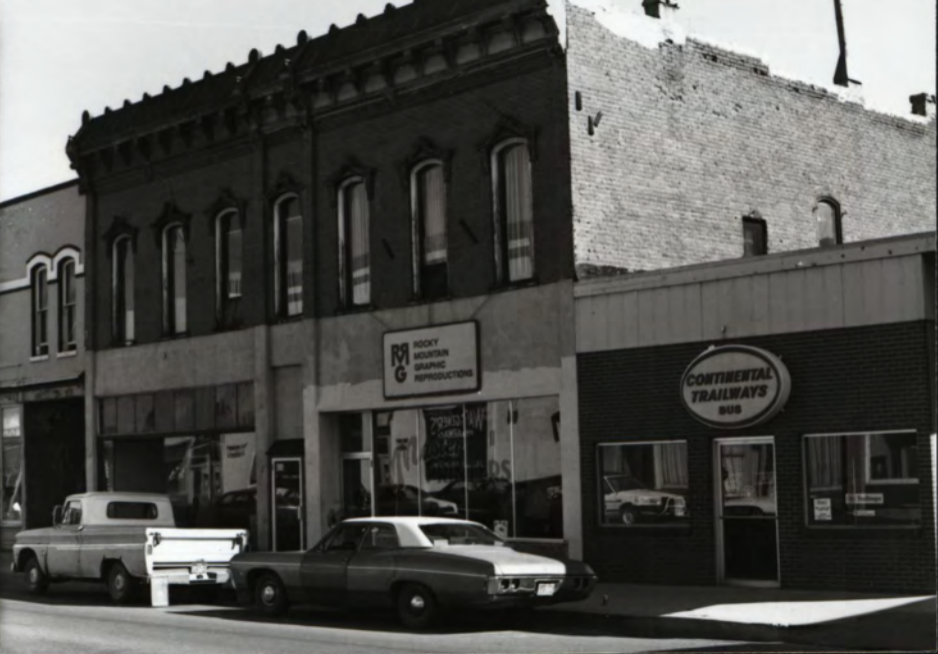
Frame Number 8
 Roll Number CF4
 Facade Orientation S

10) Unaltered Altered Explain: Stucco, brick siding over large
portion of lower facade

This two story brick commercial structure is distinguished by a stamped metal cornice and seven segmental arch bays which are accented by ornate window caps. (From an early photo in the Centennial publication, these window caps were a later addition). The central bay and the entrance below it are flanked by pilasters that rise to the cornice. A large part of the lower store front area has been altered through the addition of stucco.
