ARCHITECTURAL/HISTORICAL COMPONENT FORM

1) Resource No. 5CF272 2) Temp No. 61 3) Name Capricorn Liquors

4) Address 123 North F 5) District Name Salida Commercial District

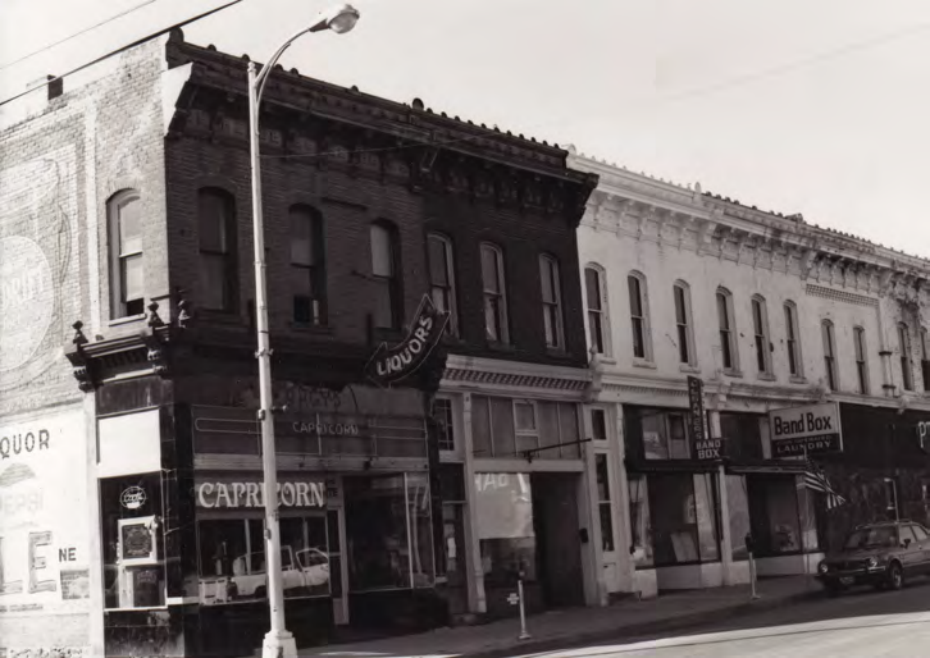
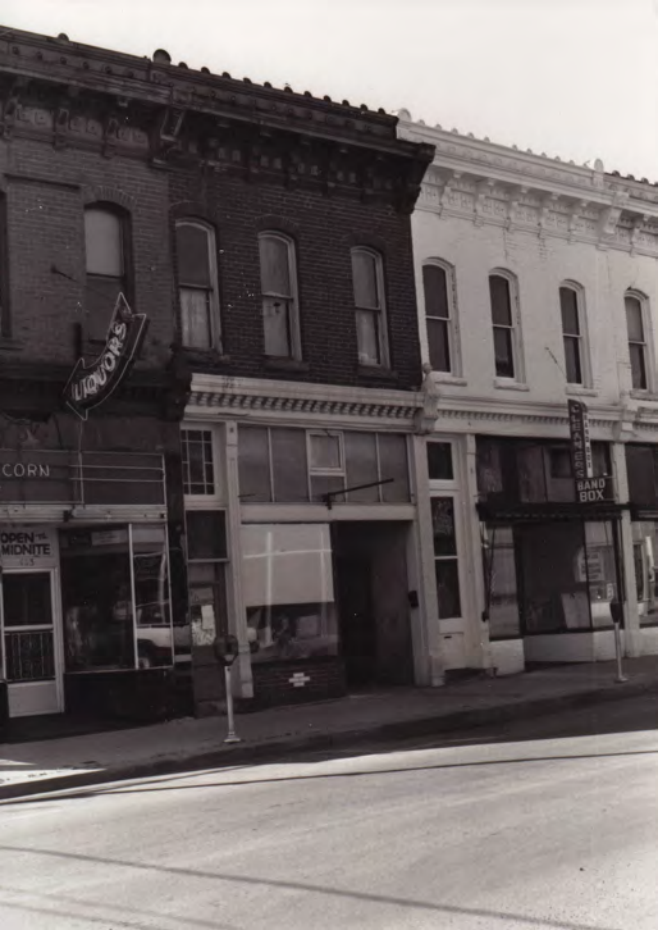
Frame Number 11
Roll Number CF4
Facade Orientation W

10) Unaltered Altered Explain: Carrara glass popular in the 1930's,
has been added to the storefront area

Special Features/Surroundings: See resource no. 5CF263.
An old sign for Snowdrift Shortening on north facade

The Capricorn Liquor Store is the northernmost building in a row of similar commercial structures. It is identified by the features common to its neighbors - a bracketed metal cornice, three segmental arch bays, and a continuous lintel separating the storefront area from the upper floor. On the ground level, a 1930's facade using carrara glass and neon light illumination is evident.
