ARCHITECTURAL/HISTORICAL COMPONENT FORM

1) Resource No. 5CF287 2) Temp No. 76 3) Name Kolbeck's Auto Service

3)Resource Name Kolbeck's Auto Service 4)Project Name FCRC Survey

23)Report Title Historical Surveys of Colorado Communities: Upper Arkansas Valley, Salida

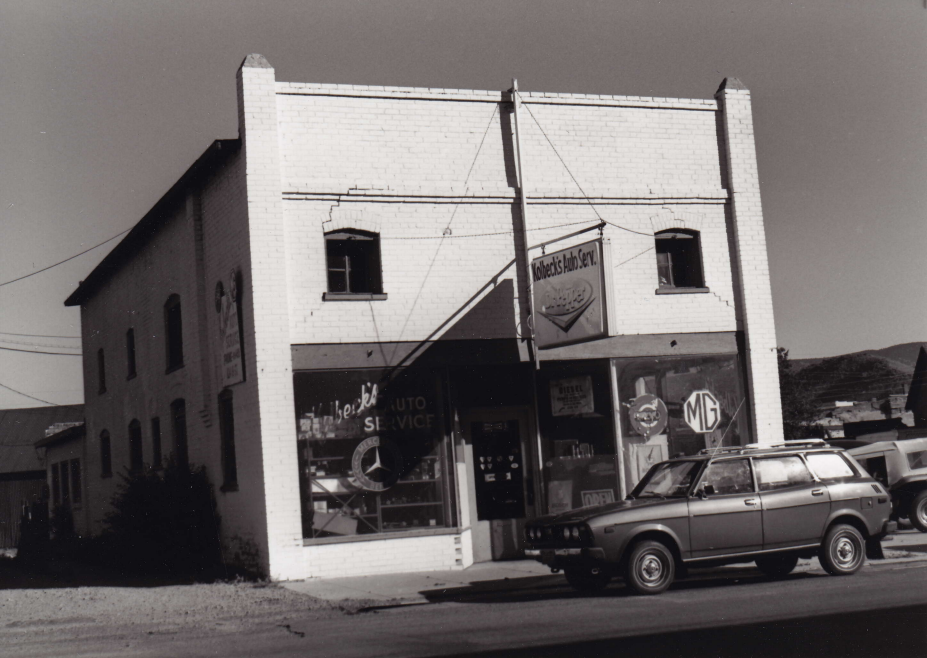
Frame Number 7
 Roll Number CF5
 Facade Orientation E

10) Unaltered Altered Explain: Although an original photo of the structure is unavailable, it appears that the storefront area is a recent modification. The building served as a hose house from c. 1904-1914 and garage entrances would have filled the lower portion of the building.

18)Disturbance:none light moderate X heavy total ; Explain Storefront appears
to be a recent modification

The building is distinguished by a parapet and two small segmental arch bays on the street facade. The lower level features a storefront area which would appear to be a recent modification because the building's original function (as a hose house) would have necessitated large garage entrances.

20)Management Recommendations continued maintenance of building
