ARCHITECTURAL/HISTORICAL COMPONENT FORM

- 1) Resource No. 5CF227 2) Temp No. 16 3) Name C.G. Casuals/Great American T-Shirts  
 4) Address 126-132 F Street 5) District Name Salida Commercial District

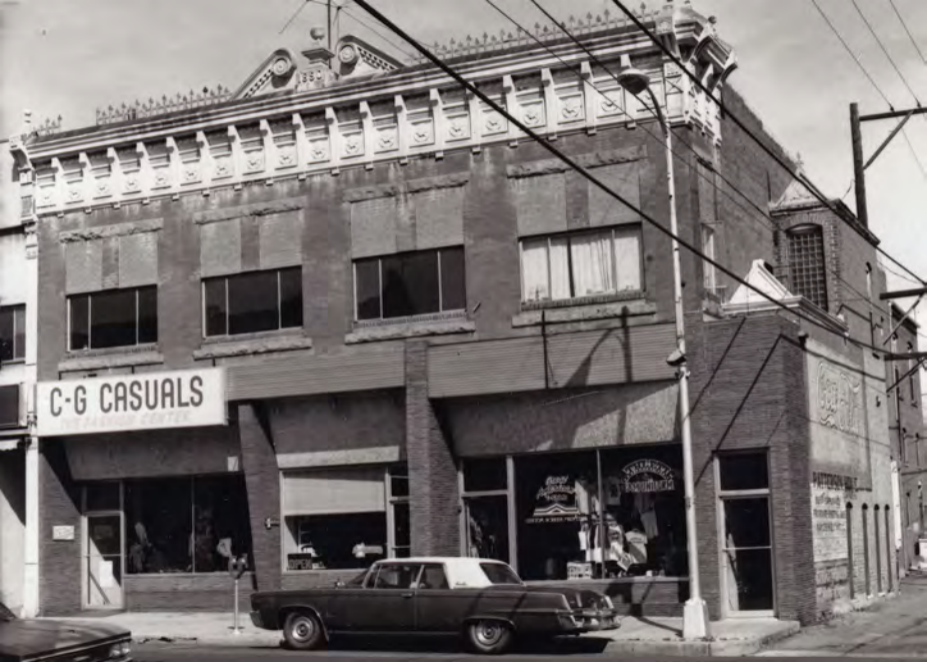
Frame Number 19  
 Roll Number CF1  
 Facade Orientation E

10) Unaltered  Altered  Explain: Original storefronts totally altered.  
Second story windows partially bricked in.

15) Special Features/Surroundings: The building's richly decorated cornice distinguishes it from its neighboring structures. The building itself continues the dominant patterns of the district.

This two story brick structure, named the Hively Block on the 1893 Sanborn map, is distinguished by a richly detailed cornice complete with brackets and metal roof cresting. On the second story the original paired bays have been partially bricked in and replaced by modern windows. The stone lintels and sills which highlighted the openings are still visible. Of special interest is the outside entrance on the north facade of the building. Although the street level entrance has been extensively altered, the windows lighting the stairway and the decorative pediment-like features above them are evident. On the ground floor the original storefronts have been totally modified.
