ARCHITECTURAL/HISTORICAL COMPONENT FORM

1) Resource No. 5CF220 2) Temp No. 9 3) Name American Selco Inc.

4) Address 128 North F 5) District Name Salida Commercial District

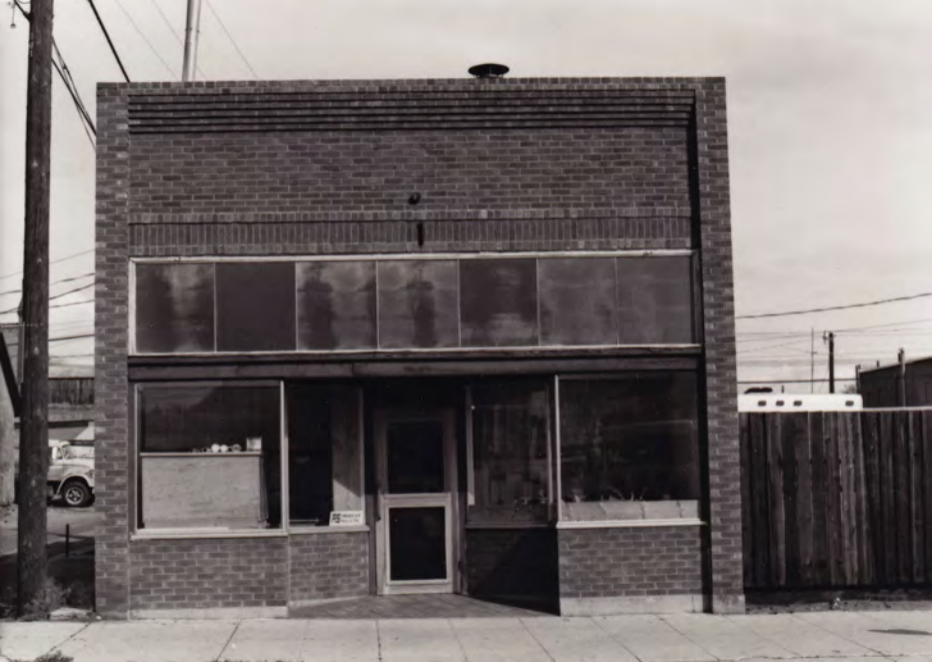
Frame Number	<u>11</u>
Roll Number	<u>CF1</u>
Facade Orientation	<u>E</u>

10) Unaltered Altered Explain: According to the assessor's card this structure was rebuilt in 1942. It has a new brick facade and a concrete block north wall

15) Special Features/Surroundings: The building is flanked by an alley (to the south) and an empty lot (to the north)

Although this one story brick structure was partially rebuilt in 1942, it plays a contributing role in the district. The building retains the features common to nearly all of the district's structures: a recessed entrance with flanking display windows and a transom window. The building is also characterized by simple brickwork patterns.
